# LIDAR Inspection Report of **Box Culvert** ch.1041+070

**Bridge Chainage:** 1041+070(CKRP)

## **CH: 1041+070 – Box CULVERT**

### **DISTRESS PHOTOS**

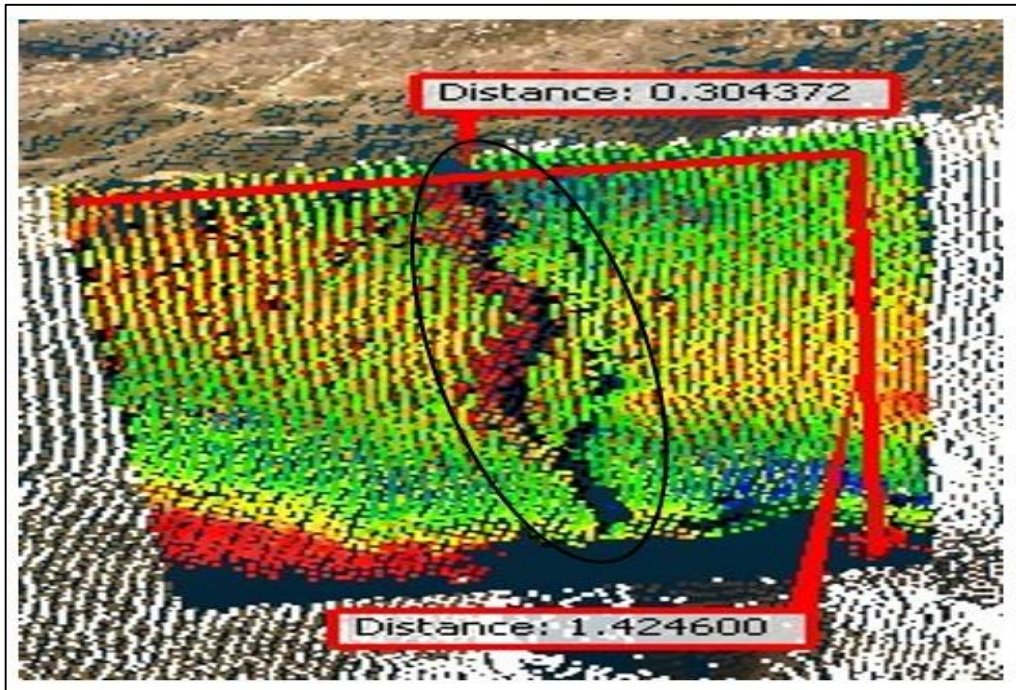
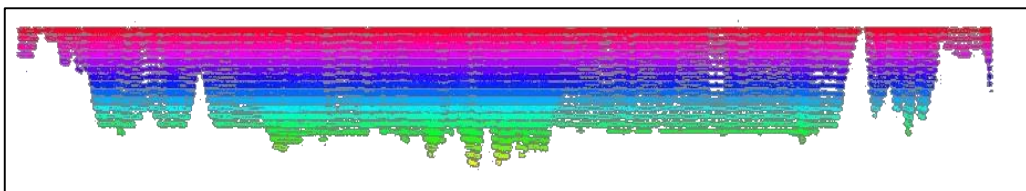
| Sl. No. | Description | Distress Notation | Observation | Location | | Distress Details | | | Area of Repair |
|---|---|---|---|---|---|---|---|---|---|
| 3 | Wing wall | | Damage | | | | | | |

1. Wing wall damage observed on LHS, measuring 1.42 m in length and 0.30 m in width, covering an area of 0.426 m<sup>2</sup>.

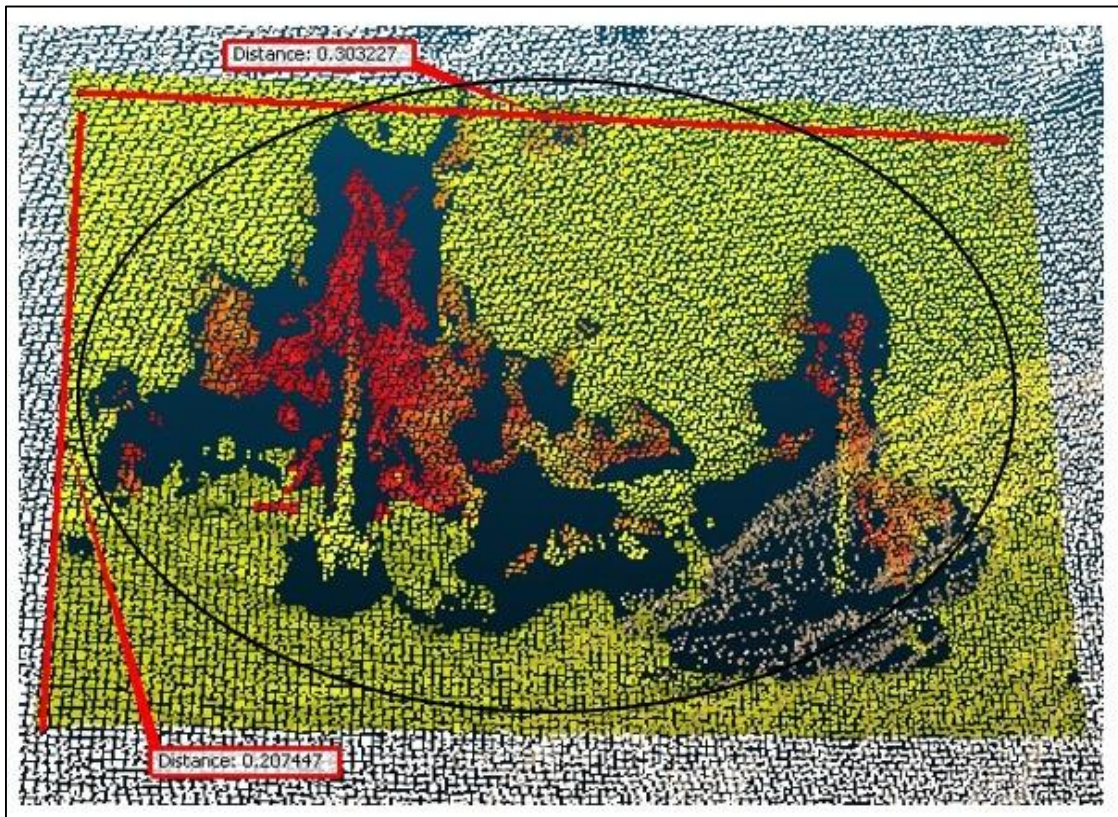
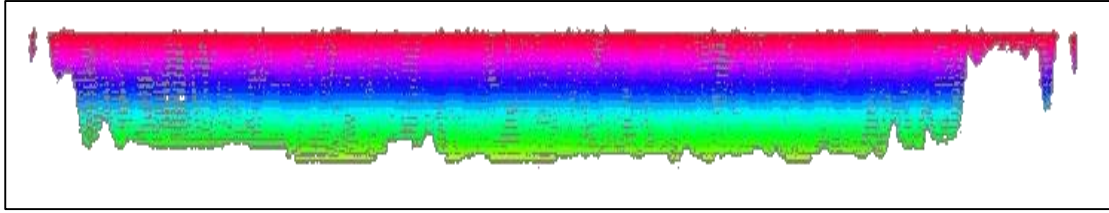
2. Abutment wall damage observed, measuring 0.30 m in length and 0.20 m in width, covering an area of 0.06 m<sup>2</sup>.

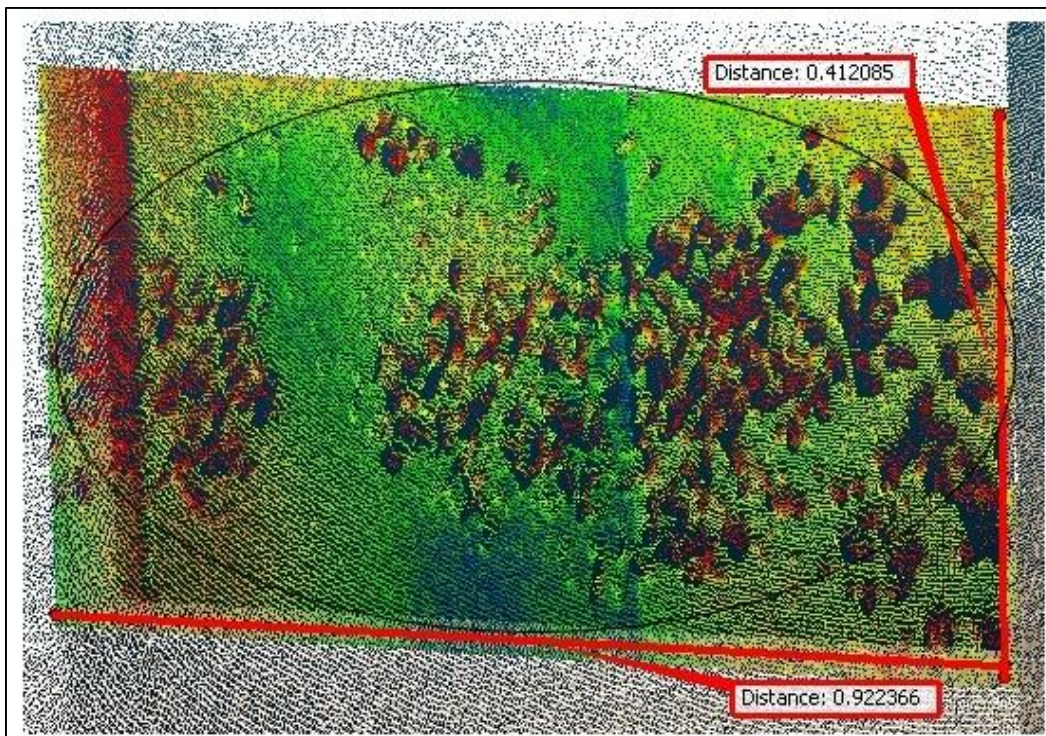
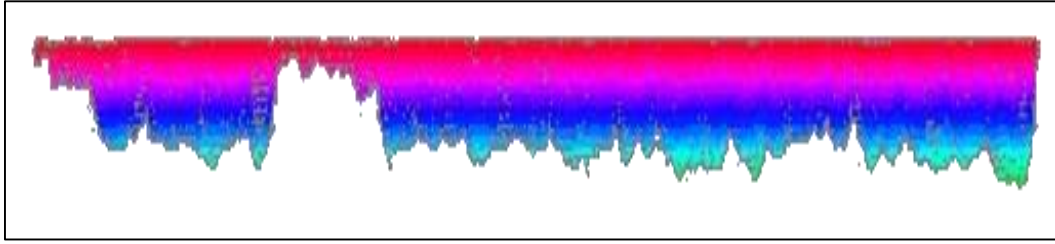
3. **Scaling observed on abutment wall, measuring 0.92 m in length and 0.41 m in width, covering an area of 0.3772 m<sup>2</sup>.**
