# **LIDAR Inspection Report of **Box Culvert** ch.1042+819**

**Bridge No:** Box Culvert

**Bridge Chainage:** 1042+819(CKRP)

- **CKRP:** Chittorgarh to kota
- **State:** Rajasthan NH 27
- **Zone:** RJ-06

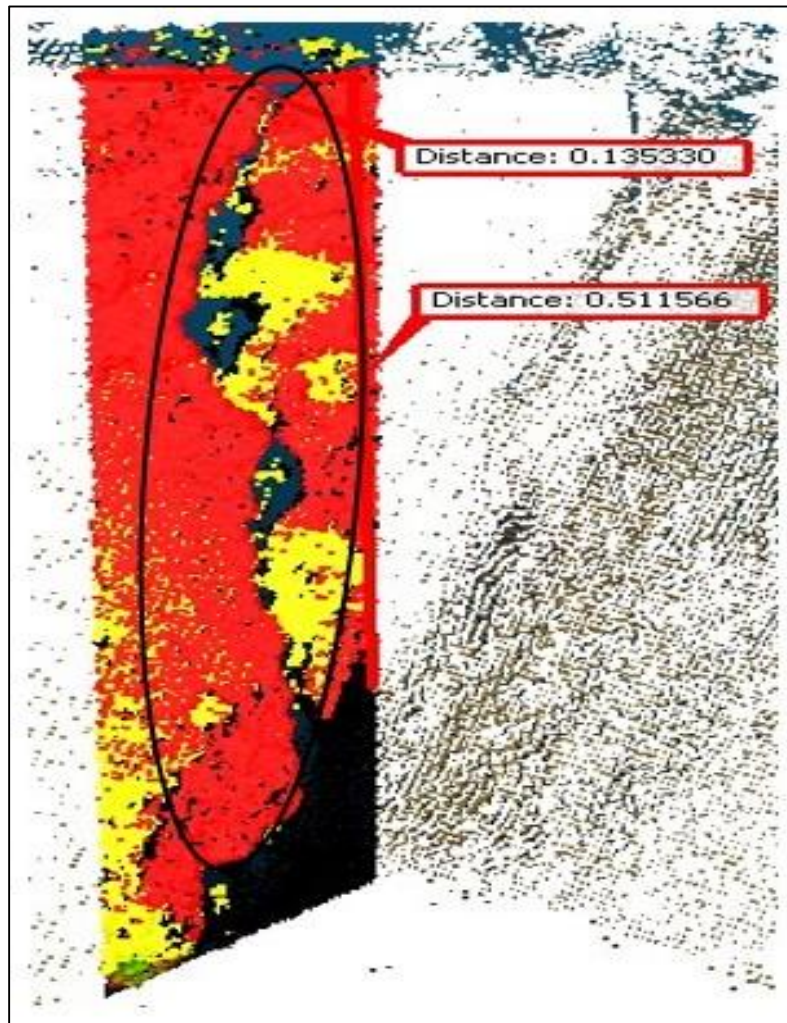
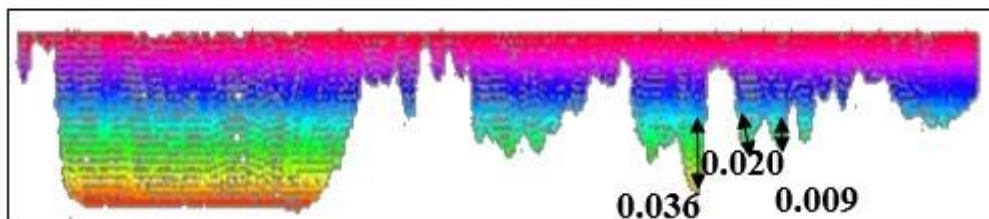
1. Wing wall damage observed on LHS, measuring 0.51 m in length and 0.13 m in width, covering an area of 0.0663 m<sup>2</sup>. Depth ranges from 0.009 (min) to 0.036 m (max), with an average depth of 0.020 m. The calculated volume of the distress is 0.0013 m

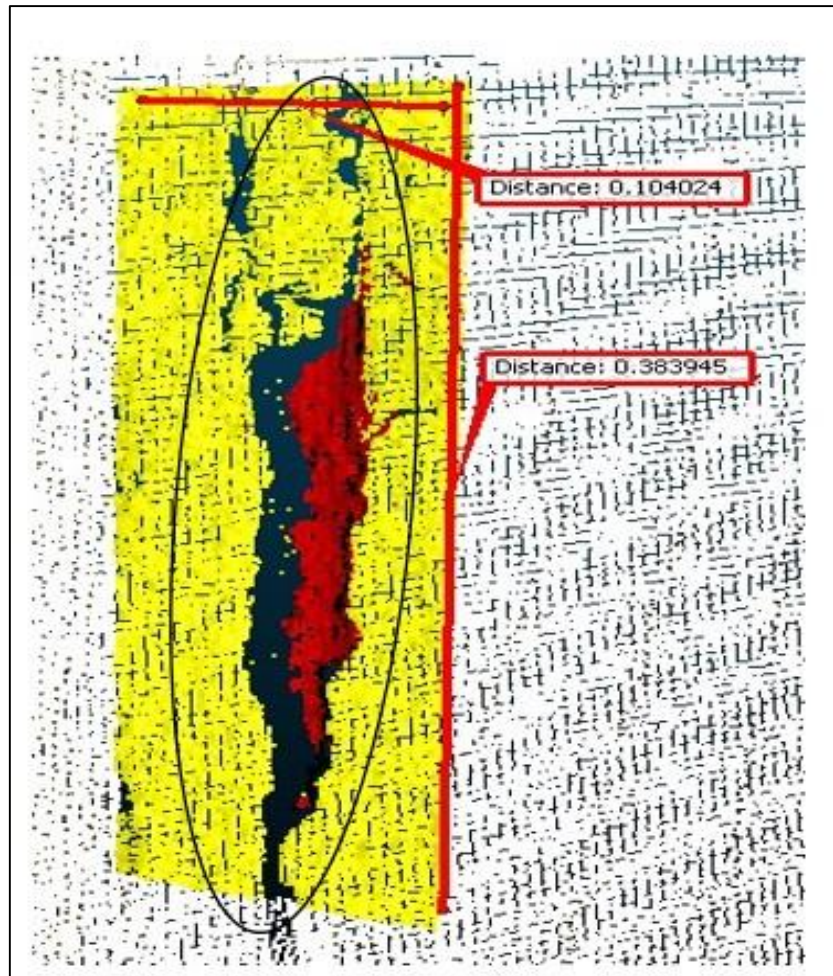
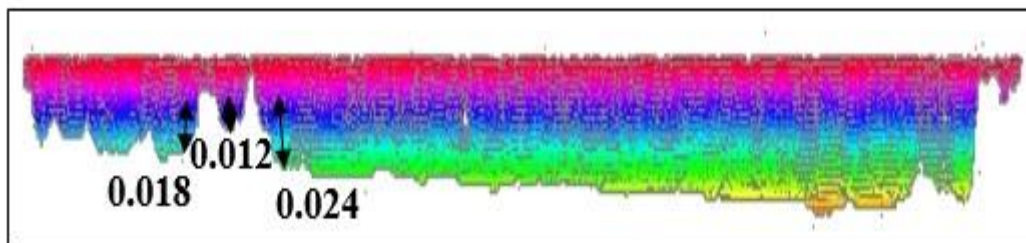
2. Wing wall damage observed on LHS, measuring 0.38 m in length and 0.10 m in width, covering an area of 0.038 m<sup>2</sup>. Depth ranges from 0.018 (min) to 0.024 m (max), with an average depth of 0.012 m. The calculated volume of the distress is 0.0004 m<sup>3</sup>

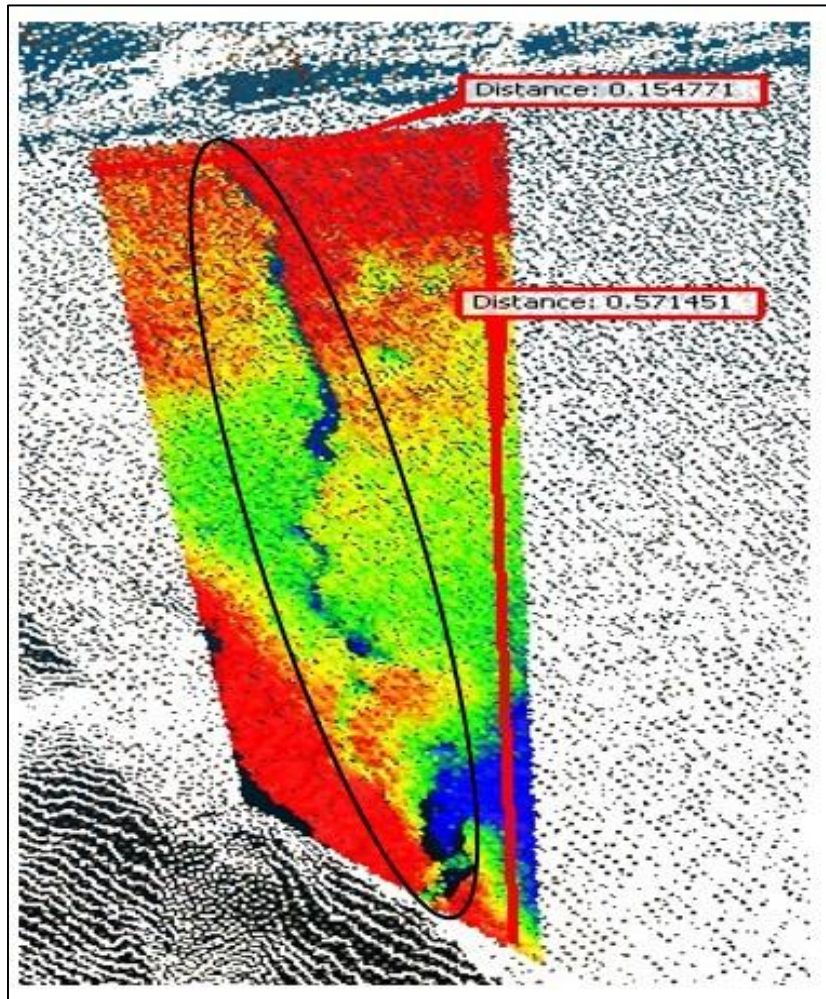
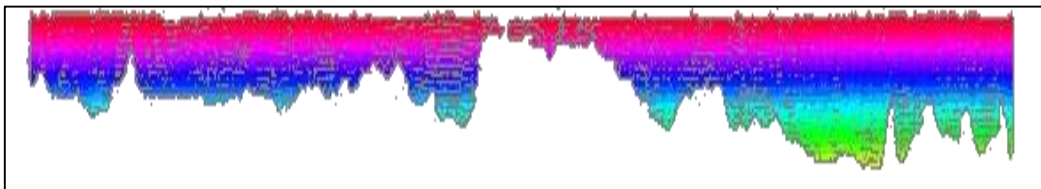
- 3. Wing wall damage observed on LHS, measuring 0.57 m in length and 0.15 m in width, covering an area of 0.0855 m<sup>2</sup>.**
