# **LIDAR Inspection Report of VUP ch.1046 + 870**

**Bridge Chainage:** 1046 + 870 (CKRP)

- **Bridge No:** -
- **Chainage:** 1046 +870
- **Structure type:** VUP

- **CKRP:** Chittorgarh to kota
- **State:** Rajasthan NH 27
- **Zone:** RJ-06

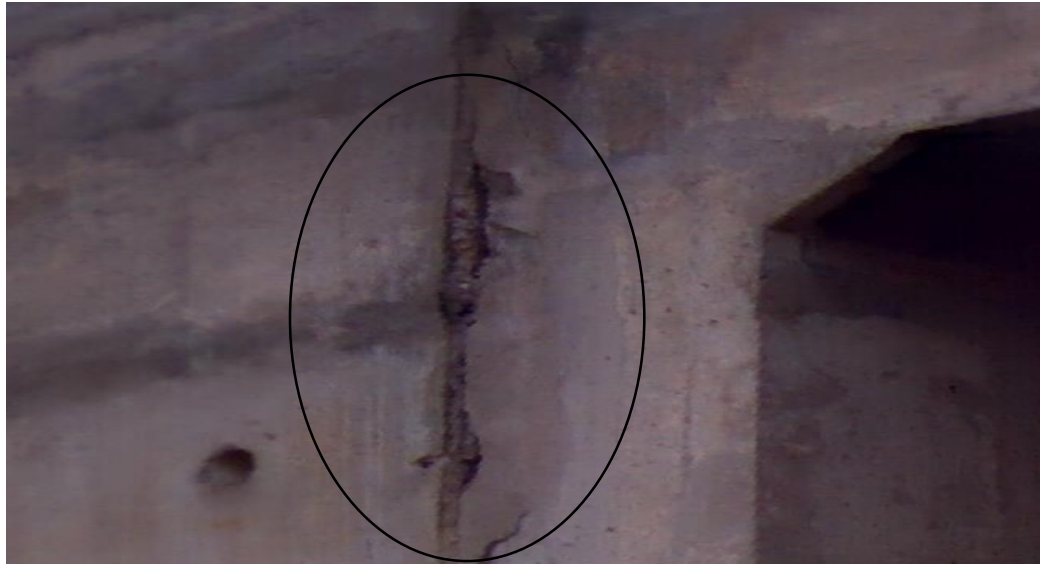
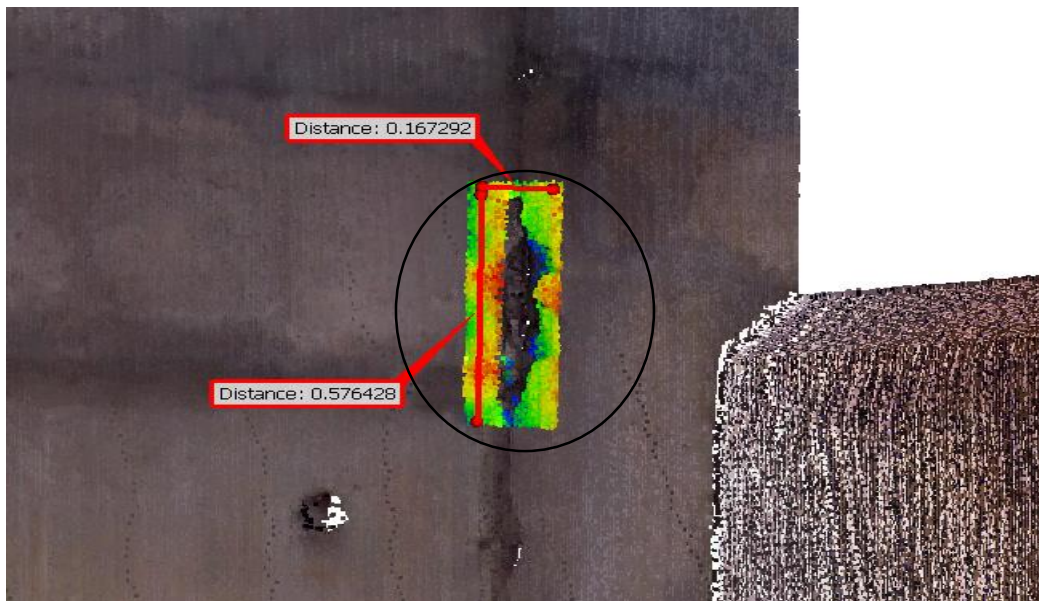
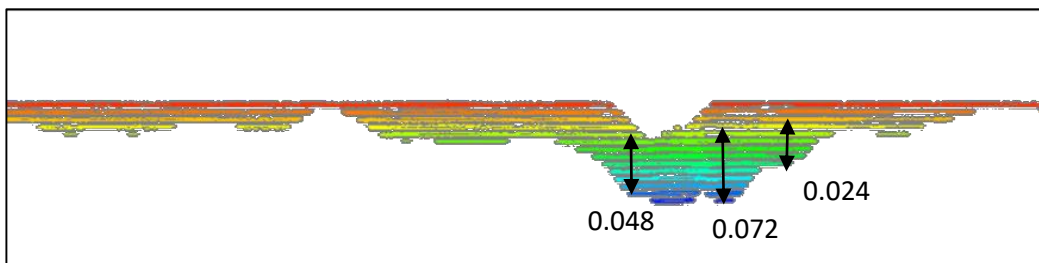
| Element Name | Observation | Location of Distress | Photo No. | Units | Distress Details | | | Area of Repair<br>(Sq.m/R<br>MT/m3) |
|---|---|---|---|---|---|---|---|---|
| Wing Wall | Damage | | 1 | M | 0.57 | 0.16 | 0.031 | 0.0028 |

**1. Damage observed on Abutment 1 RHS Wing Wall 1, measuring 0.57 m in length and 0.16 m in width, Depth ranges from 0.019 m (min) to 0.058 m (max), with an average depth of 0.031 m. The calculated volume of the distress is 0.0028m<sup>3</sup>.**

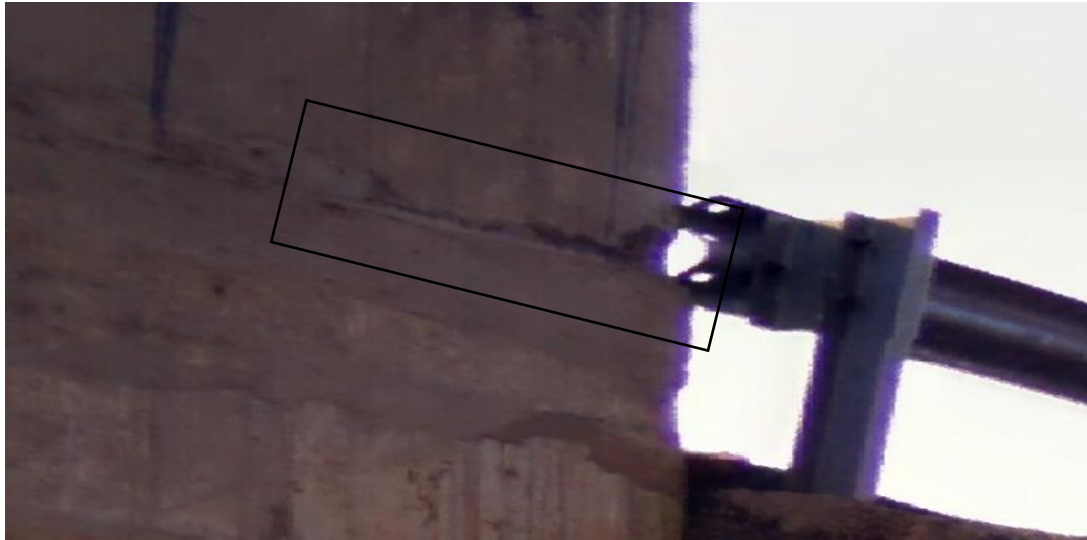
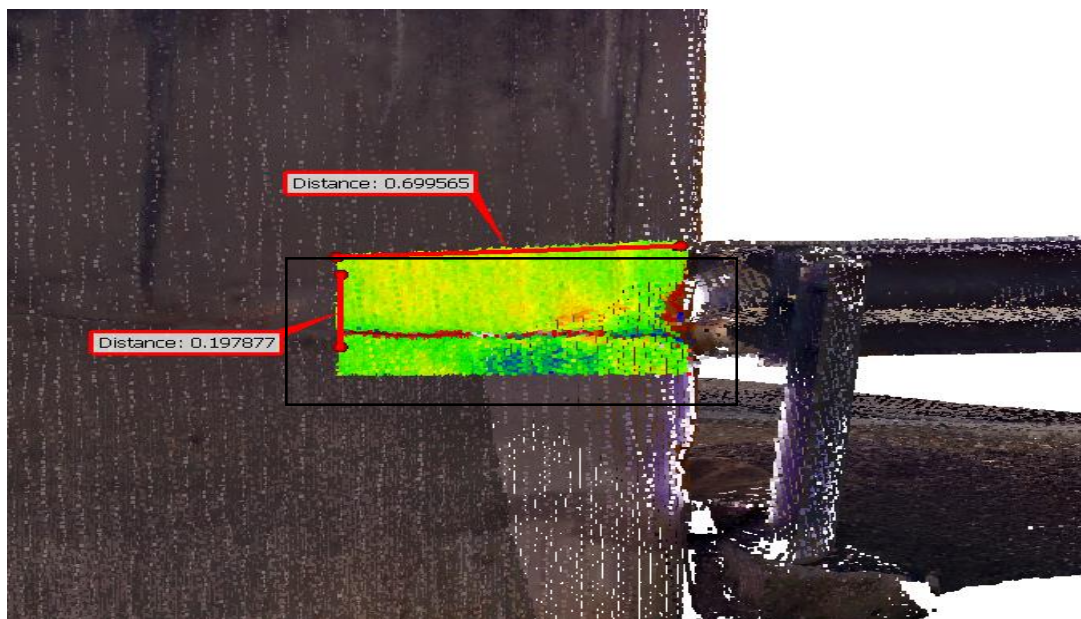
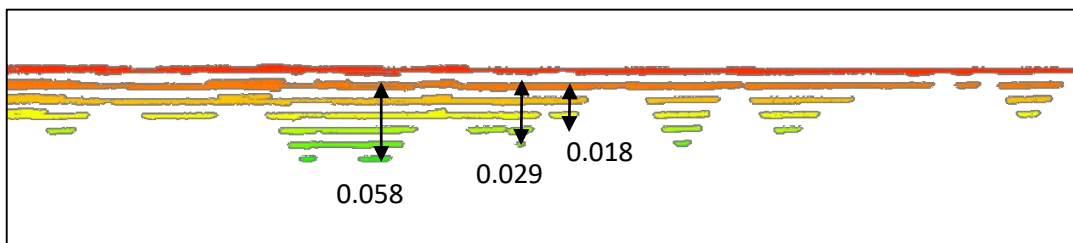
| Element Name | Observation | Location of Distress | Photo No. | Units | Distress Details | | | Area of Repair<br>(Sq.m/R<br>MT/m3) |
|---|---|---|---|---|---|---|---|---|
| Wing Wall | Damage | | 2 | M | 0.69 | 0.19 | 0.029 | 0.0038 |

**2. Damage observed on Abutment 2 LHS Wing Wall 2, measuring 0.69 m in length and 0.19 m in width, Depth ranges from 0.018 m (min) to 0.058 m (max), with an average depth of 0.029 m. The calculated volume of the distress is 0.0038m<sup>3</sup>.**

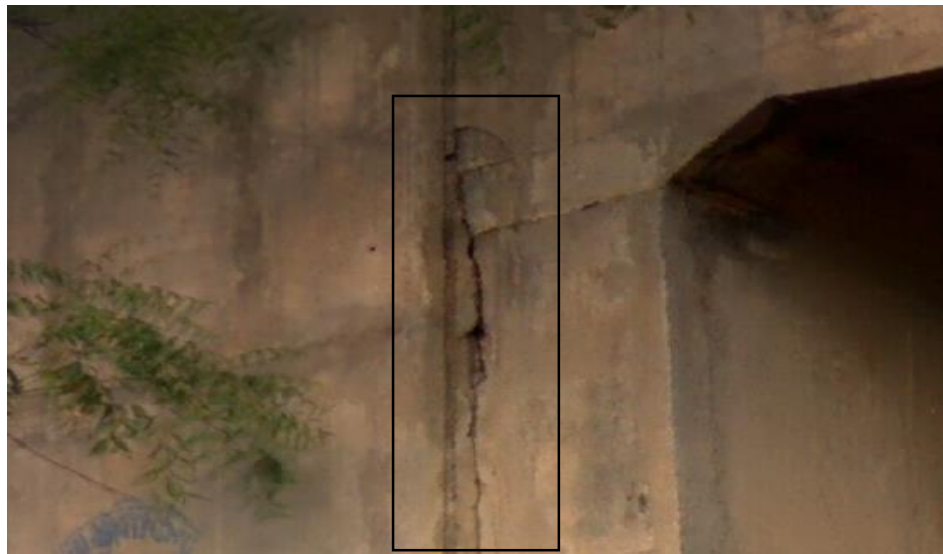
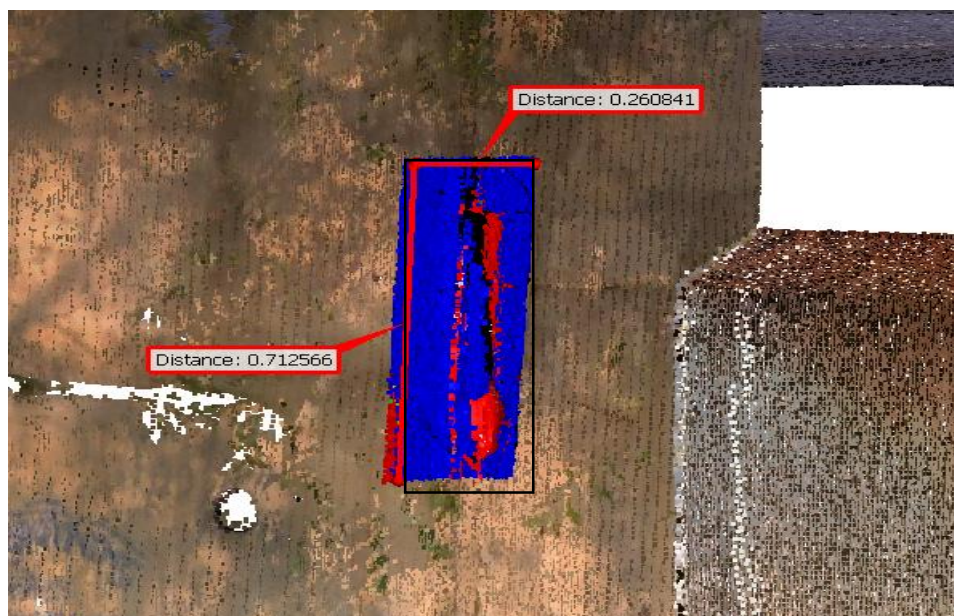
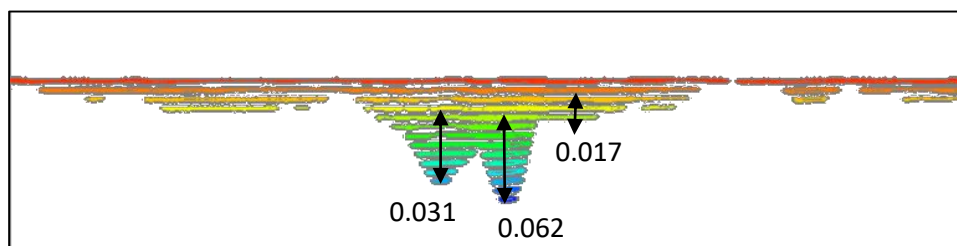
| Element Name | Observation | Location of Distress | Photo No. | Units | Distress Details | | | Area of Repair<br>(Sq.m/R<br>MT/m3) |
|---|---|---|---|---|---|---|---|---|
| Wing Wall | Damage | | 3 | M | 0.71 | 0.71 | 0.031 | 0.0057 |

**3. Damage observed on Abutment 2 LHS Wing Wall 3, measuring 0.71 m in length and 0.26 m in width, Depth ranges from 0.017 m (min) to 0.062 m (max), with an average depth of 0.031 m. The calculated volume of the distress is 0.0057 m<sup>3</sup>.**

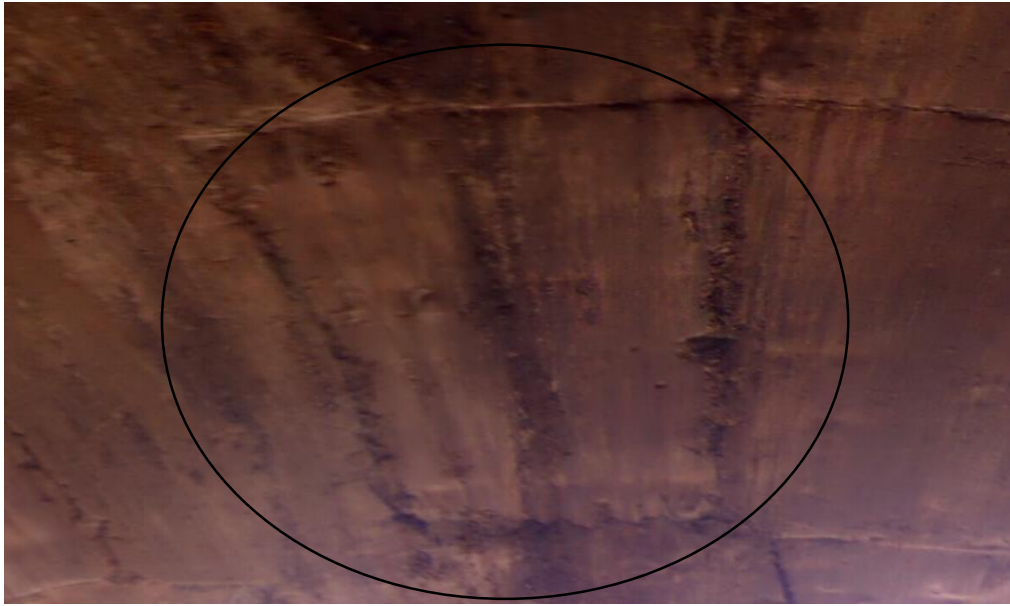
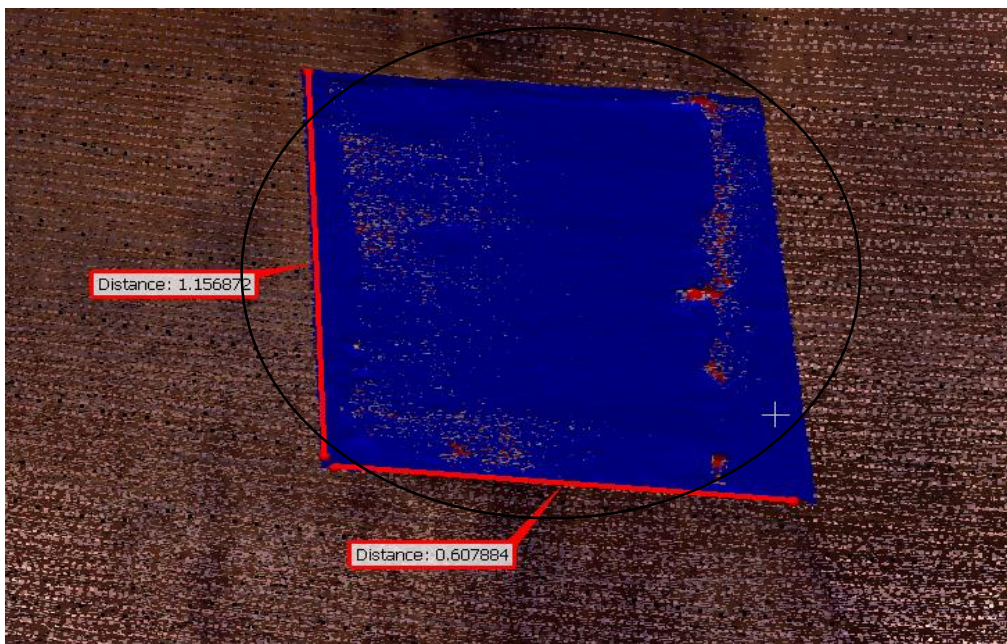
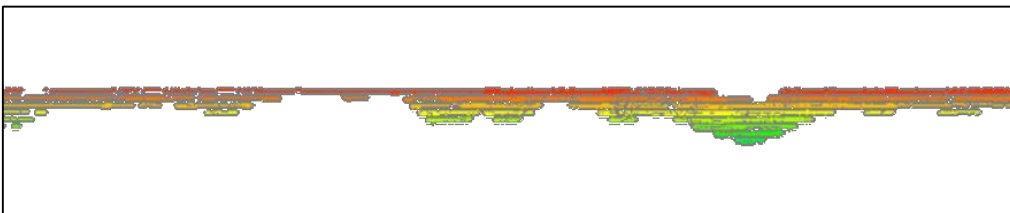
| Element Name | Observation | Location of Distress | Photo No. | Units | Distress Details | | | Area of Repair<br>(Sq.m/R<br>MT/m3) |
|---|---|---|---|---|---|---|---|---|
| Bottom Slab | Scaling | | 4 | M | 1.15 | 0.60 | | 0.69 |

**4. Scaling observed on Slab Bottom, measuring 1.15 m in length and 0.60 m in width, covering an area of 0.6900 m<sup>2</sup>.**

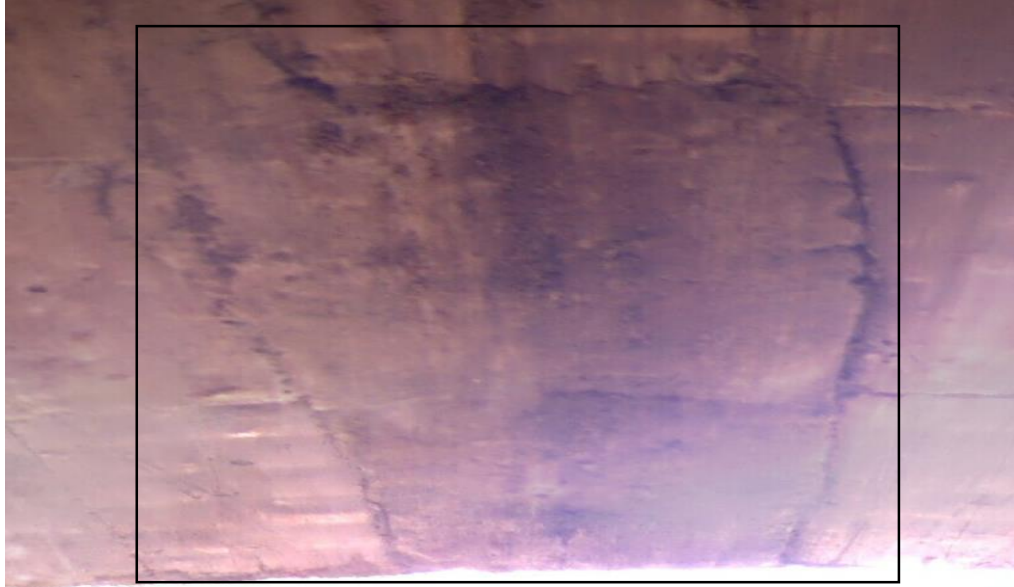
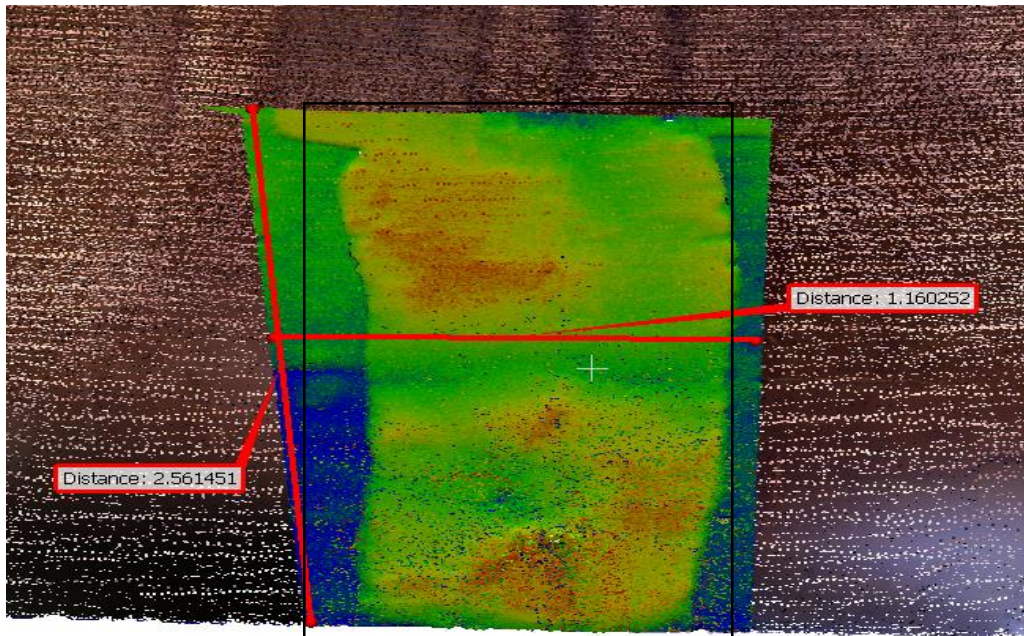
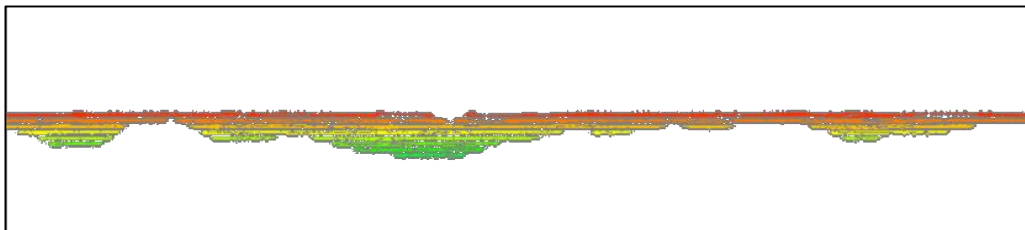
| Element Name | Observation | Location of Distress | Photo No. | Units | Distress Details | | | Area of Repair<br>(Sq.m/R<br>MT/m3) |
|---|---|---|---|---|---|---|---|---|
| Bottom Slab | Scaling | | 5 | M | 2.56 | 1.16 | | 2.9696 |

**5. Scaling observed on Slab Bottom, measuring 2.56 m in length and 1.16 m in width, covering an area of 2.9696 m<sup>2</sup>.**
