# **LIDAR Inspection Report of **Box Culvert** ch.1047+629**

**Bridge Chainage:** 1047+629(CKRP)

- **CKRP:** Chittorgarh to kota
- **State:** Rajasthan NH 27
- **Zone:** RJ-06

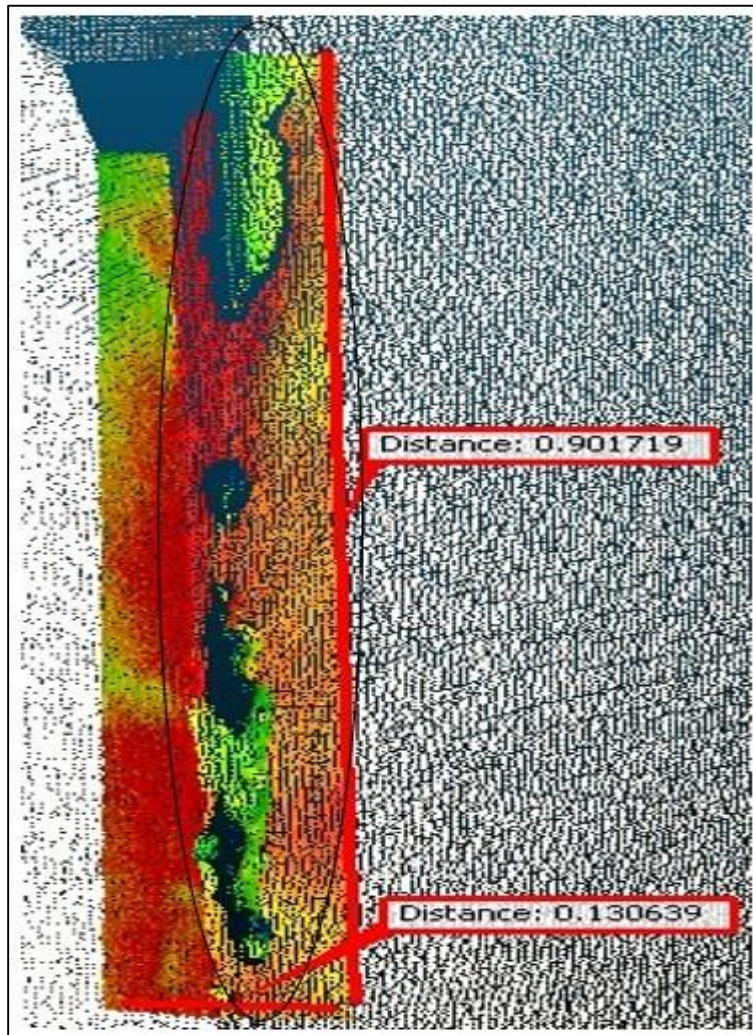
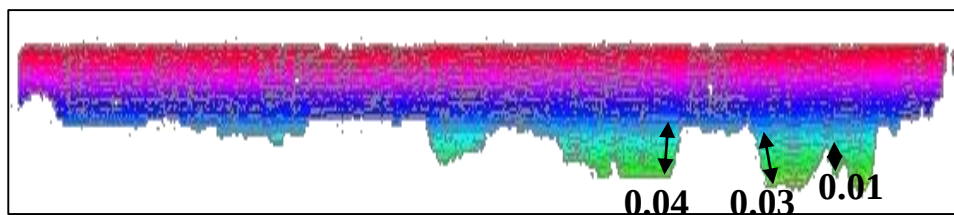
| Sl. No. | Description | Distress Notation | Observation | Location | | Distress Details | | | Area of Repair |
|---|---|---|---|---|---|---|---|---|---|
| 3 | Wing wall | | Damage | | | | | | |

1. Wing wall damage observed, measuring 0.90 m in length and 0.13 m in width, covering an area of 0.117 m<sup>2</sup>. Depth ranges from 0.01 (min) to 0.04 m (max), with an average depth of 0.03 m. The calculated volume of the distress is 0.003 m<sup>3</sup>.

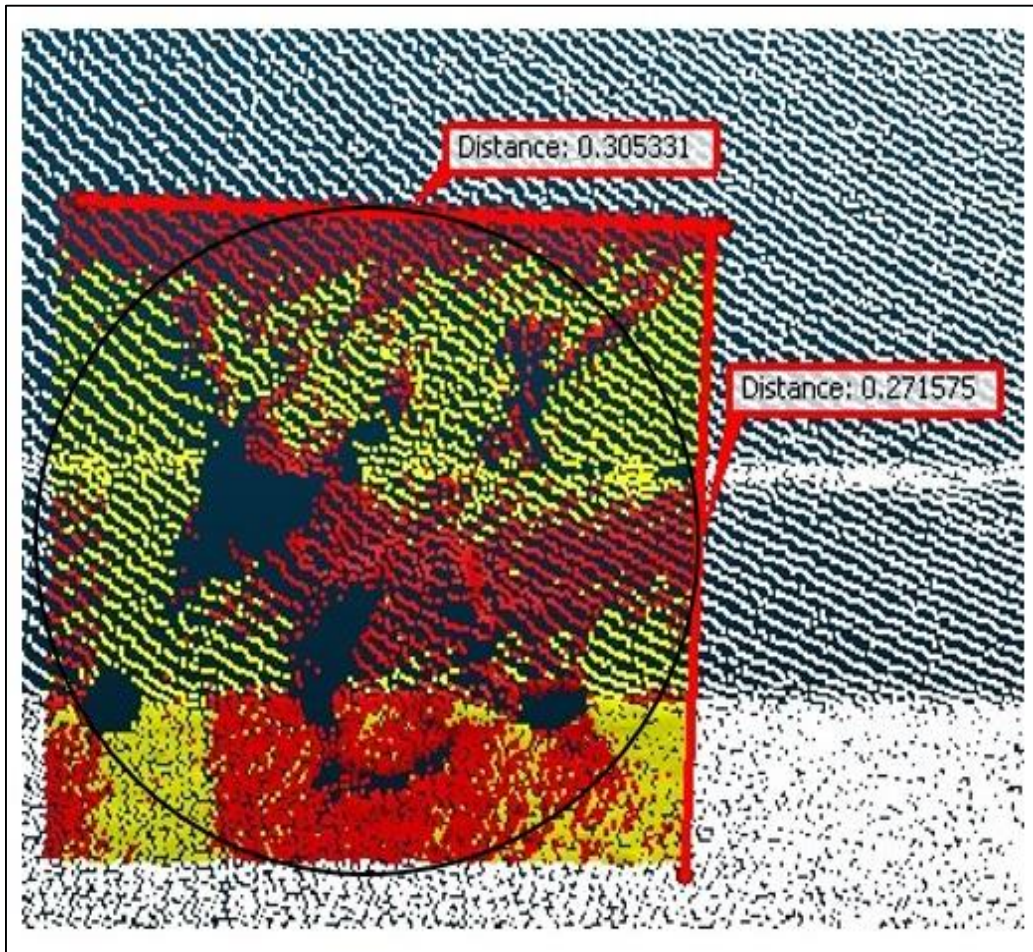
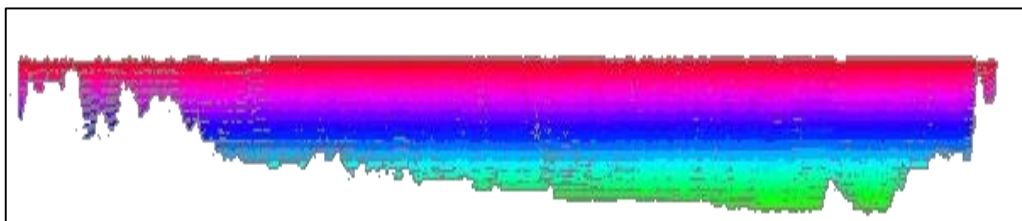
2. Abutment wall damage observed, measuring 0.30 m in length and 0.27 m in width, covering an area of 0.081 m<sup>2</sup>.
