# LIDAR Inspection Report of **Box Culvert** ch.1050+157

**Bridge Chainage:** 1050+157 (CKRP)

# **CH: 1050+157 – Box CULVERT**

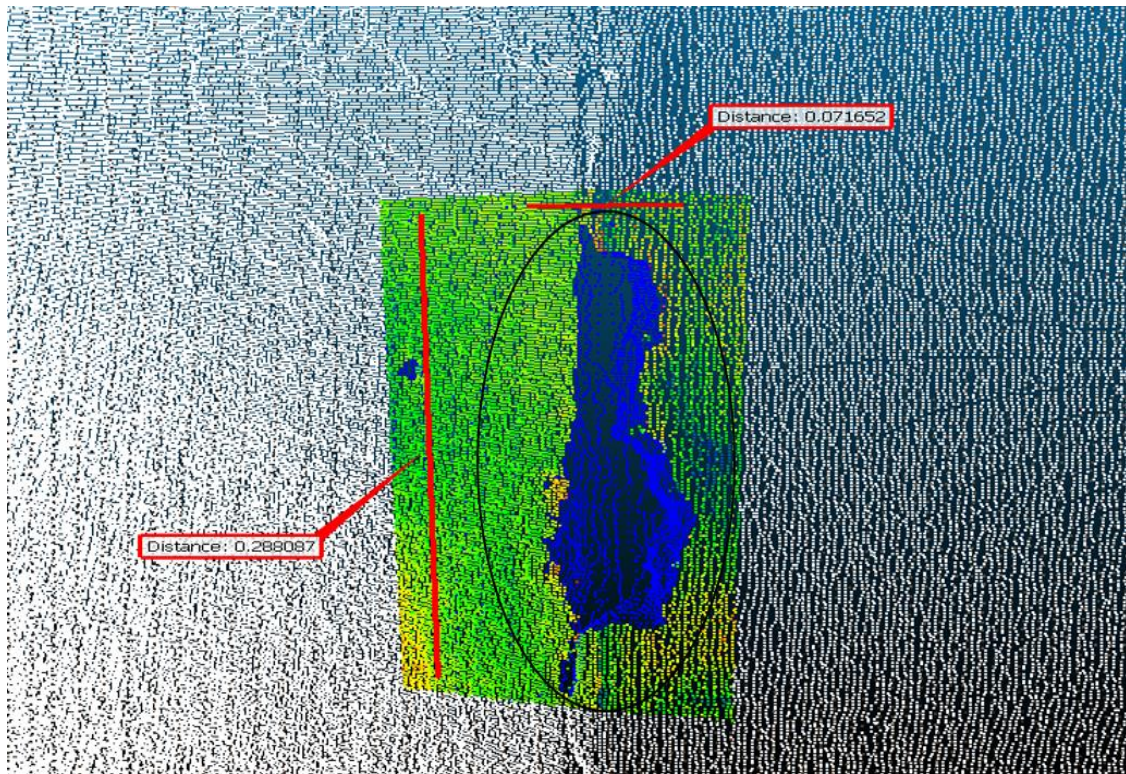
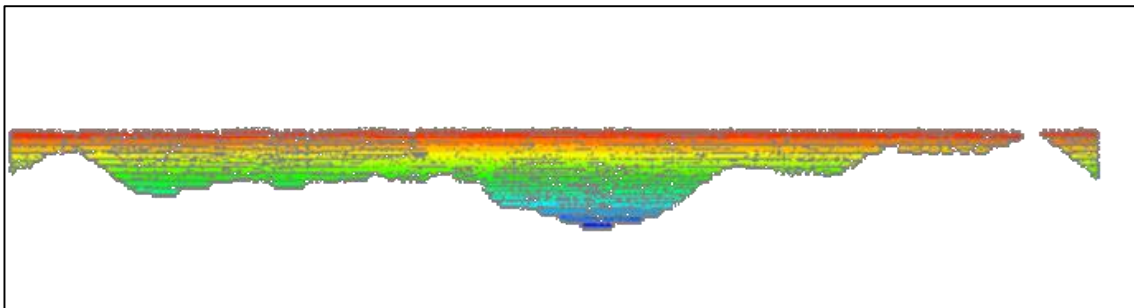
1. Wing wall damage observed on LHS , measuring 0.2880 m in length and 0.0716 m in width, covering an area of 0.021 m<sup>2</sup>.

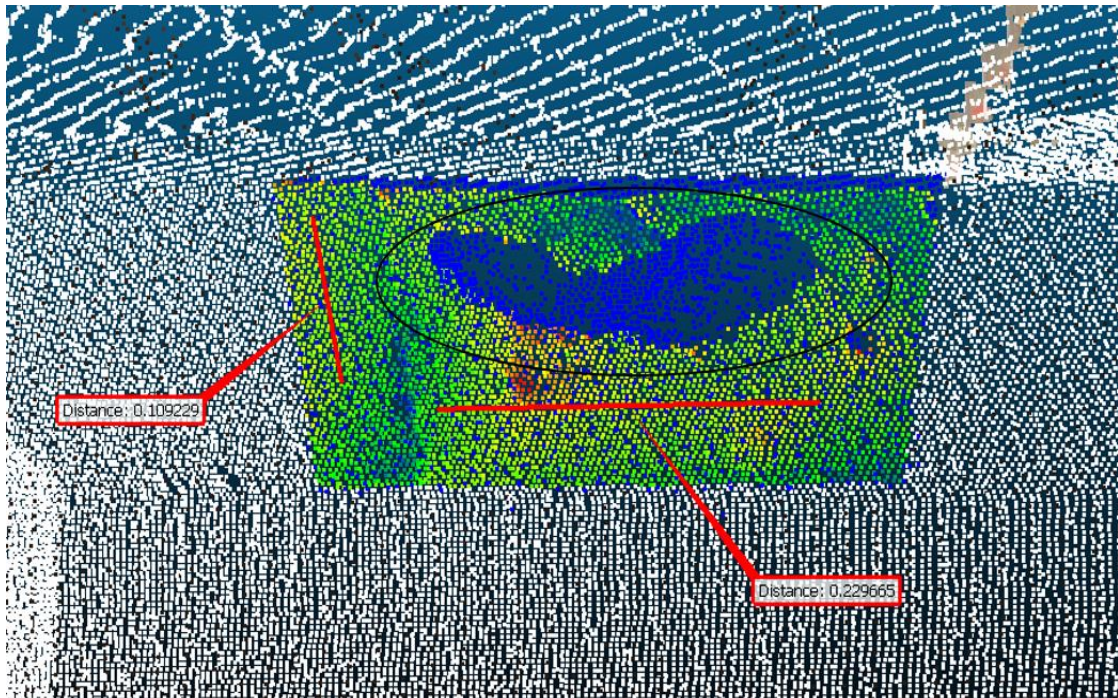
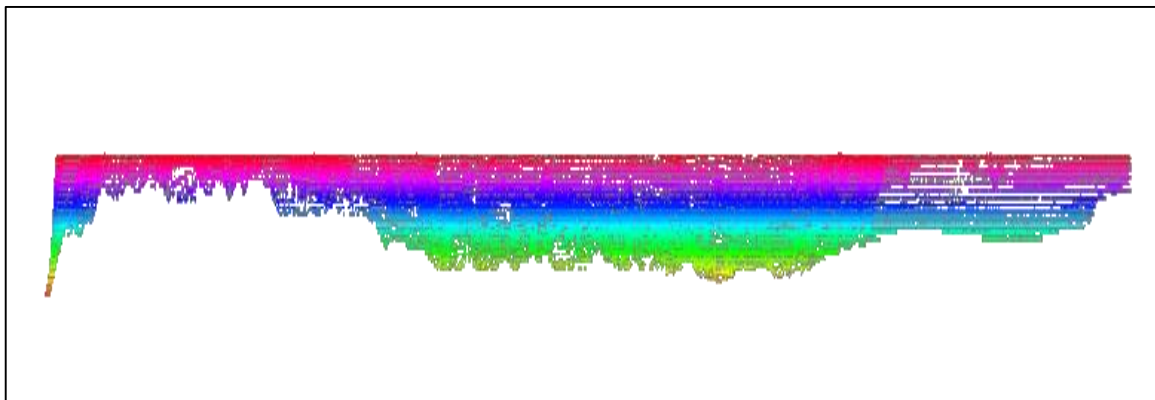
2. Abutment 1 damage observed on LHS, measuring 0.2296 m in length and 0.1092 m in width, covering an area of 0.025 m<sup>2</sup>.

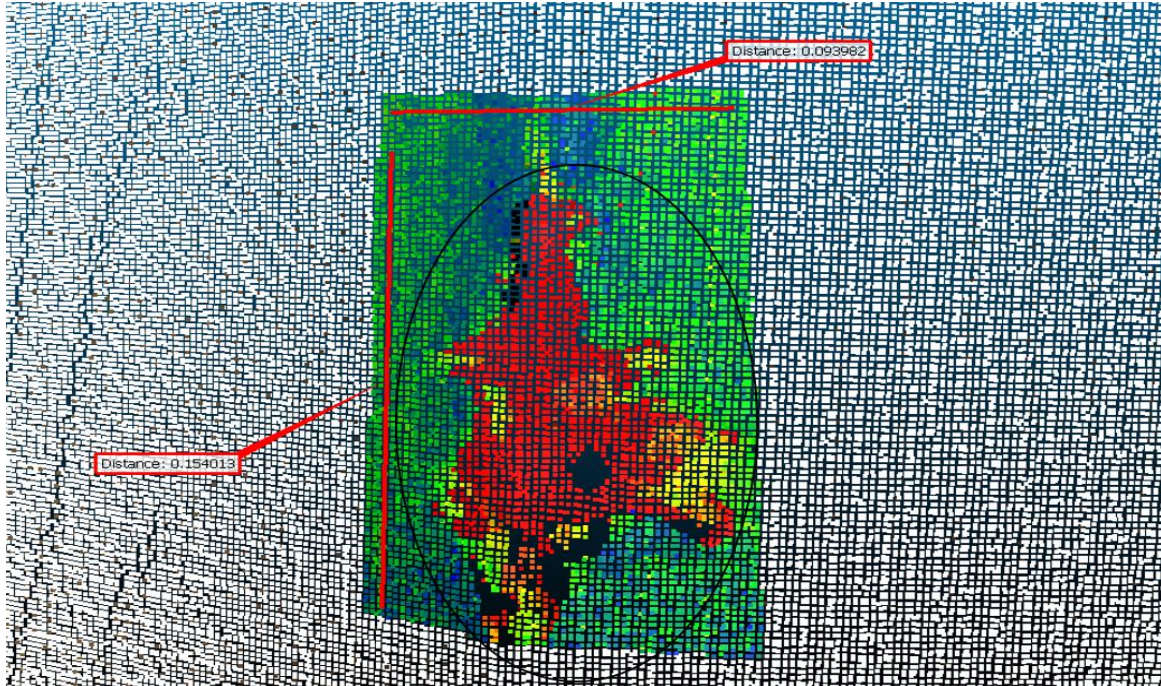
- 3. Return wall damage observed on RHS, measuring 0.1540 m in length and 0.0939 m in width, covering an area of 0.014 m<sup>2</sup>.**
