# LIDAR Inspection Report of **Box Culvert** ch.1050+749

**Bridge Chainage:** 1050+749 (CKRP)

**Latitude/Longitude:** 25.14459, 75.73489

# **CH: 1050+749 – Box CULVERT**

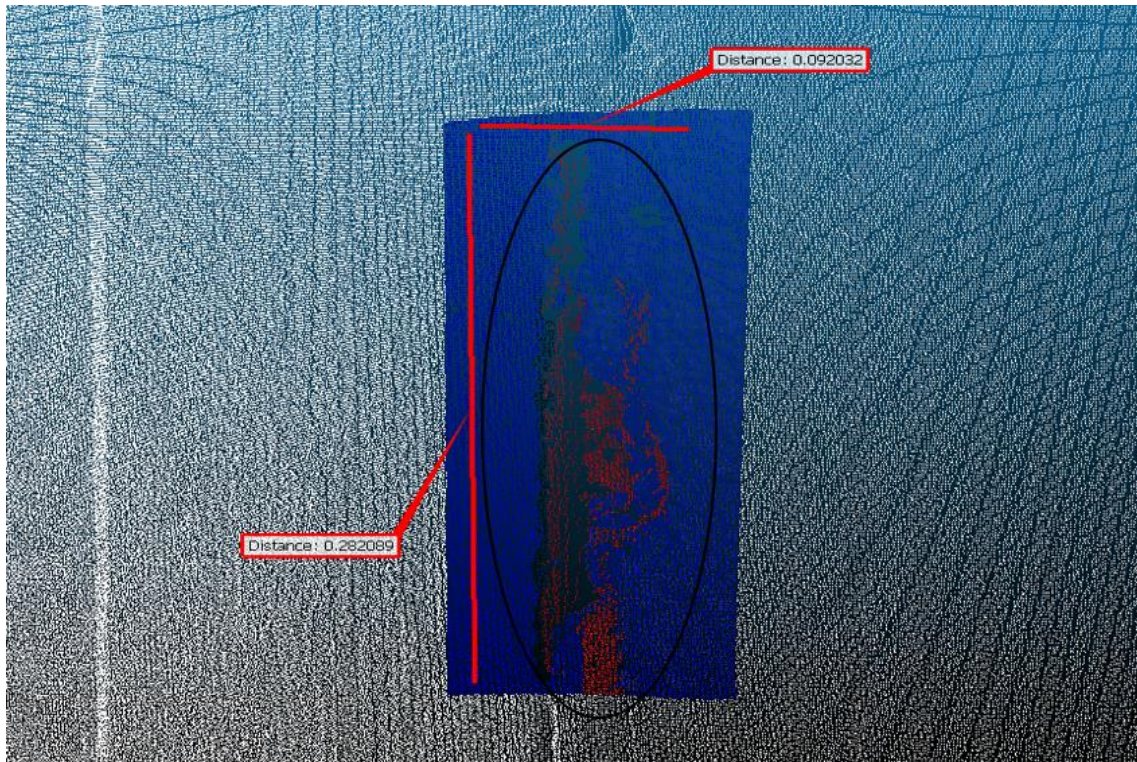
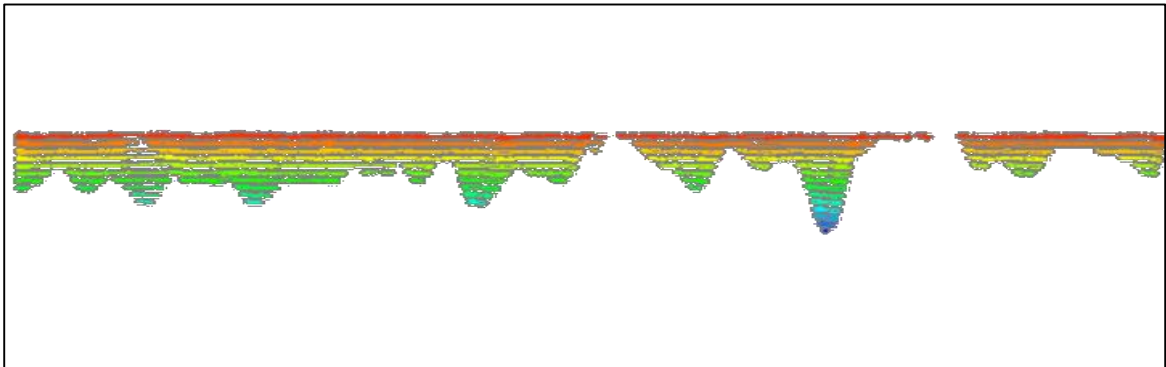
| Sl. No. | Description | Distress Notation | Observation | Location | | Distress Details | | | Area of Repair |
|---|---|---|---|---|---|---|---|---|---|
| 1 | Return wall | | Damage (LHS) | | | | | | |

1. Return wall damage observed on LHS, measuring 0.2820 m in length and 0.0920 m in width, covering an area of 0.026 m<sup>2</sup>.

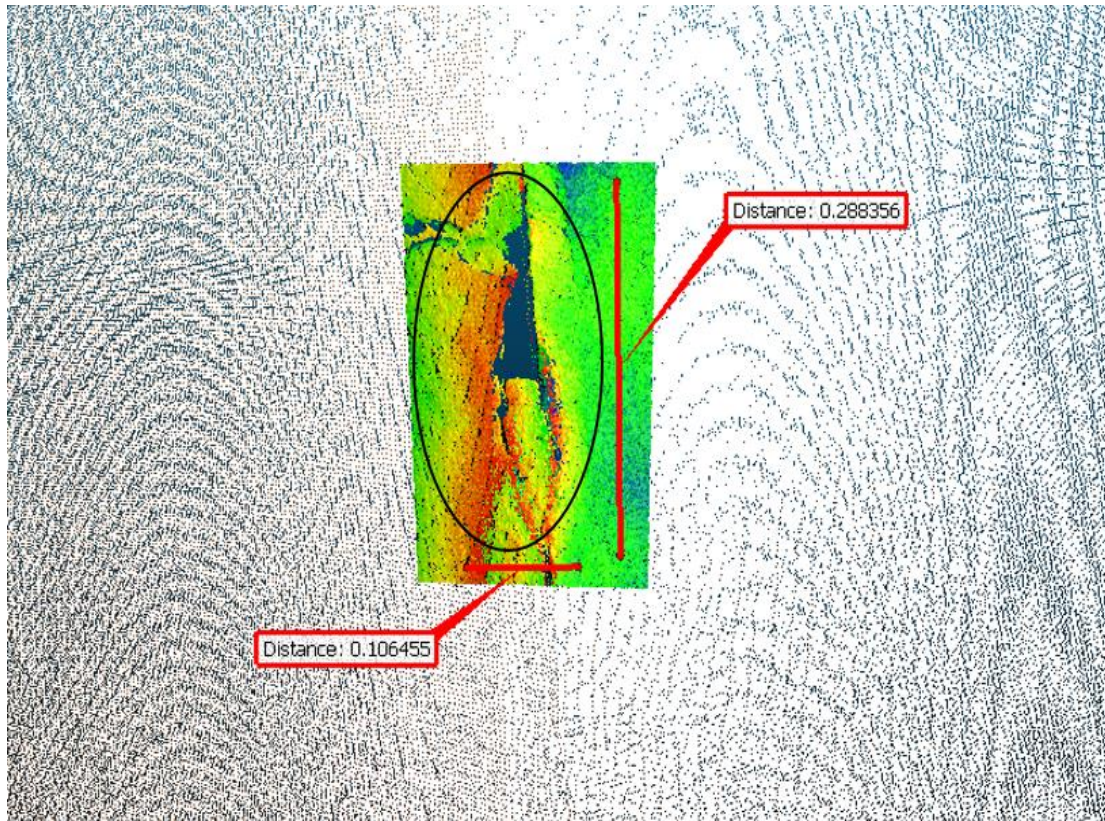
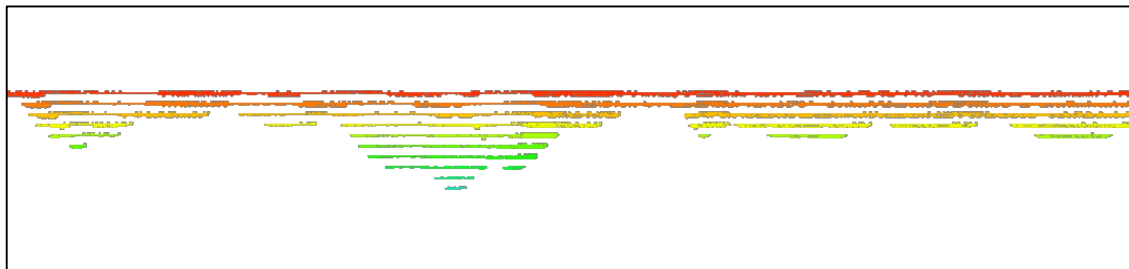
2. Return wall damage observed on LHS, measuring 0.2883 m in length and 0.1064 m in width, covering an area of 0.031 m<sup>2</sup>.

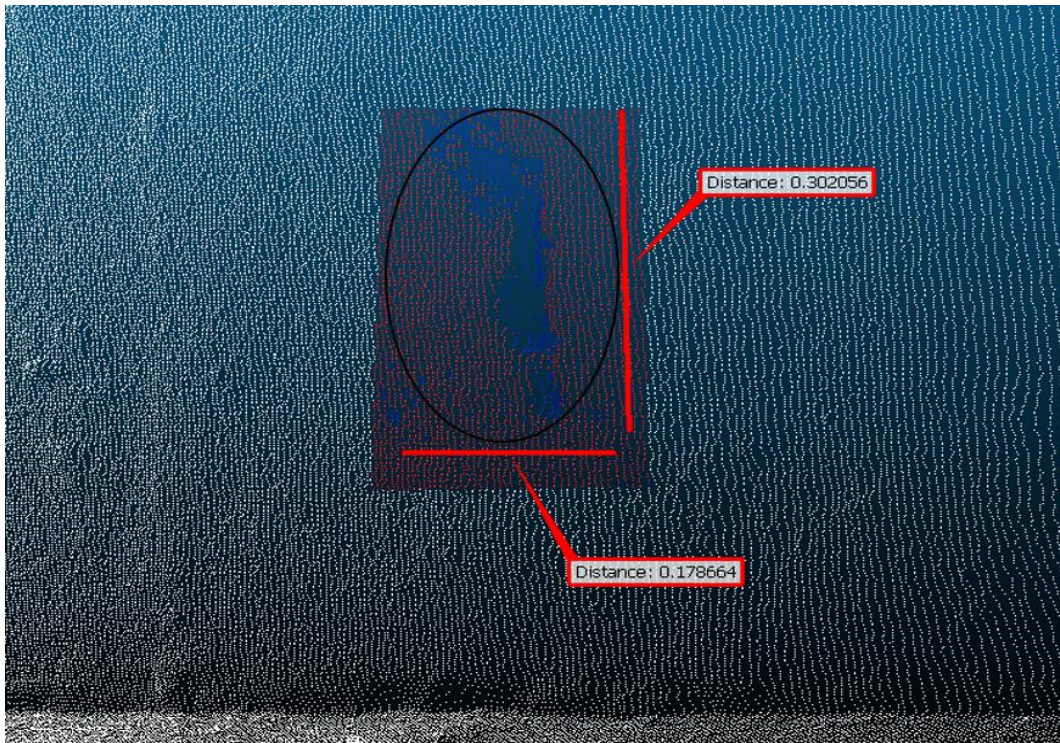
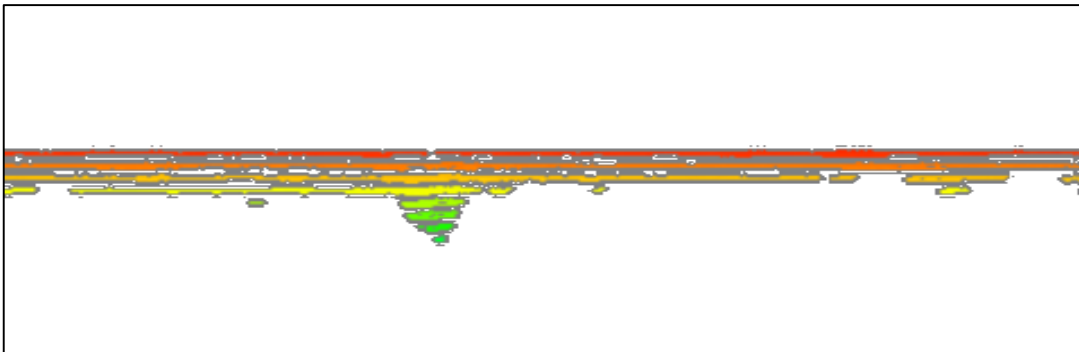
| Sl. No. | Description | Distress Notation | Observation | Location | | Distress Details | | | Area of Repair |
|---|---|---|---|---|---|---|---|---|---|
| 3 | Wing wall | | Damage (RHS) | | | | | | |

- 3. Return wall damage observed on RHS, measuring 0.3020 m in length and 0.1786 m in width, covering an area of 0.054 m<sup>2</sup>.**
