# LIDAR Inspection Report of **Box Culvert** ch.948+470

**Bridge Chainage:** 948 + 470 (CKRP)

- **CKRP:** Chittorgarh to kota
- **State:** Rajasthan NH 27
- **Zone:** RJ-06

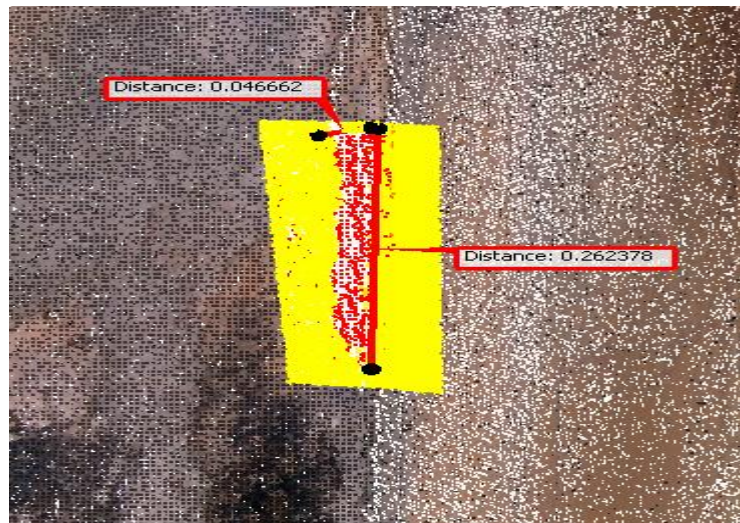
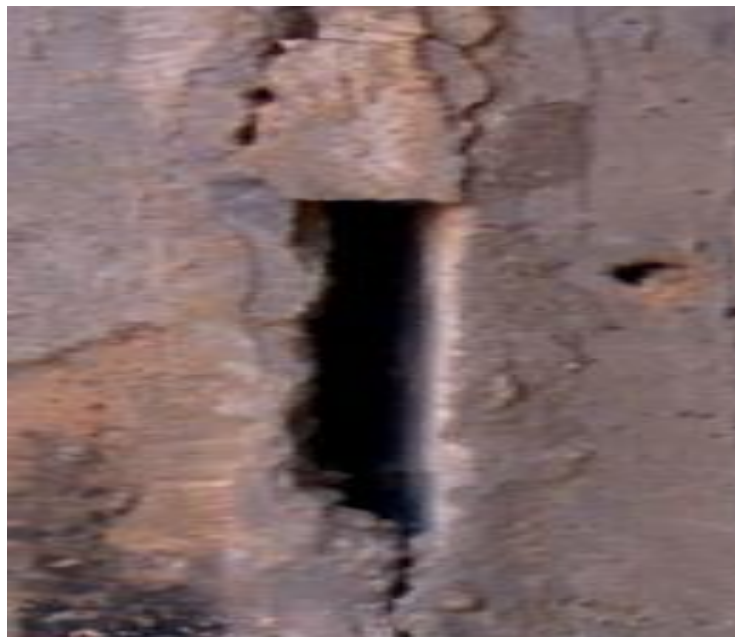
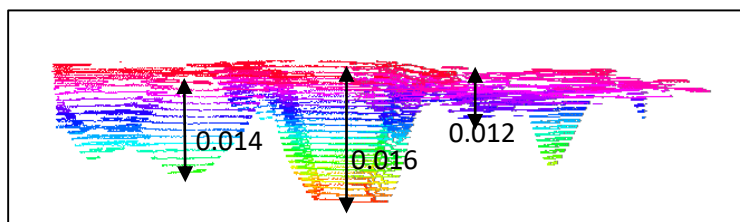
| Element Name | Observation | Location of Distress | Photo No. | Units | Distress Details | | | Area of Repair (Sq.m/ RMT/ m3) |
|---|---|---|---|---|---|---|---|---|
| Wing Wall | Damage | - | 1 | M | 0.26 | 0.046 | 0.014 | 0.0001 |

**1. Damage observed at the junction of wing wall and abutment wall, measuring 0.26 m in length and 0.046 m in width. Depth ranges from 0.012 m (min) to 0.016 m (max), with an average depth of 0.014 m. The calculated volume of the distress is 0.0001 m<sup>3</sup>.**

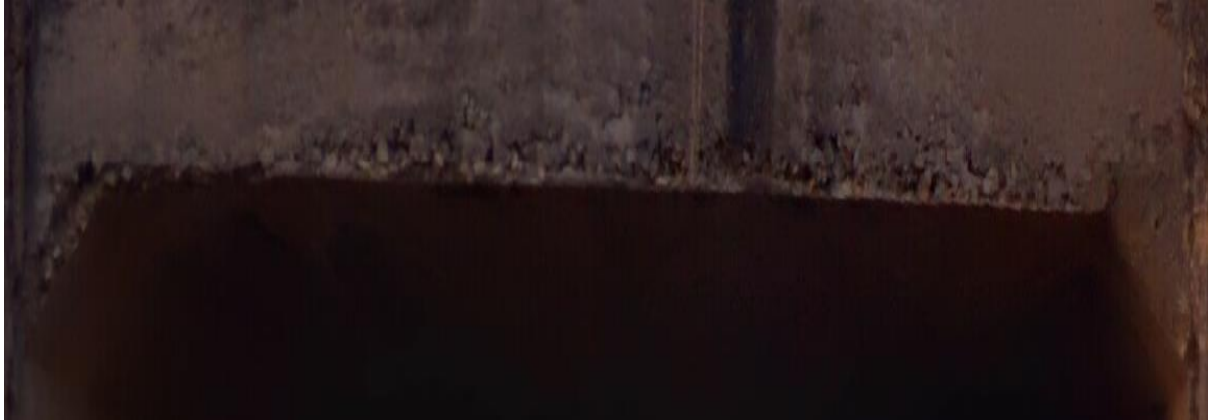
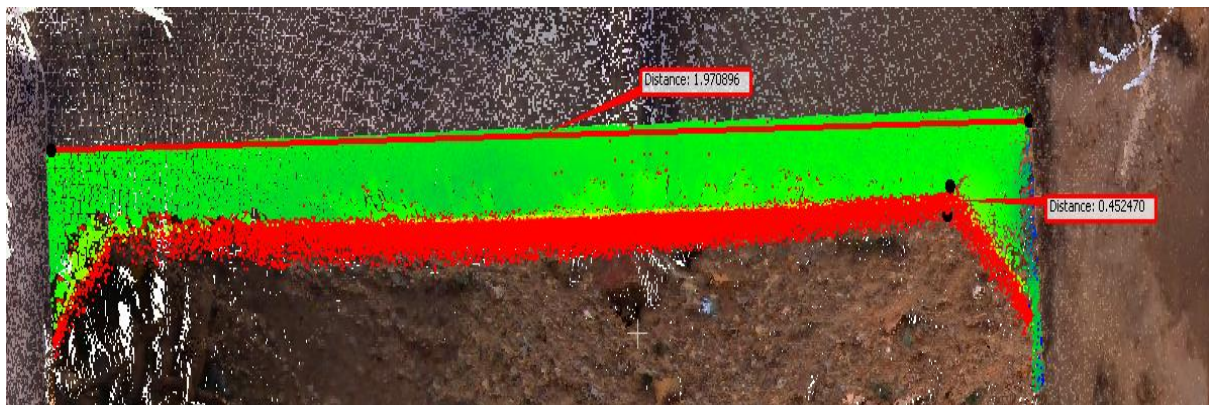
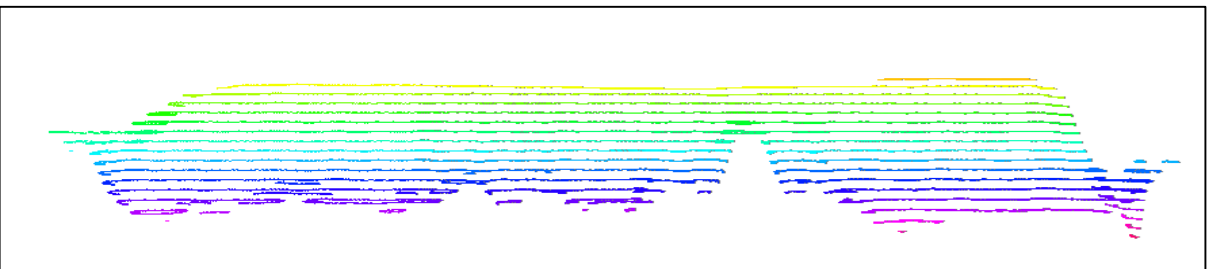
| Element Name | Observation | Location of Distress | Photo No. | Units | Distress Details | | | Area of Repair (Sq.m/ RMT/ m3) |
|---|---|---|---|---|---|---|---|---|
| Parapet Wall | Scaling | - | 2 | M | 1.97 | 0.45 | | 0.097 |

1. Scaling observed on parapet wall, measuring 1.97 m in length and 0.45 m in width, covering an area of 0.89 m<sup>2</sup>.
