# **LIDAR Inspection Report of Box Culvert ch.949+870**

**Bridge Chainage:** 949+870

- **Bridge No:** -
- **Chainage:** 949+870
- **Structure type:** Box Culvert

- **CKRP:** Chittorgarh to kota
- **State:** Rajasthan NH 27
- **Zone:** RJ-20

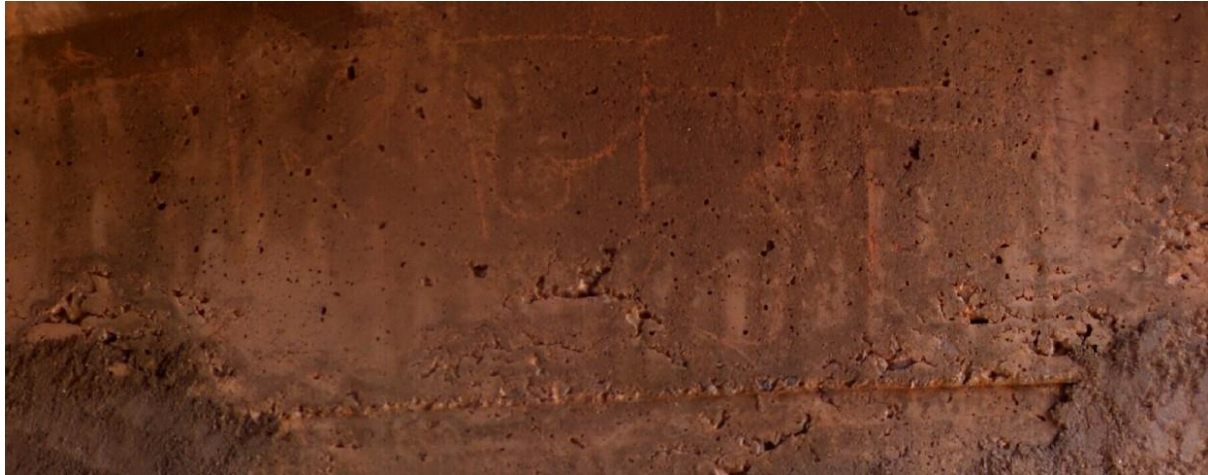
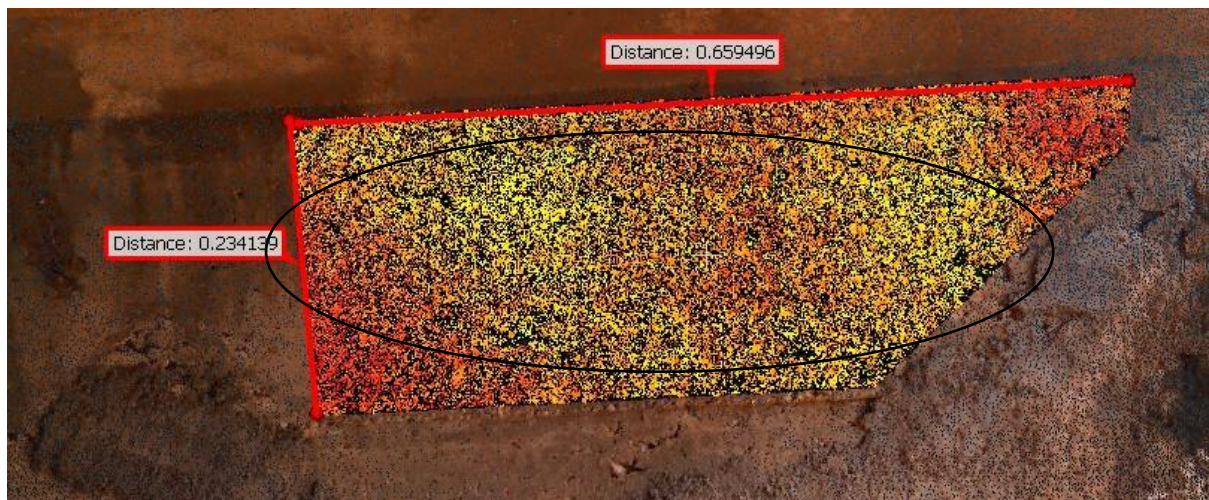
| Element Name | Observation | Location of Distress | Photo No. | Units | Distress Details | | | Area of Repair (Sq.m/R MT/m3) |
|---|---|---|---|---|---|---|---|---|
| Abutment 1 | Scalling | - | 1 | Sq m | 0.65 | 0.23 | - | 0.14 |

**1. Scaling observed on Abutment 1 RHS side, measuring 0.65 m in length and 0.23 m in width, covering an area of 0.14 m<sup>2</sup>.**

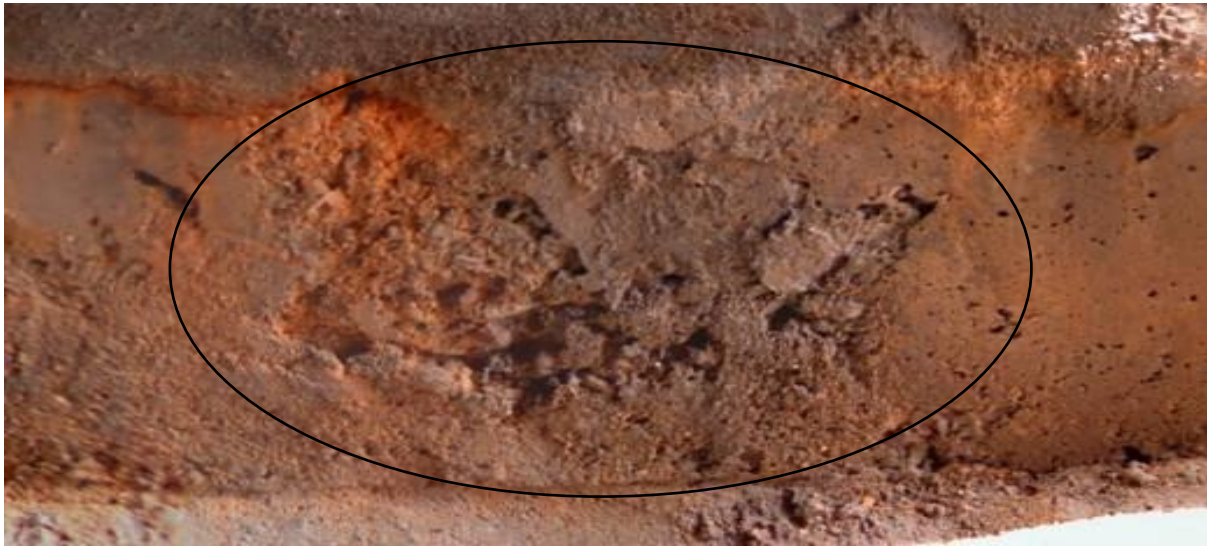
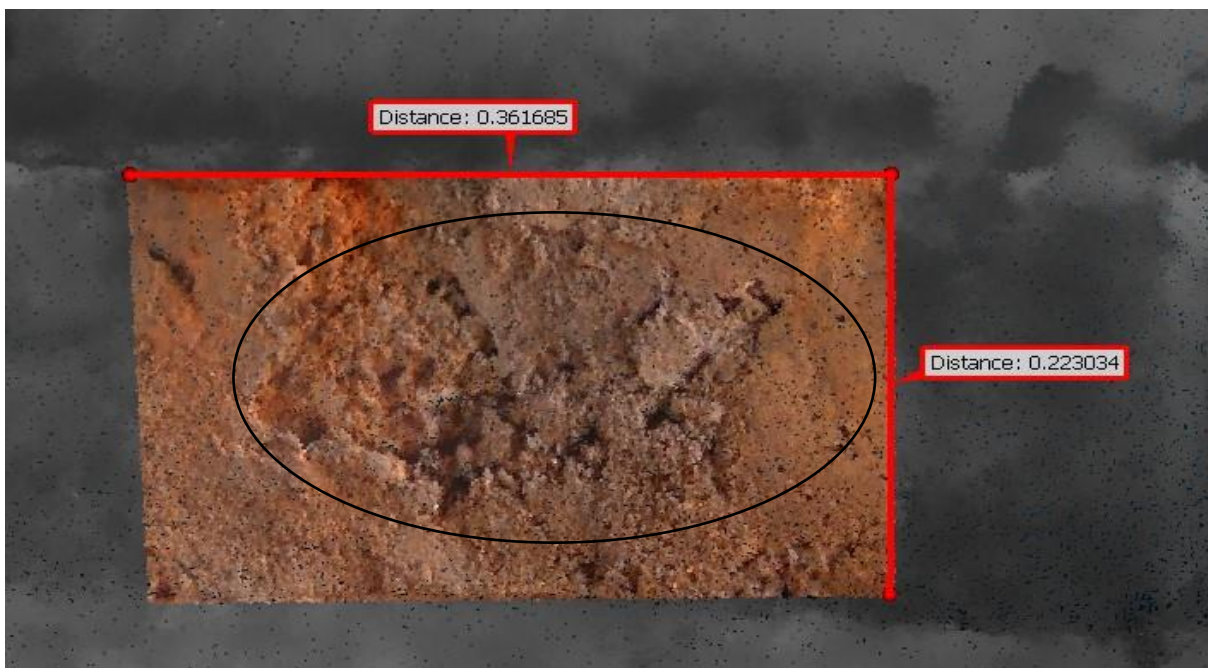
| Element Name | Observation | Location of Distress | Photo No. | Units | Distress Details | | | Area of Repair (Sq.m/R MT/m3) |
|---|---|---|---|---|---|---|---|---|
| Abutment 1 | Damage | - | 2 | Sq m | 0.36 | 0.22 | - | 0.07 |

**2.Damage observed on Abutment 1 RHS side, measuring 0.36 m in length and 0.22 m in width, covering an area of 0.07 m<sup>2</sup>.**

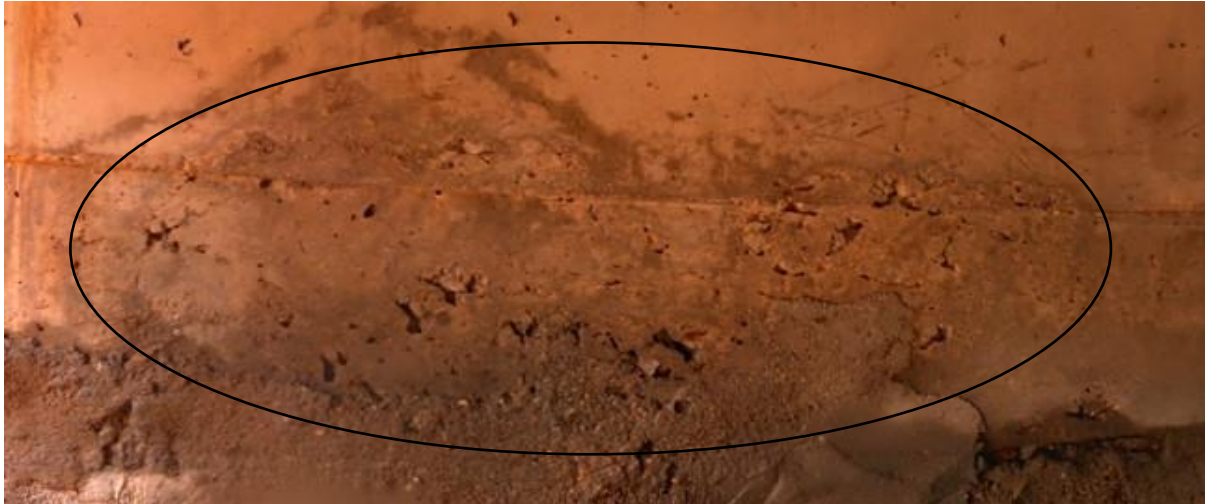
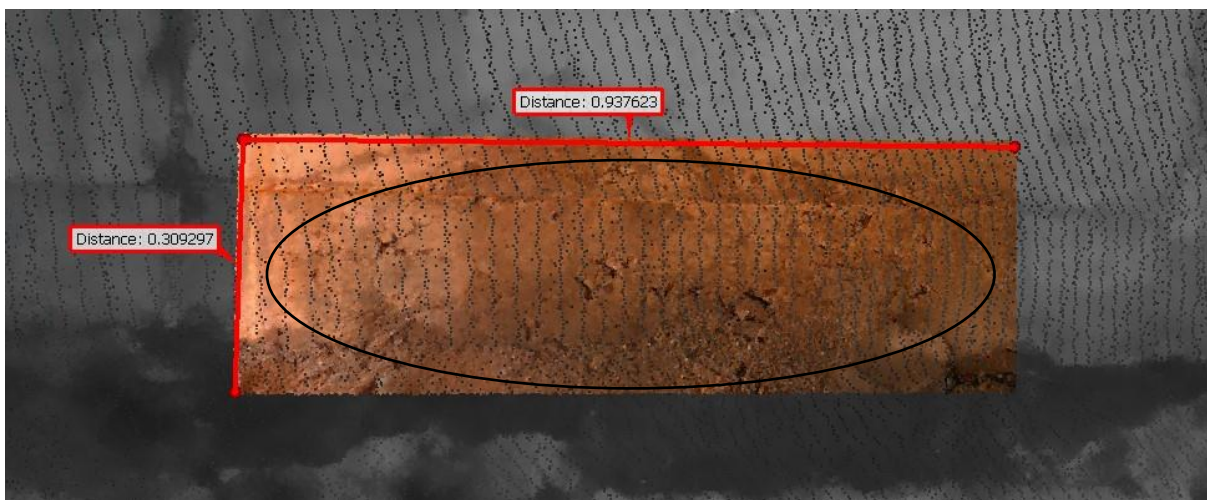
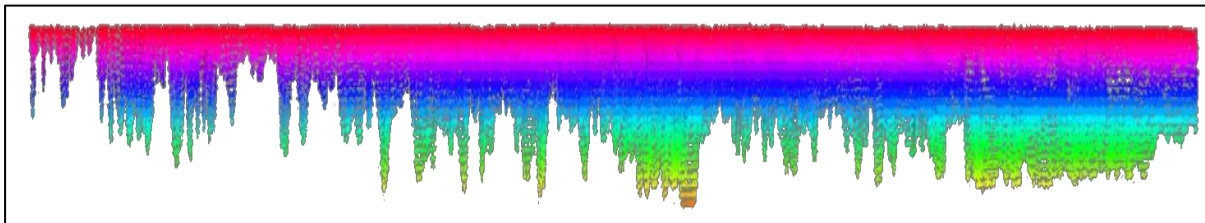
| Element Name | Observation | Location of Distress | Photo No. | Units | Distress Details | | | Area of Repair (Sq.m/R MT/m3) |
|---|---|---|---|---|---|---|---|---|
| Abutment 2 | Scalling | - | 3 | Sq m | 0.93 | 0.30 | - | 0.27 |

**3. Scaling observed on Abutment 2 RHS side, measuring 0.93 m in length and 0.30 m in width, covering an area of 0.27 m<sup>2</sup>.**

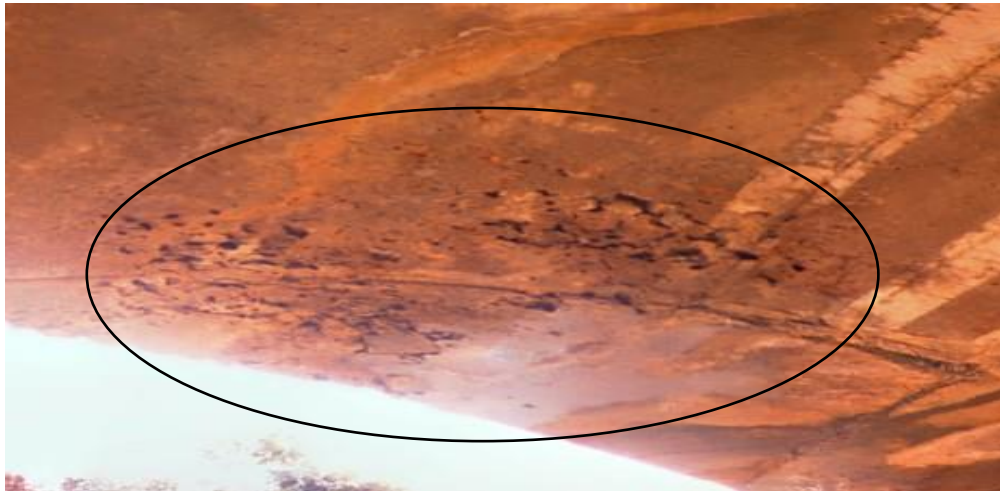
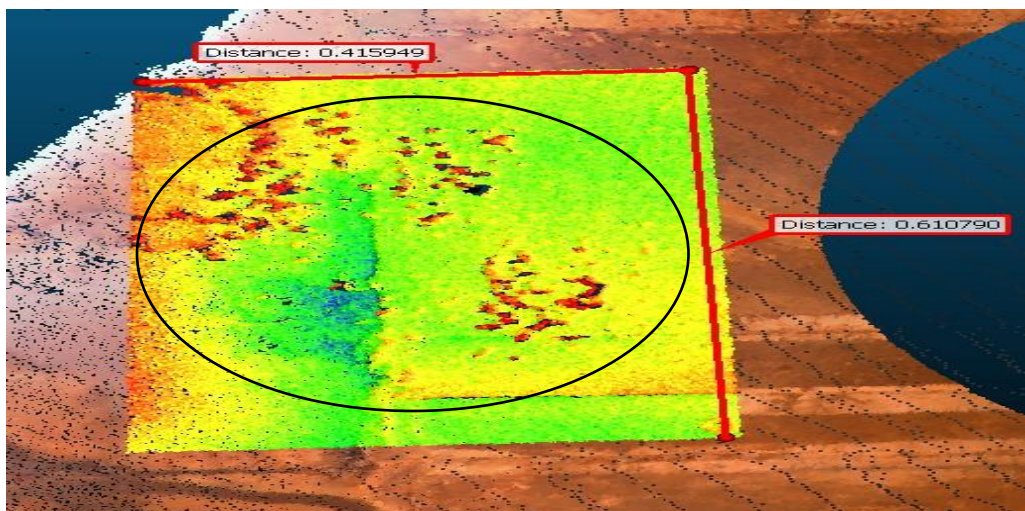
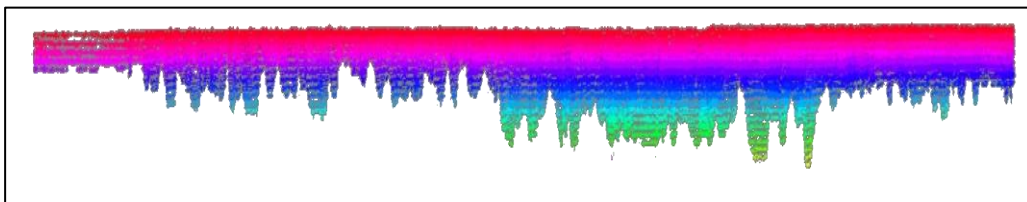
| Element Name | Observation | Location of Distress | Photo No. | Units | Distress Details | | | Area of Repair (Sq.m/R MT/m3) |
|---|---|---|---|---|---|---|---|---|
| Deck Slab | Scalling | - | 4 | Sq m | 0.61 | 0.41 | - | 0.25 |

**4. Scaling observed on deck slab RHS side, measuring 0.61 m in length and 0.41 m in width, covering an area of 0.25 m<sup>2</sup>.**
