# LIDAR Inspection Report of **Box Culvert** ch.949+940

**Bridge No:** Box Culvert

**Bridge Chainage:** 949+940 (CKRP)

# **CH: 949+940 – BOX CULVERT**

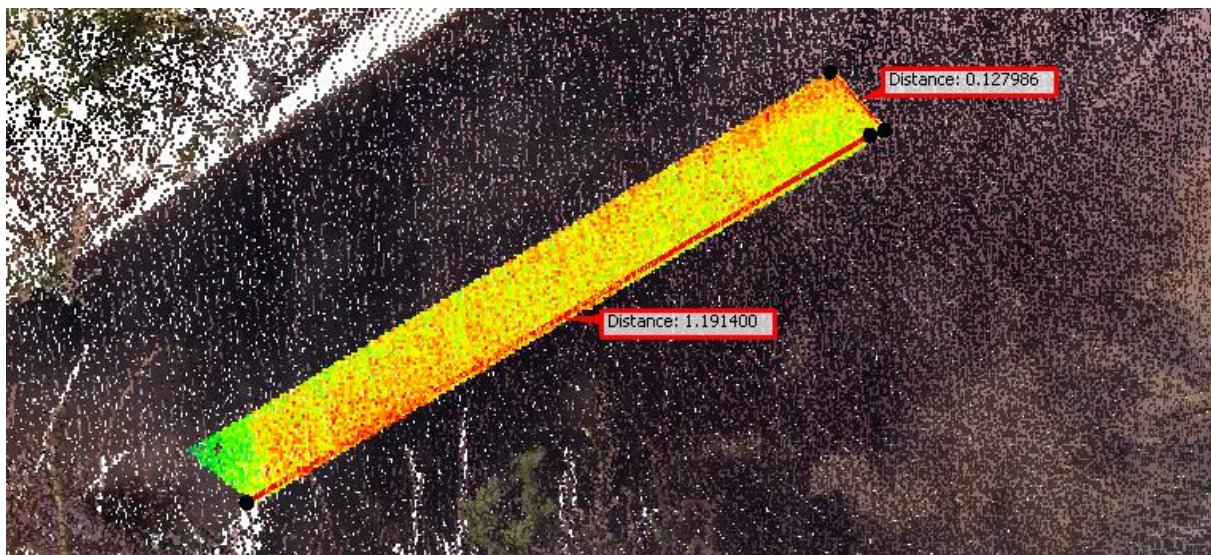
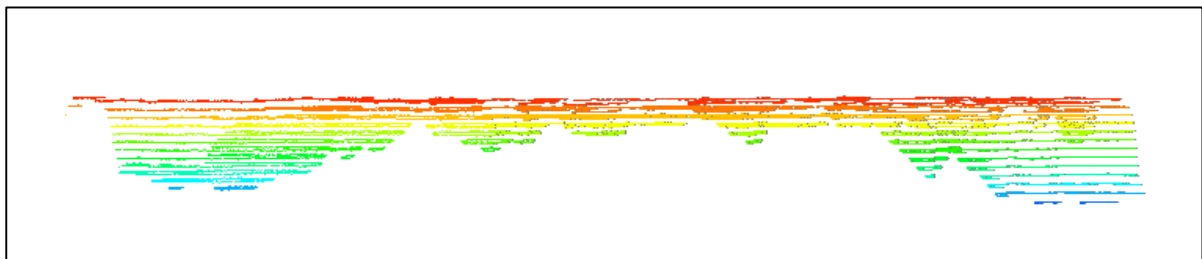
| Element Name | Observation | Location of Distress | Photo No. | Units | Distress Details | | | Area of Repair (Sq.m/R MT/m3) |
|---|---|---|---|---|---|---|---|---|
| Wing wall | Scaling | - | 1 | M | 1.19 | 0.12 | - | 0.1428 |

**1. Scaling observed on wing wall, measuring 1.19 m in length and 0.12 m in width, covering an area of 0.1428 m<sup>2</sup>.**
