# **LIDAR Inspection Report of MNB ch.950+820**

**Bridge No:** MNB – 951/2

**Bridge Chainage:** 950 + 820 (CKRP)

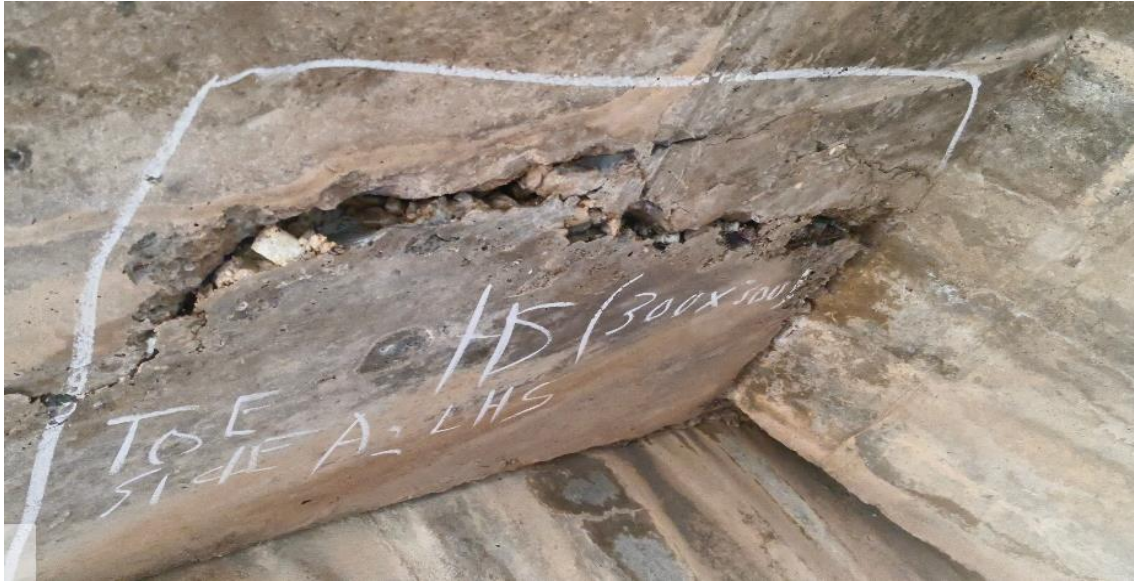
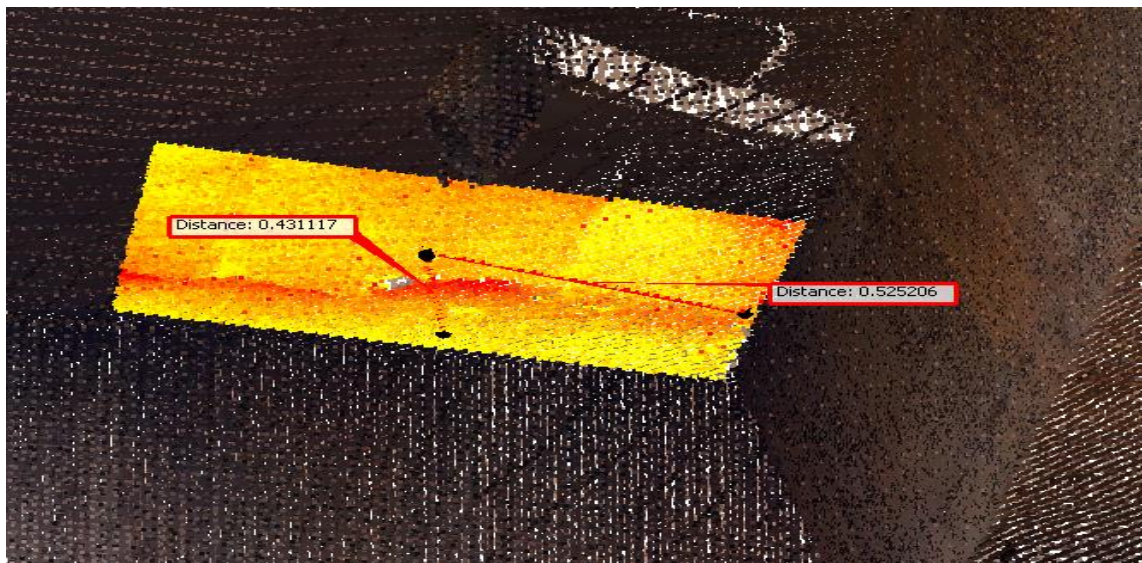
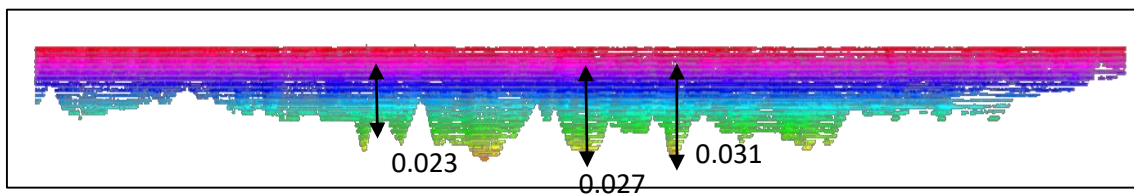
| Element Name | Observation | Location of Distress | Photo No. | Units | Distress Details | | | Area of Repair (Sq.m/R MT/m3) |
|---|---|---|---|---|---|---|---|---|
| Abutment 2 | Hollow Section | | 1 | M | 0.52 | 0.43 | 0.027 | 0.0060 |

1. Hollow section observed at A2 (LHS), measuring 0.52 m in length and 0.43 m in width. Depth ranges from 0.023 m (min) to 0.031 m (max), with an average depth of 0.027 m. The calculated volume of the distress is 0.0060 m<sup>3</sup>.

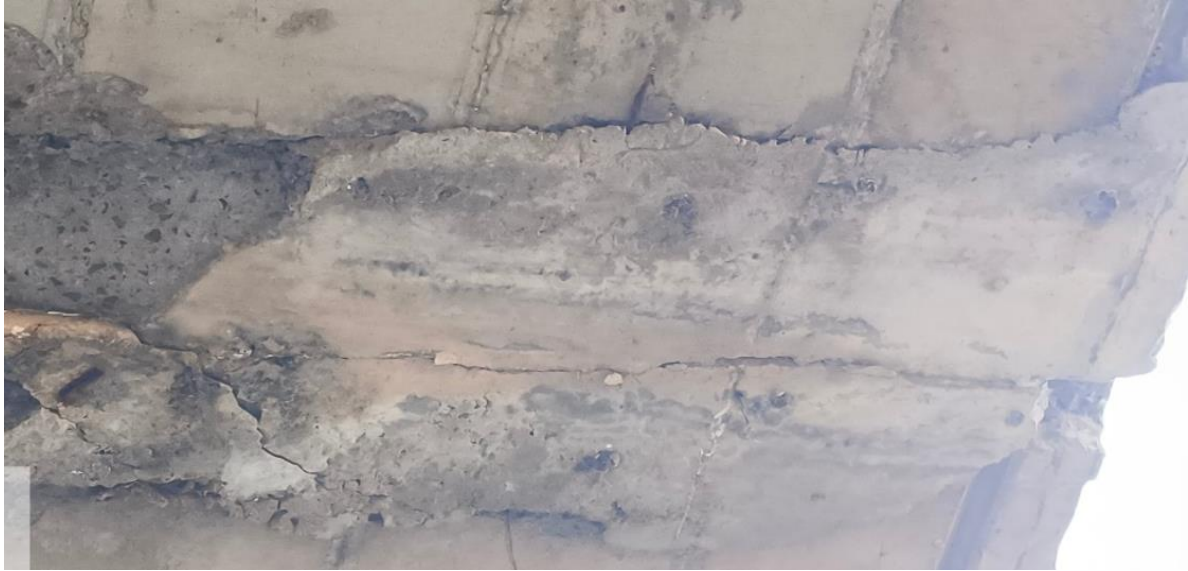
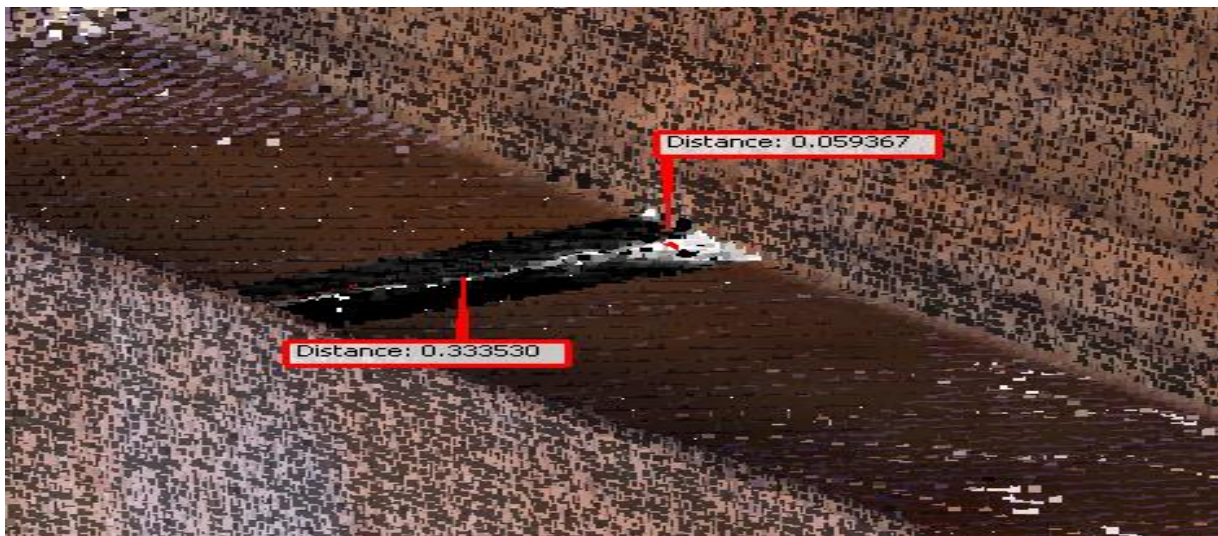
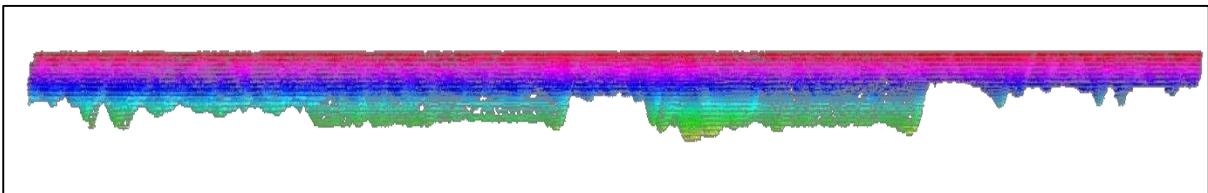
| Element Name | Observation | Location of Distress | Photo No. | Units | Distress Details | | | Area of Repair (Sq.m/R MT/m3) |
|---|---|---|---|---|---|---|---|---|
| Pier 1 | Steel Exposed | | 2 | M | 0.33 | 0.05 | | 0.1947 |

**2. P1 LHS expansion joint toe side damage SE, measuring 0.59 m in length and 0.33 m in width, covering an area of 0.1947 m<sup>2</sup>.**

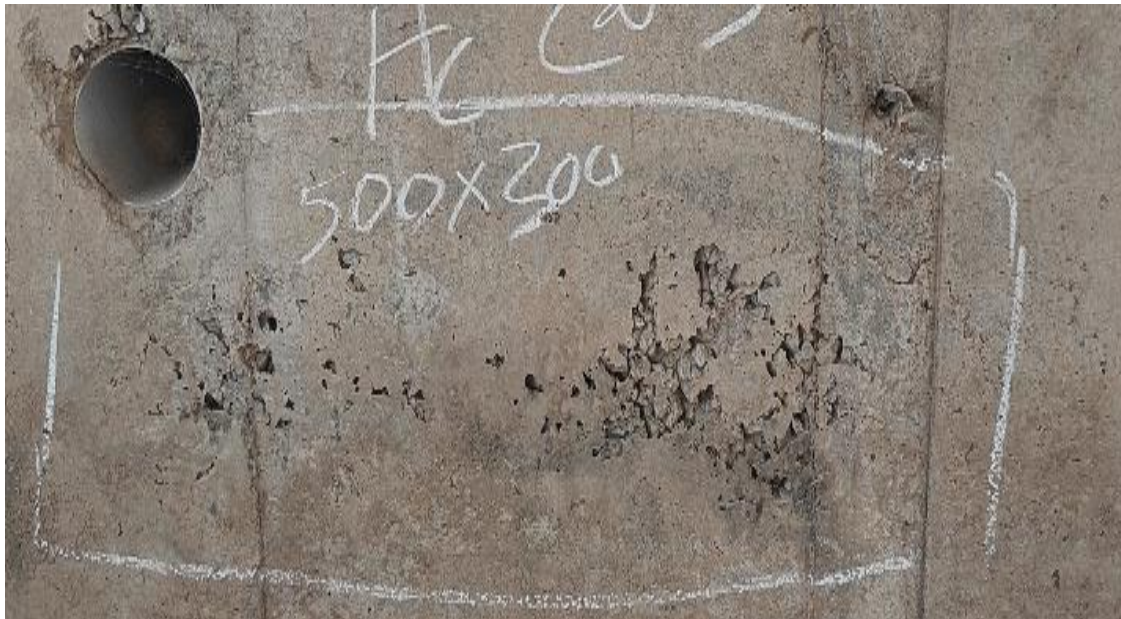
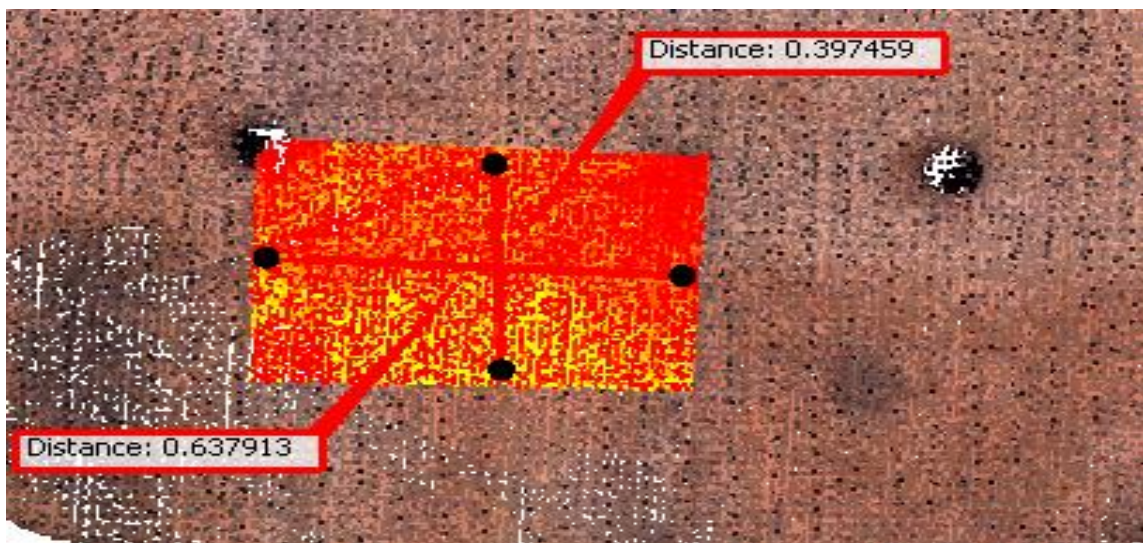
| Element Name | Observation | Location of Distress | Photo No. | Units | Distress Details | | | Area of Repair (Sq.m/R MT/m3) |
|---|---|---|---|---|---|---|---|---|
| Abutment 1 | Honeycombing | | 4 | M | 0.25 | 0.32 | 0.021 | 0.0016 |

**3.A1 RHS abutment wall honeycombing, measuring 0.25 m in length and 0.32 m in width, covering an area of 0.08 m<sup>2</sup>.**

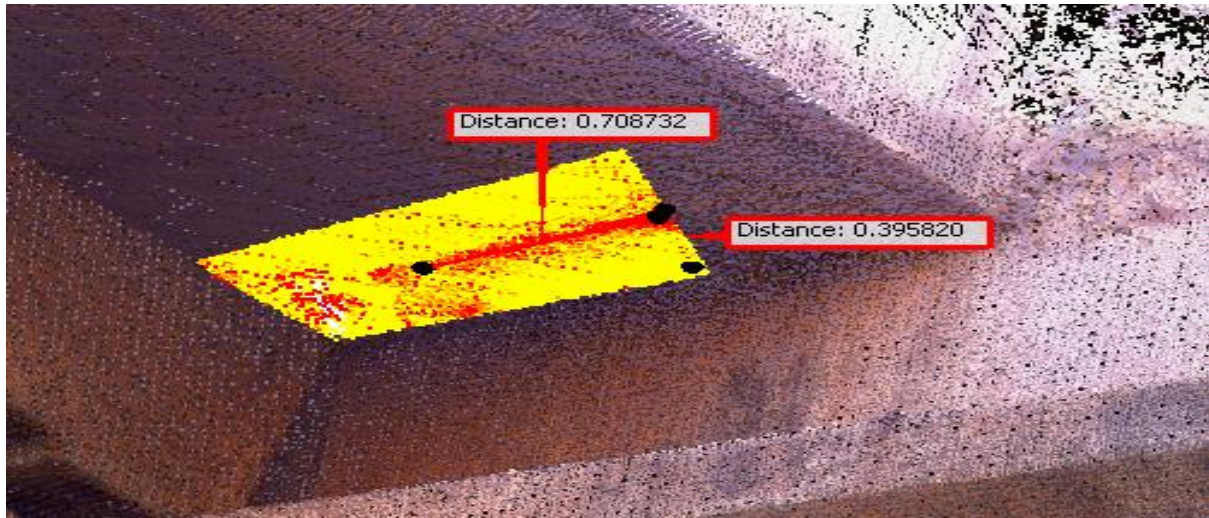
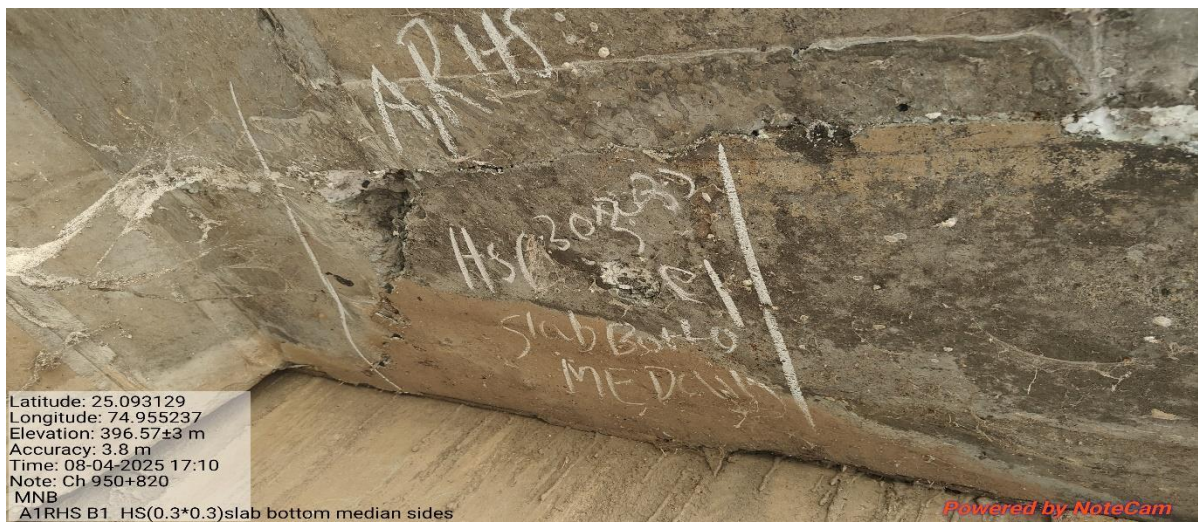
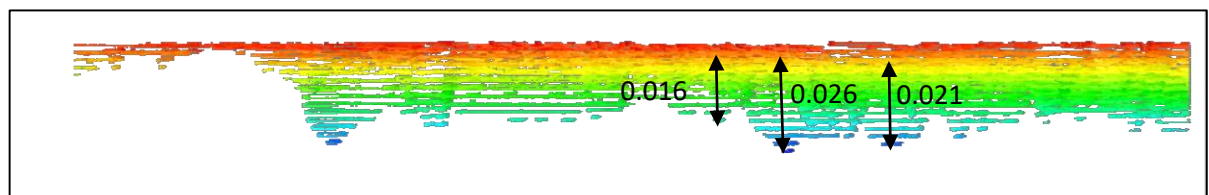
| Element Name | Observation | Location of Distress | Photo No. | Units | Distress Details | | | Area of Repair (Sq.m/R MT/m3) |
|---|---|---|---|---|---|---|---|---|
| Slab Bottom | Hollow Section | | 3 | M | 0.70 | 0.39 | | 0.273 |

**4. Hollow section observed at A1 (RHS) B1 on slab bottom median sides, measuring 0.70 m in length and 0.39 m in width. Depth ranges from 0.016 m (min) to 0.026 m (max), with an average depth of 0.021 m. The calculated volume of the distress is 0.0512 m<sup>3</sup>.**
