# LIDAR Inspection Report of **Slab Culvert** ch.951+445

**Bridge Chainage:** 951 + 445 (CKRP)

- **CKRP:** Chittorgarh to kota
- **State:** Rajasthan NH 27
- **Zone:** RJ-06

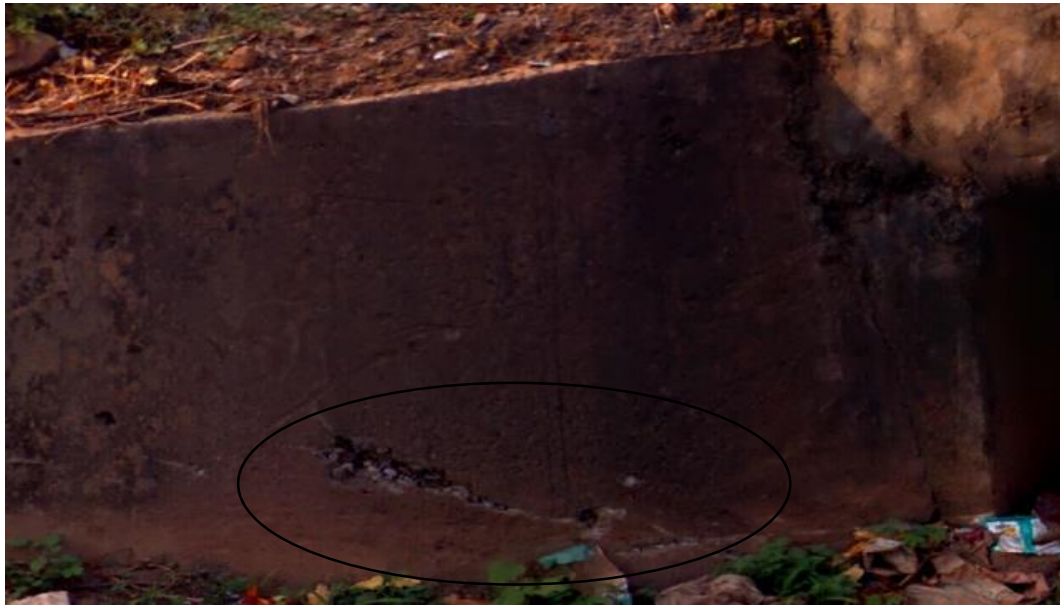
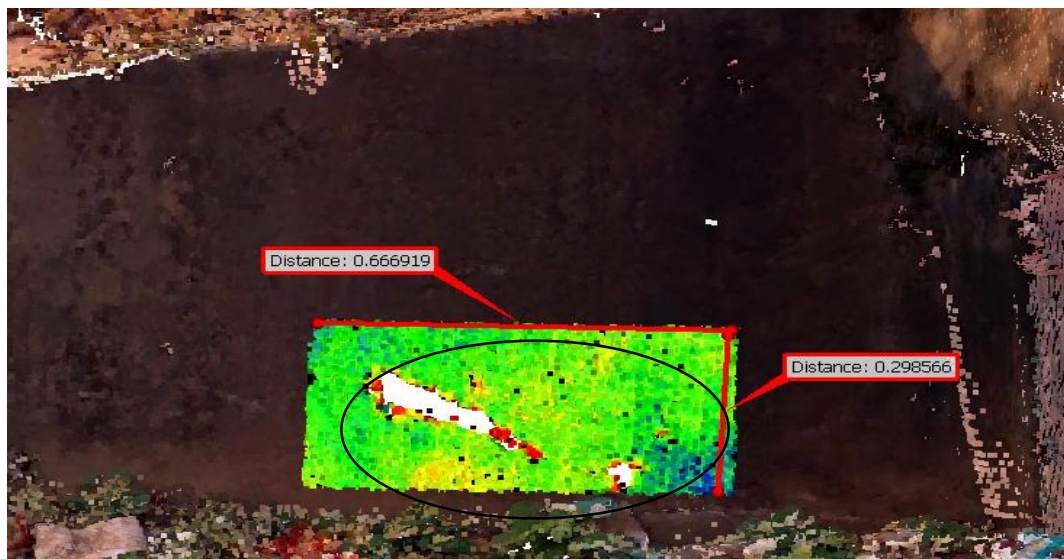
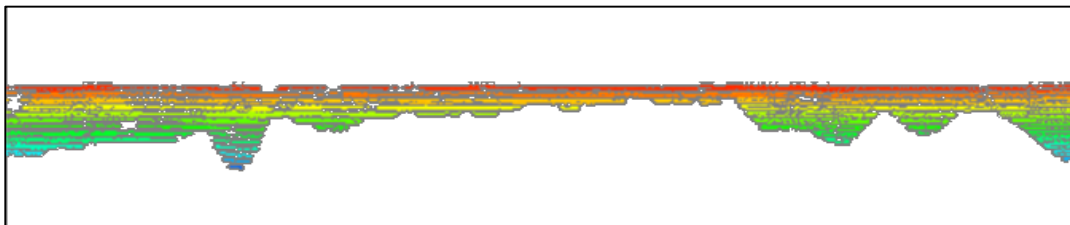
| Element Name | Observation | Location of Distress | Photo No. | Units | Distress Details | | | Area of Repair (Sq.m/ RMT/ m3) |
|---|---|---|---|---|---|---|---|---|
| Abutment 1 | Scaling | | 1 | M | 0.66 | 0.29 | | 0.1914 |

1. Scaling observed on RHS Abutment 1, measuring 0.66 m in length and 0.29 m in width, covering an area of 0.1914 m<sup>2</sup>.

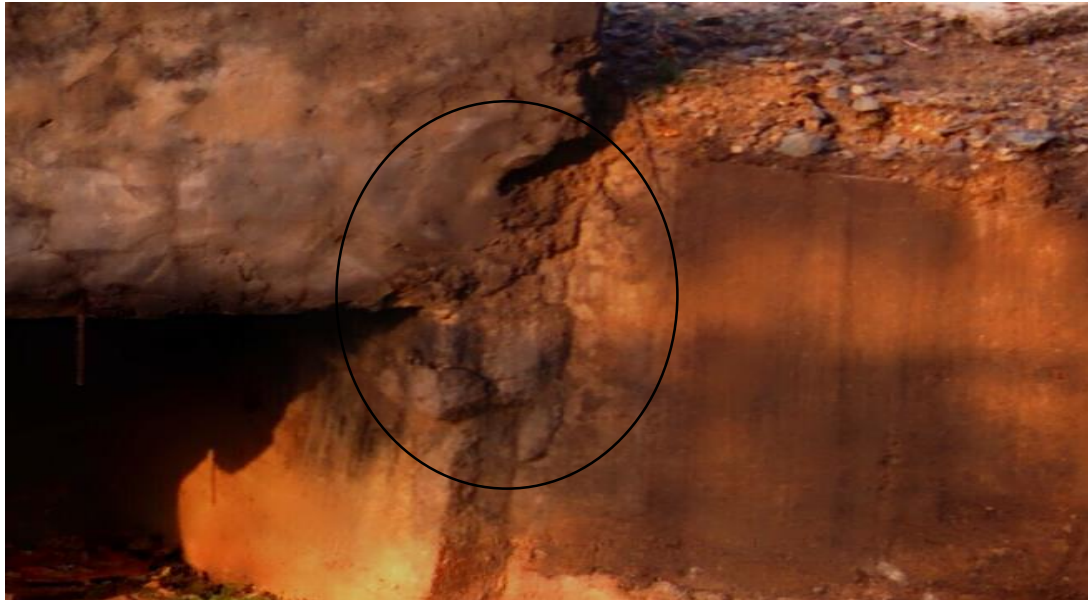
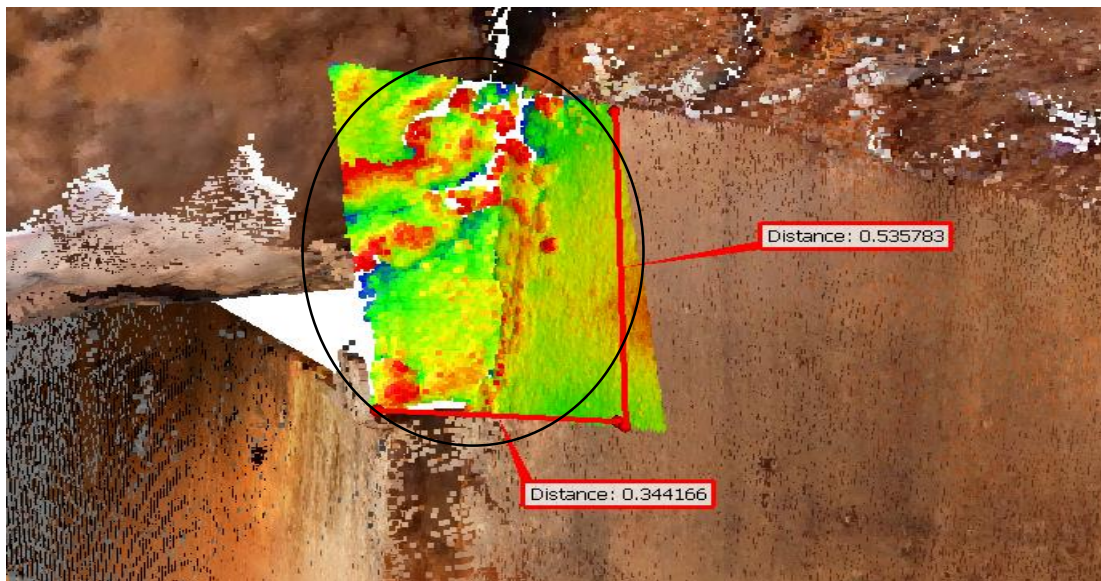
| Element Name | Observation | Location of Distress | Photo No. | Units | Distress Details | | | Area of Repair (Sq.m/ RMT/ m3) |
|---|---|---|---|---|---|---|---|---|
| Abutment 1 | Scaling | | 2 | M | 0.53 | 0.34 | | 0.1802 |

2. Scaling observed on RHS Abutment 1, measuring 0.53 m in length and 0.34 m in width, covering an area of 0.1802 m<sup>2</sup>.

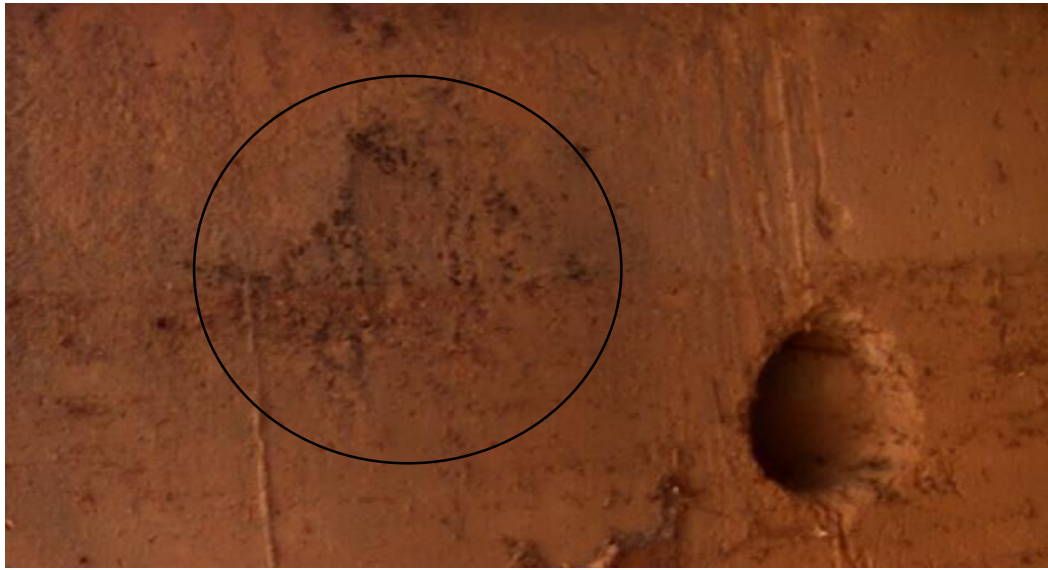
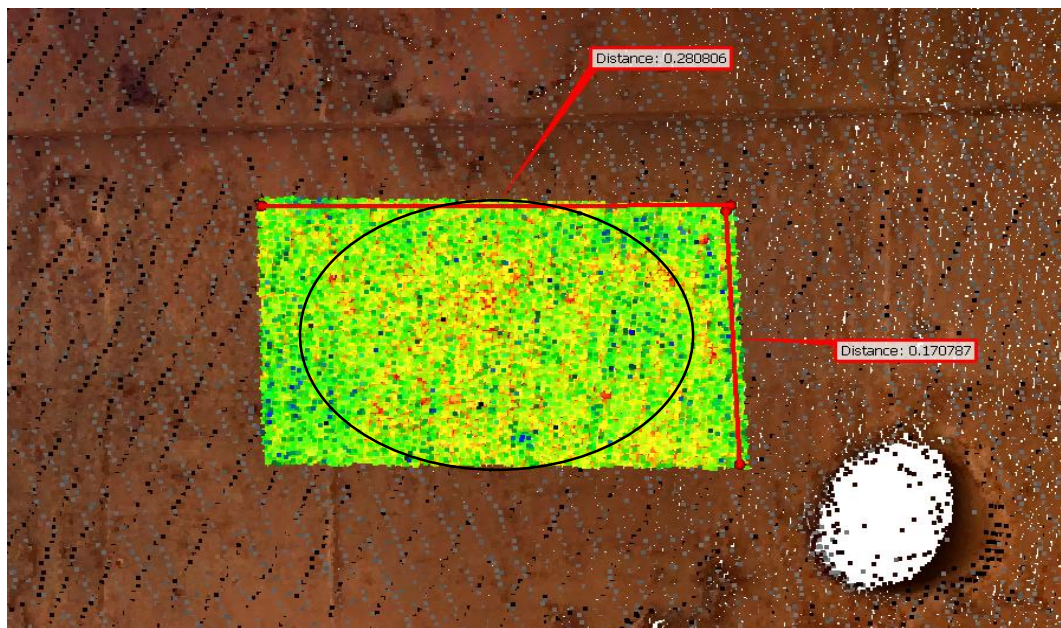
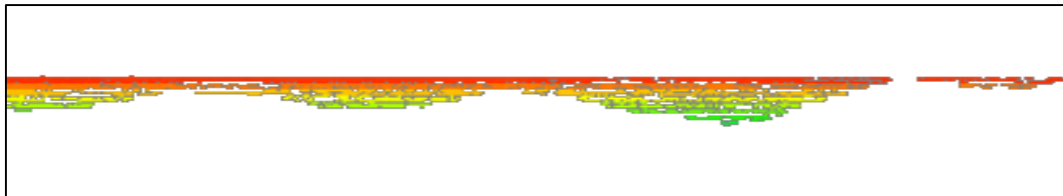
| Element Name | Observation | Location of Distress | Photo No. | Units | Distress Details | | | Area of Repair (Sq.m/ RMT/ m3) |
|---|---|---|---|---|---|---|---|---|
| Abutment 1 | Scaling | | 3 | M | 0.26 | 0.17 | | 0.0442 |

- 3. Scaling observed on RHS Abutment 1 , measuring 0.26 m in length and 0.17 m in width, covering an area of 0.0442 m<sup>2</sup>.**

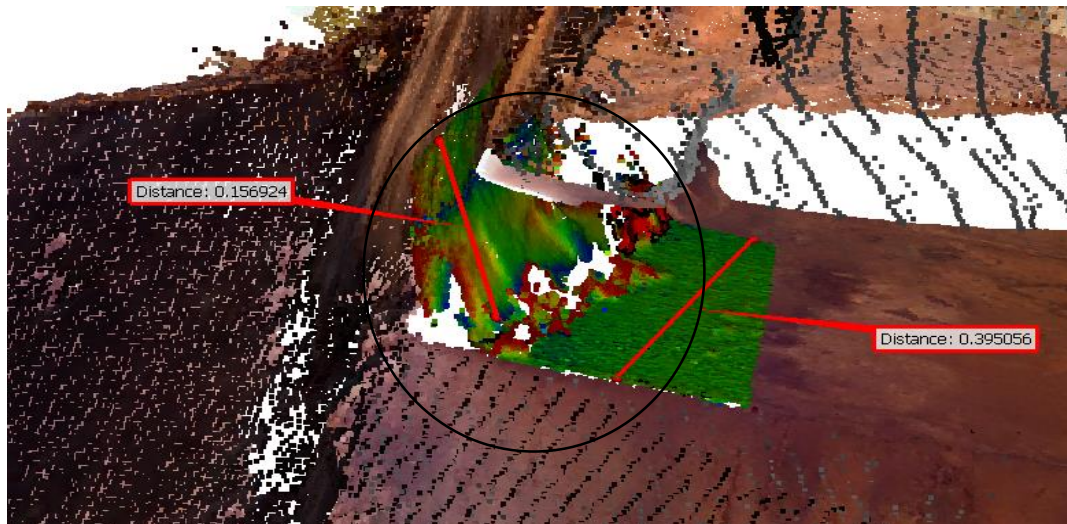
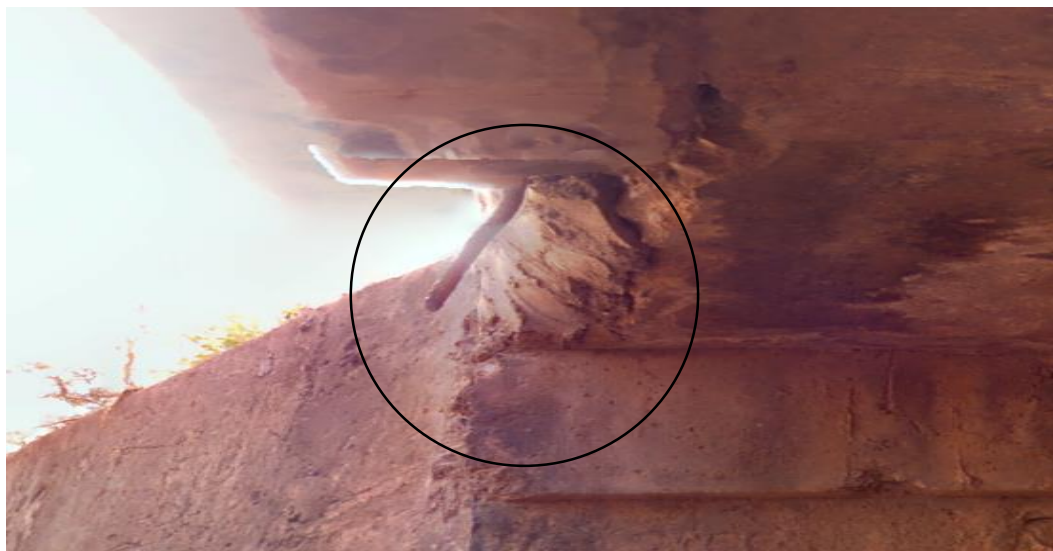
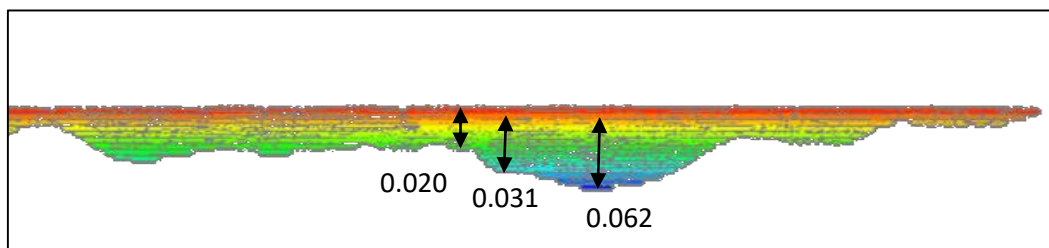
| Element Name | Observation | Location of Distress | Photo No. | Units | Distress Details | | | Area of Repair (Sq.m/ RMT/ m3) |
|---|---|---|---|---|---|---|---|---|
| Slab Bottom | Steel Exposed | | 4 | M | 0.39 | 0.15 | 0.031 | 0.0018 |

**4. Steel exposed on RHS slab bottom, measuring 0.39 m in length and 0.15 m in width, Depth ranges from 0.020 m (min) to 0.062 m (max), with an average depth of 0.031 m. The calculated volume of the distress is 0.0018 m<sup>3</sup>.**
