# **LIDAR Inspection Report of Box Culvert ch.953+810**

**Bridge Chainage:** 953+810

- **Bridge No:** -
- **Chainage:** 953+810
- **Structure type:** Box Culvert

- **CKRP:** Chittorgarh to kota
- **State:** Rajasthan NH 27
- **Zone:** RJ-20

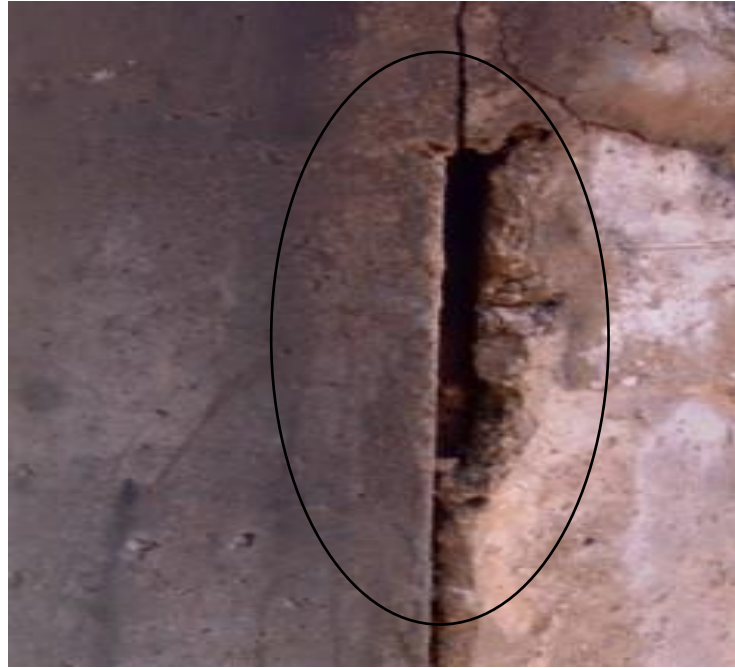
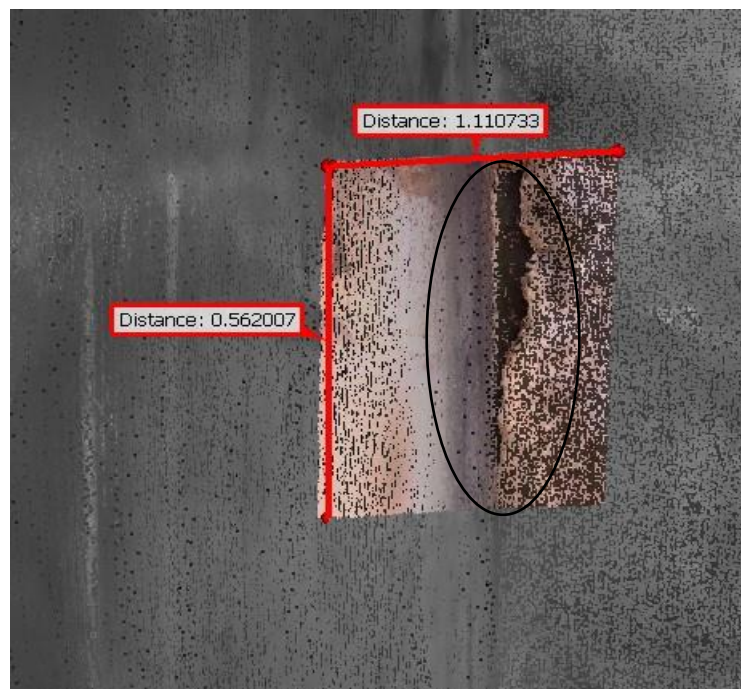
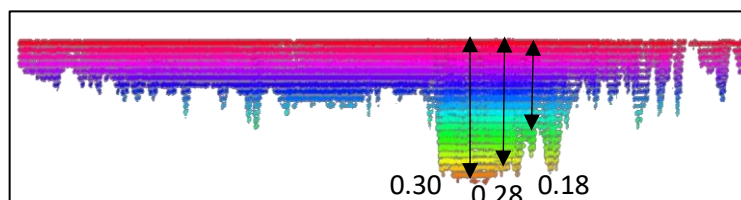
| Element Name | Observation | Location of Distress | Photo No. | Units | Distress Details | | | Area of Repair (Sq.m/ RMT/m <sup>3</sup> ) |
|---|---|---|---|---|---|---|---|---|
| Abutment 1 | Damage | - | 1 | Cu m | 1.11 | 0.56 | 0.28 | 0.17 |

**1.Damage observed on Abutment 1 LHS side, measuring 1.11 m in length and 0.56 m in width, with a depth ranging from 0.18 m (min) to 0.30 m (max), and an average depth of 0.28 m, covering a volume of 0.17 m<sup>3</sup>.**

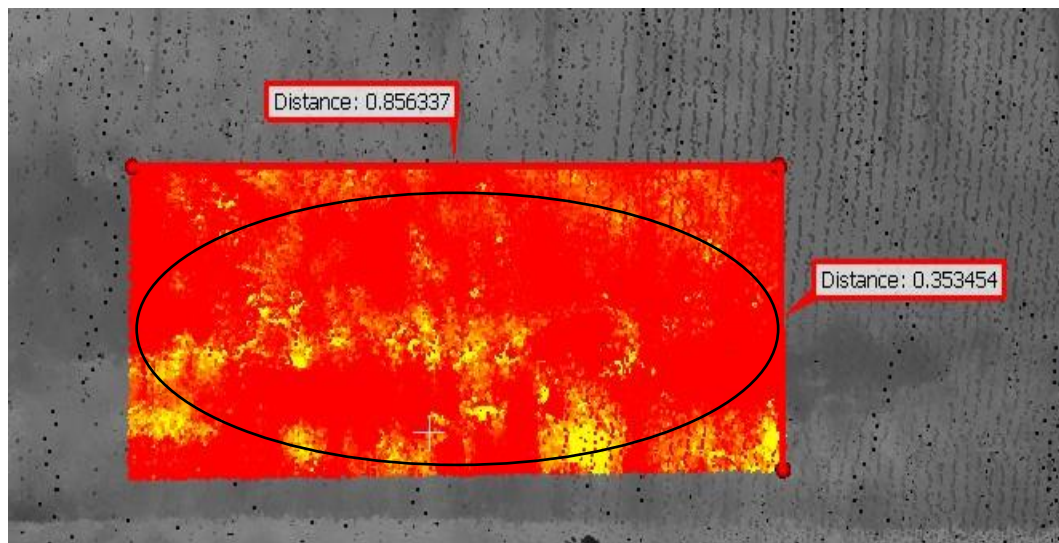
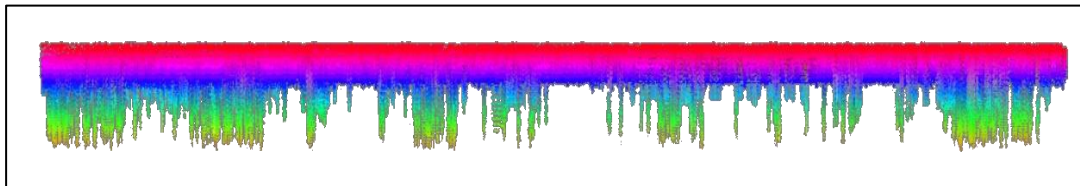
| Element Name | Observation | Location of Distress | Photo No. | Units | Distress Details | | | Area of Repair (Sq.m/ RMT/m <sup>3</sup> ) |
|---|---|---|---|---|---|---|---|---|
| Abutment 1 | Scalling | - | 2 | Sq m | 0.85 | 0.35 | - | 0.29 |

**2. Scaling observed on Abutment 1, measuring 0.85 m in length and 0.35 m in width, covering an area of 0.29 m<sup>2</sup>.**

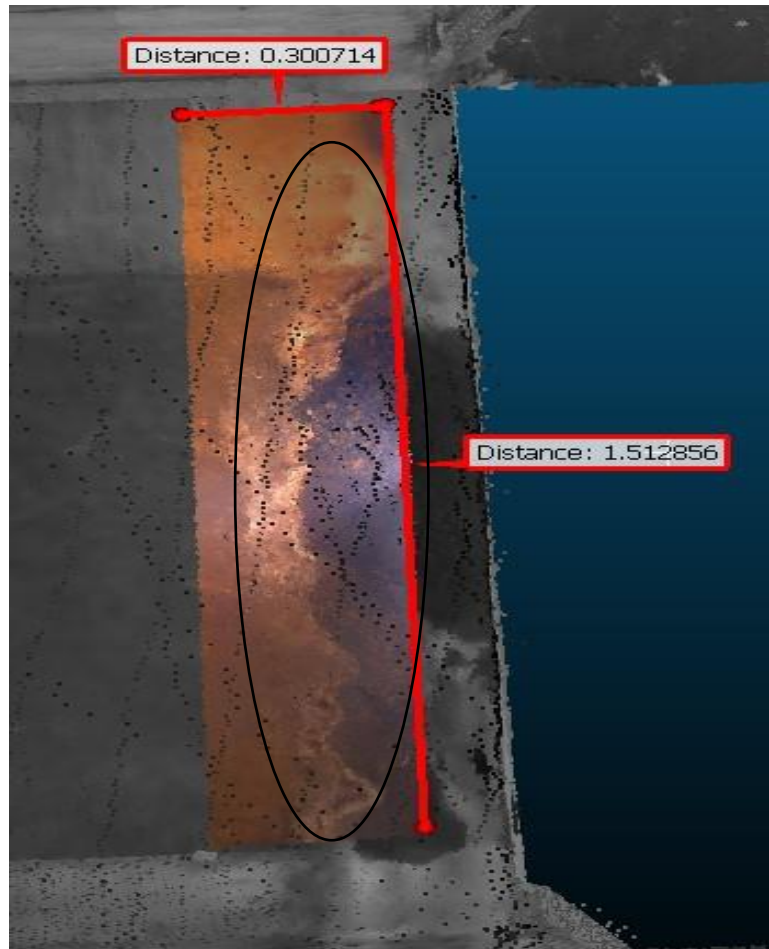
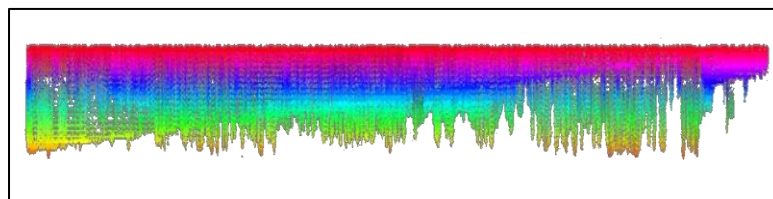
| Element Name | Observation | Location of Distress | Photo No. | Units | Distress Details | | | Area of Repair (Sq.m/ RMT/m <sup>3</sup> ) |
|---|---|---|---|---|---|---|---|---|
| Deck Slab | Efflorescence | - | 3 | Sq m | 1.51 | 0.30 | - | 0.45 |

**3.Efflorescence observed on deck slab RHS side, measuring 1.51 m in length and 0.30 m in width, covering an area of 0.45 m<sup>2</sup>.**
