# **LIDAR Inspection Report of Slab Culvert ch.955+570**

**Bridge Chainage:** 955 + 570 (CKRP)

- **CKRP:** Chittorgarh to kota
- **State:** Rajasthan NH 27
- **Zone:** RJ-06

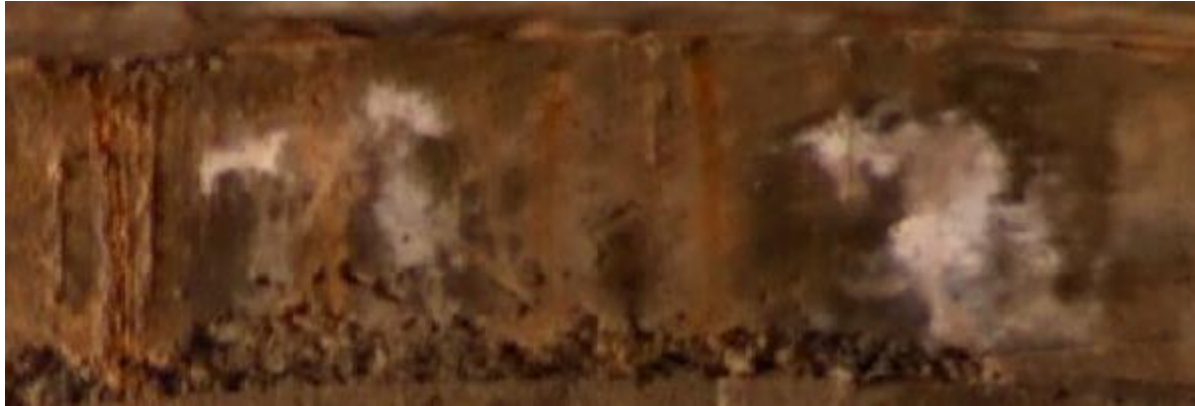
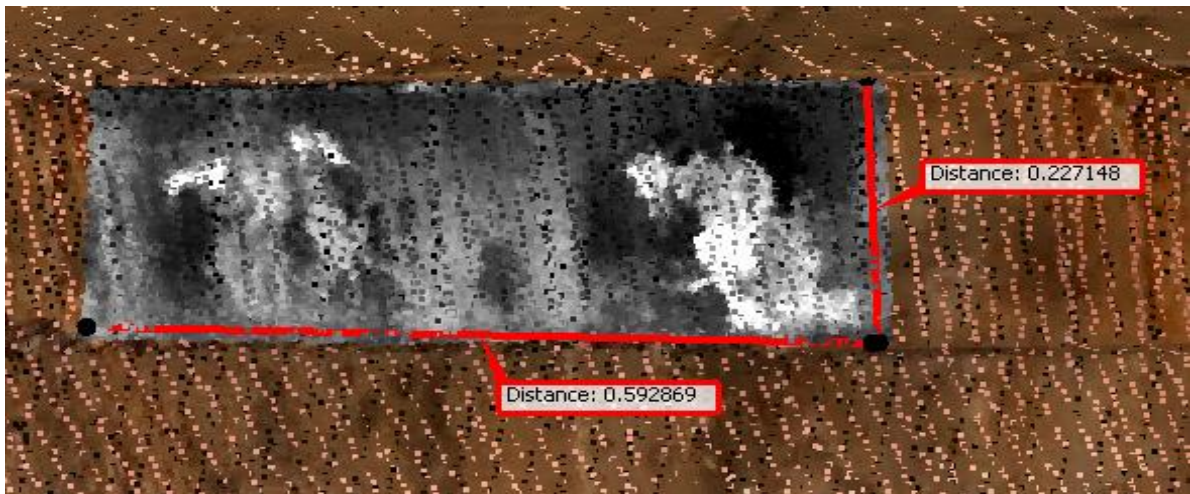
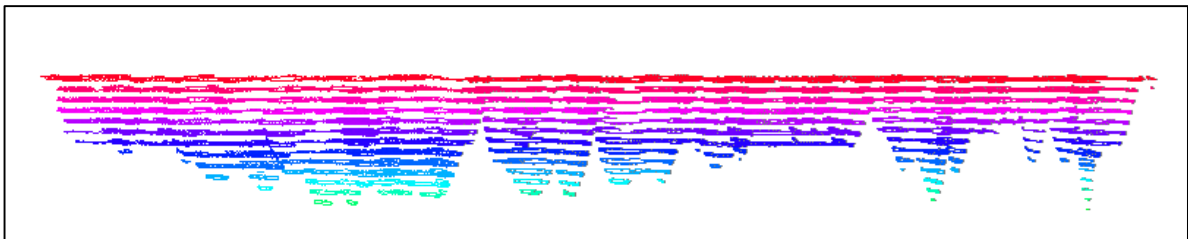
| Element Name | Observation | Location of Distress | Photo No. | Units | Distress Details | | | Area of Repair (Sq.m/R MT/m3) |
|---|---|---|---|---|---|---|---|---|
| Abutment | Efflorescence | - | 1 | M | 0.59 | 0.22 | | 0.1298 |

**1.Efflorescence observed on abutment, measuring 0.59 m in length and 0.22 m in width, covering an area of 0.13 m<sup>2</sup>.**

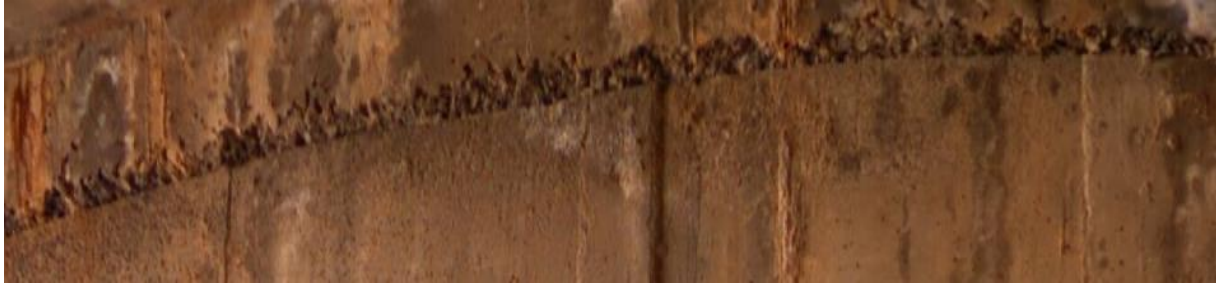
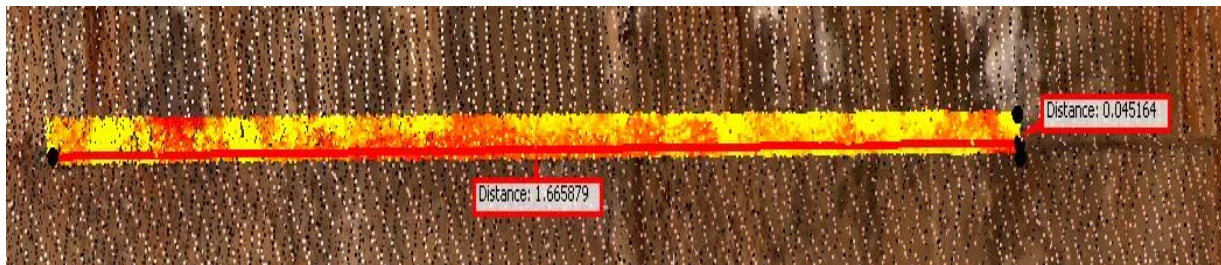
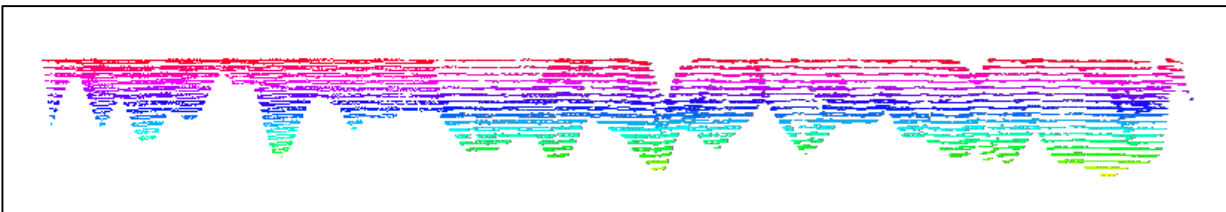
| Element Name | Observation | Location of Distress | Photo No. | Units | Distress Details | | | Area of Repair (Sq.m/R MT/m3) |
|---|---|---|---|---|---|---|---|---|
| Abutment | Honeycombing | - | 2 | M | 1.66 | 0.045 | | 0.0747 |

**2.Honeycombing observed on abutment wall, measuring 1.66 m in length and 0.045 m in width, covering an area of 0.0747 m<sup>2</sup>.**
