# LIDAR Inspection Report of **Slab Culvert** ch.956+350

**Bridge Chainage:** 956 + 350 (CKRP)

- **CKRP:** Chittorgarh to kota
- **State:** Rajasthan NH 27
- **Zone:** RJ-06

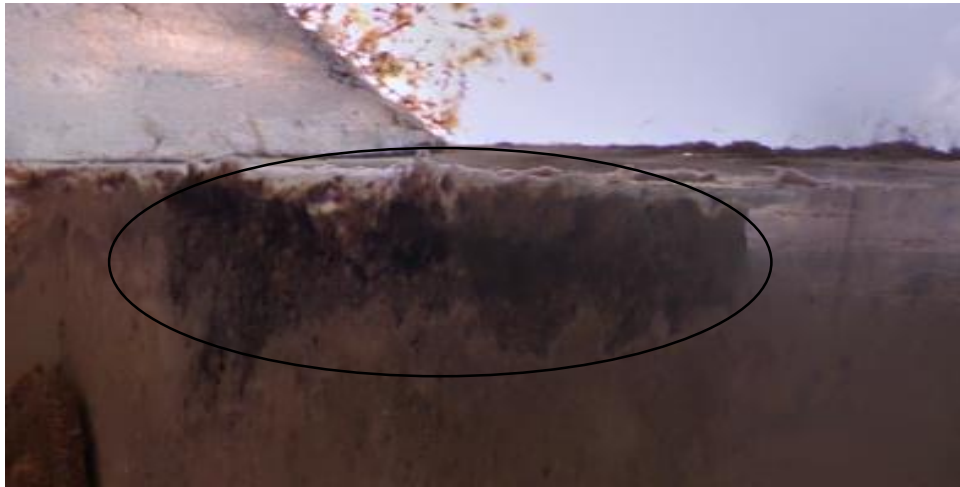
| Element Name | Observation | Location of Distress | Photo No. | Units | Distress Details | | | Area of Repair (Sq.m/R MT/m3) |
|---|---|---|---|---|---|---|---|---|
| Slab | Damage | - | 1 | M | 0.99 | 0.15 | | 0.148 |

1. Slab damage observed on LHS, measuring 0.99 m in length and 0.15 m in width, covering an area of 0.148 m<sup>2</sup>.

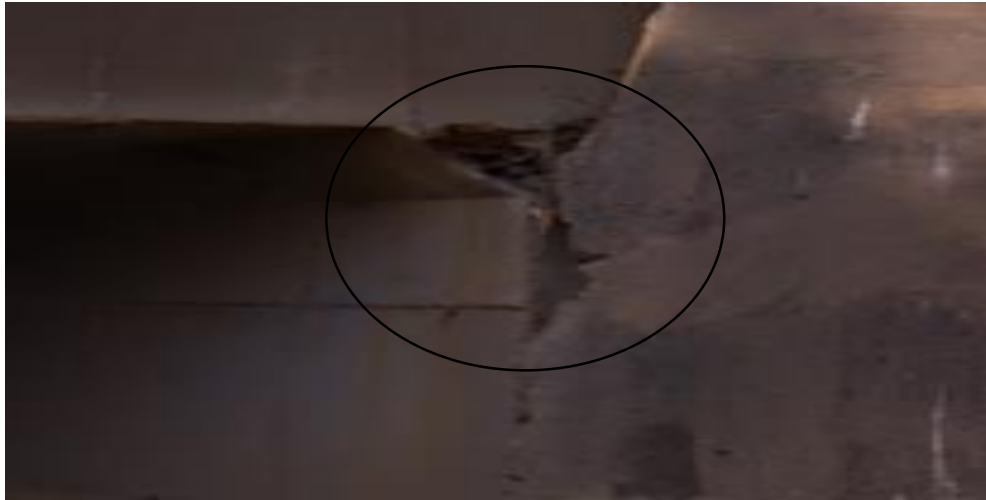
| Element Name | Observation | Location of Distress | Photo No. | Units | Distress Details | | | Area of Repair (Sq.m/R MT/m3) |
|---|---|---|---|---|---|---|---|---|
| Abutment Wall | Damage | | 2 | M | 1.41 | 0.18 | | 0.253 |

2. Damage observed on RHS abutment wall, measuring 1.41 m in length and 0.18 m in width, covering an area of 0.253 m<sup>2</sup>.
