# LIDAR Inspection Report of **Box Culvert** ch.956+445

**Bridge Chainage:** 956 + 445 (CKRP)

- **CKRP:** Chittorgarh to kota
- **State:** Rajasthan NH 27
- **Zone:** RJ-06

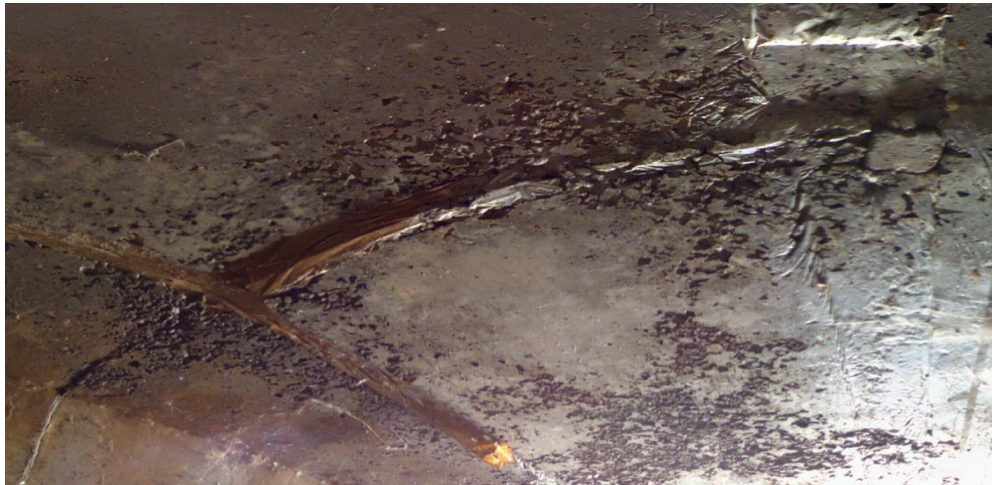
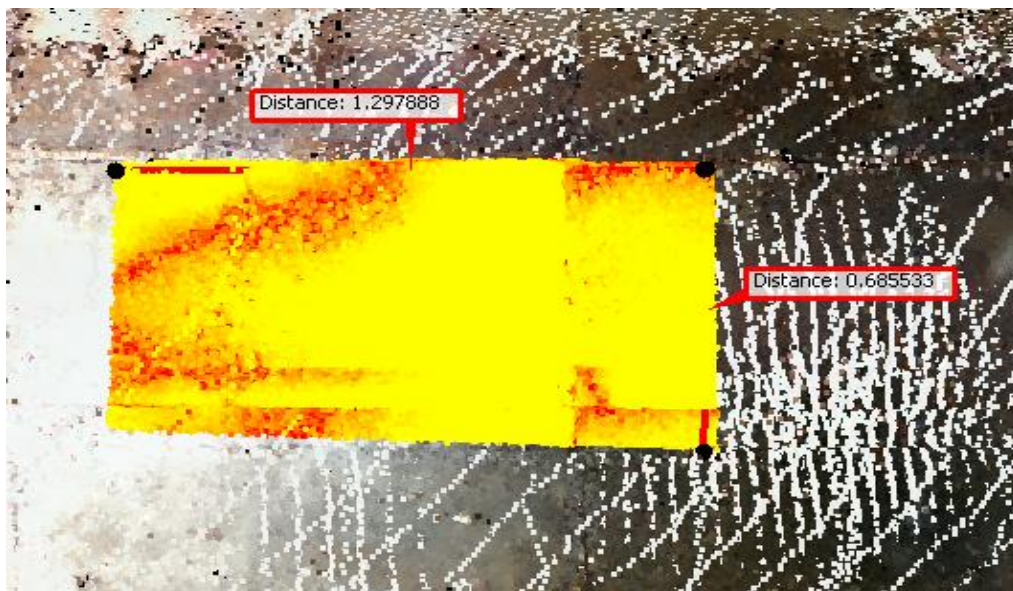
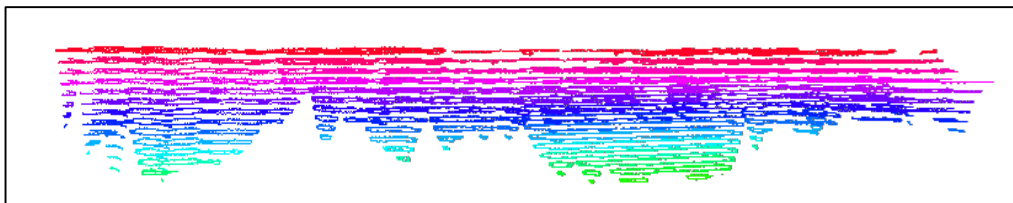
| Element Name | Observation | Location of Distress | Photo No. | Units | Distress Details | | | Area of Repair<br>(Sq.m/R MT/m3) |
|---|---|---|---|---|---|---|---|---|
| Slab Bottom | Scaling | | 1 | | 1.29 | 0.68 | | 0.877 |

1. Scaling observed on Slab Bottom, measuring 1.29 m in length and 0.68 m in width, covering an area of 0.877 m<sup>2</sup>

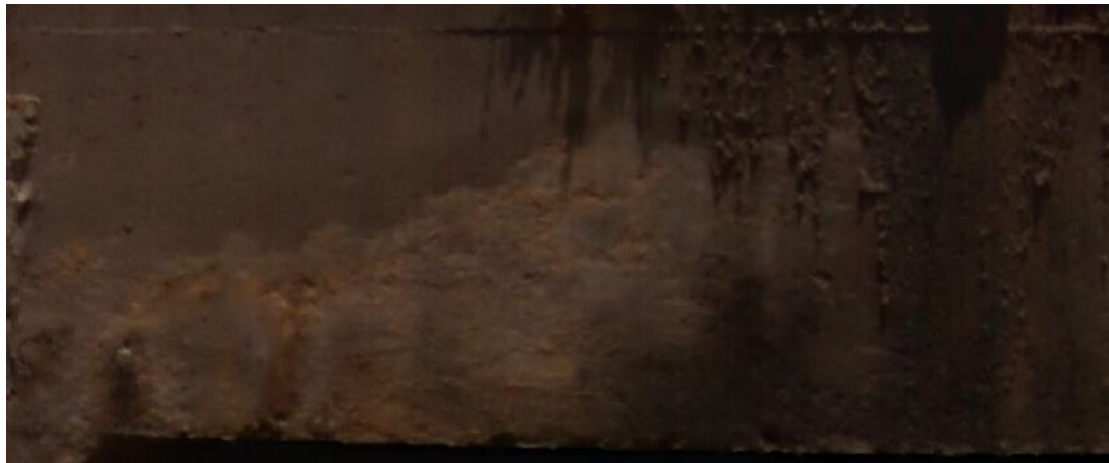
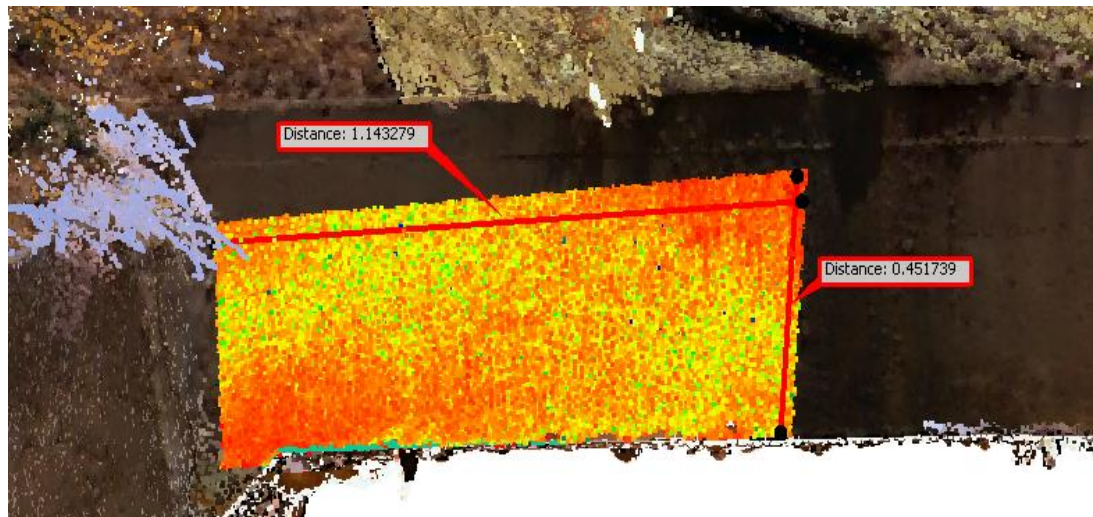
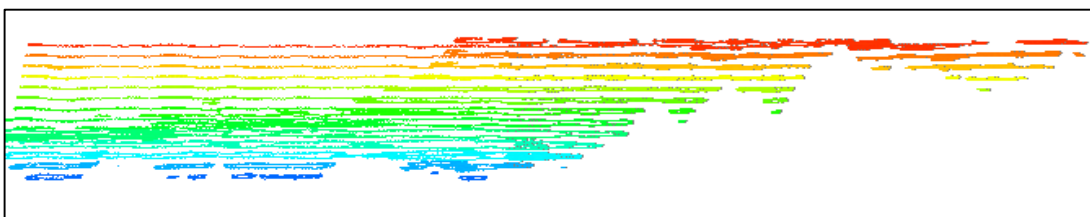
| Element Name | Observation | Location of Distress | Photo No. | Units | Distress Details | | | Area of Repair<br>(Sq.m/R MT/m3) |
|---|---|---|---|---|---|---|---|---|
| Parapet | Scaling | | 2 | | 1.14 | 0.45 | | 0.513 |

2. Scaling observed on RHS Parapet Wall, measuring 1.14 m in length and 0.45 m in width, covering an area of 0.513 m<sup>2</sup>.
