# LIDAR Inspection Report of **Box Culvert** ch.956+680

**Bridge No:** Slab Culvert

**Bridge Chainage:** 956 + 680 (CKRP)

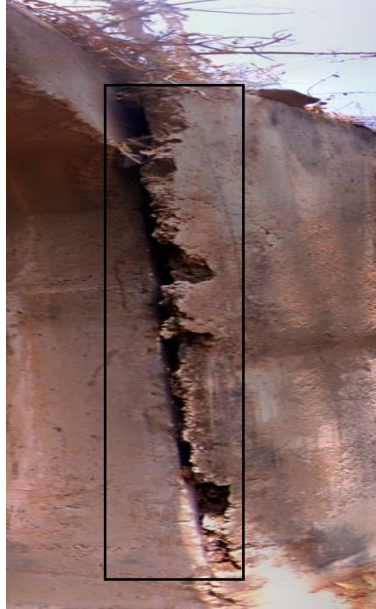
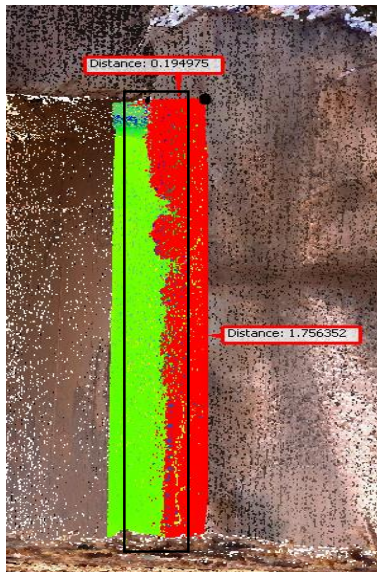
| Element Name | Observation | Location of Distress | Photo No. | Units | Distress Details | | | Area of Repair (Sq.m/R MT/m3) |
|---|---|---|---|---|---|---|---|---|
| Wing wall | Damage | | 1 | M | 1.75 | 0.19 | | 0.332 |

1. Corner damage observed at the junction of Abutment and Wing Wall on RHS, measuring 1.75 m in length and 0.19 m in width, covering an area of 0.332 m<sup>2</sup>.

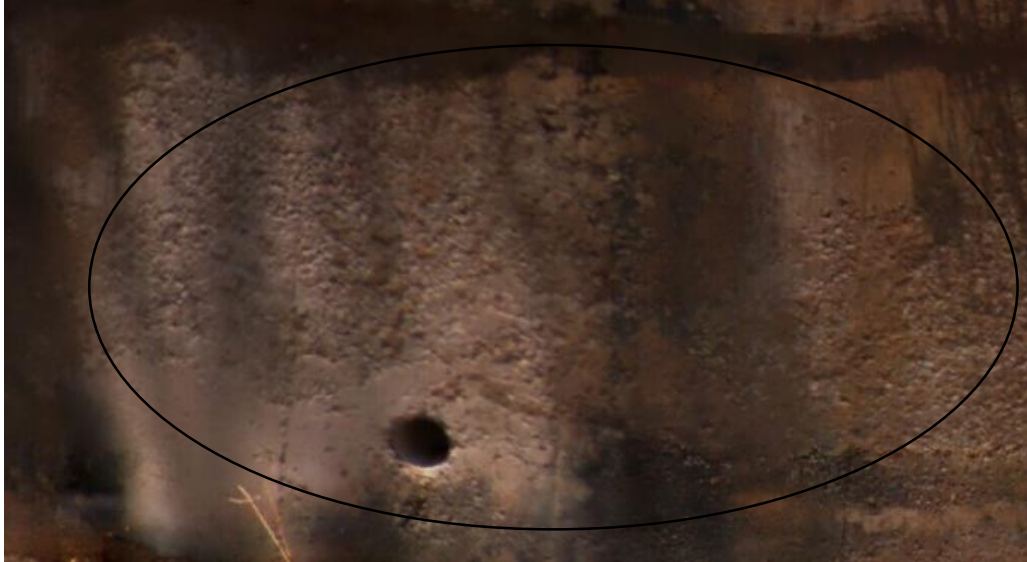
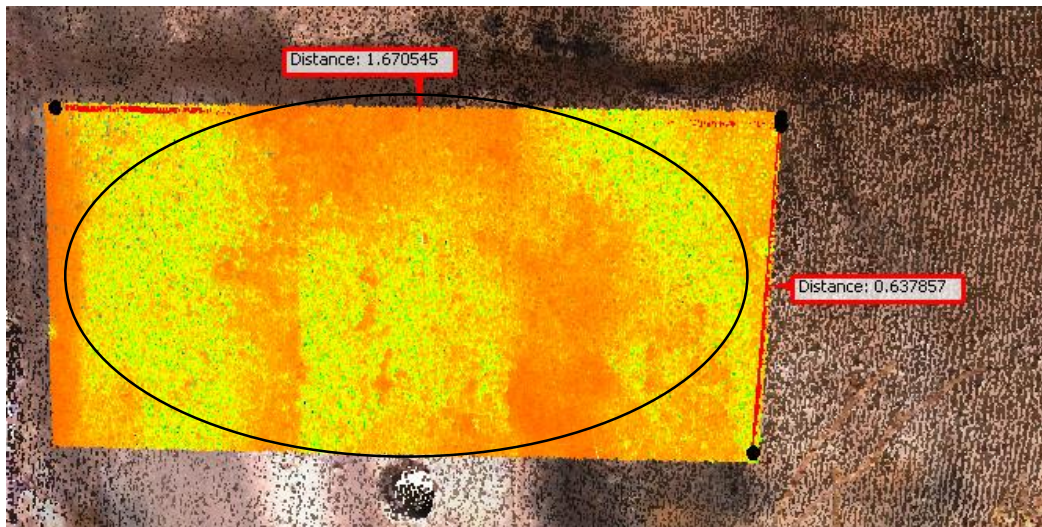
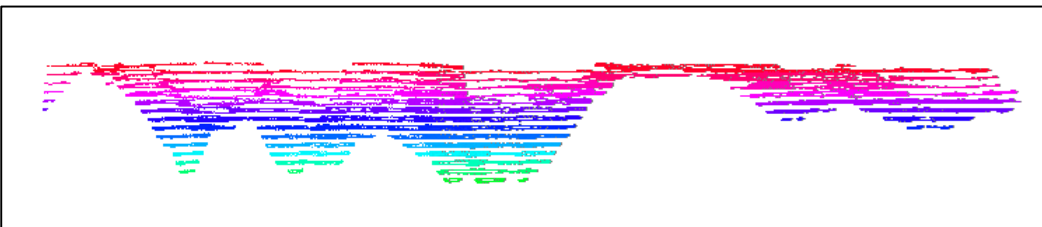
| Element Name | Observation | Location of Distress | Photo No. | Units | Distress Details | | | Area of Repair (Sq.m/R MT/m3) |
|---|---|---|---|---|---|---|---|---|
| Wing wall | Scaling | | 1 | M | 1.67 | 0.63 | | 1.052 |

- 2. Scaling observed on RHS Wing Wall, measuring 1.67 m in length and 0.63 m in width, covering an area of 1.052 m<sup>2</sup>.**
