# **LIDAR Inspection Report of PUP ch.957 + 350**

**Bridge Chainage:** 957 + 350 (CKRP)

- **CKRP:** Chittorgarh to kota
- **State:** Rajasthan NH 27
- **Zone:** RJ-06

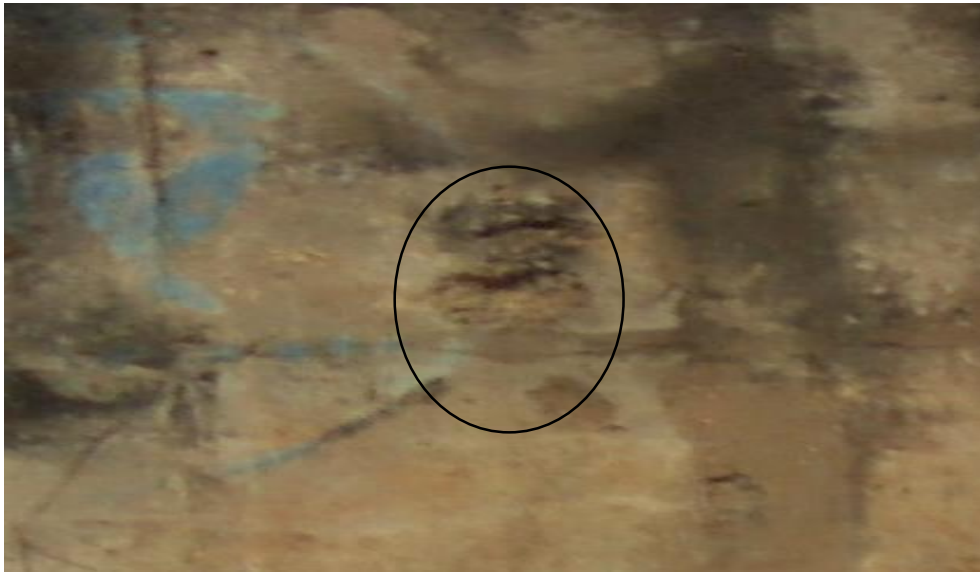
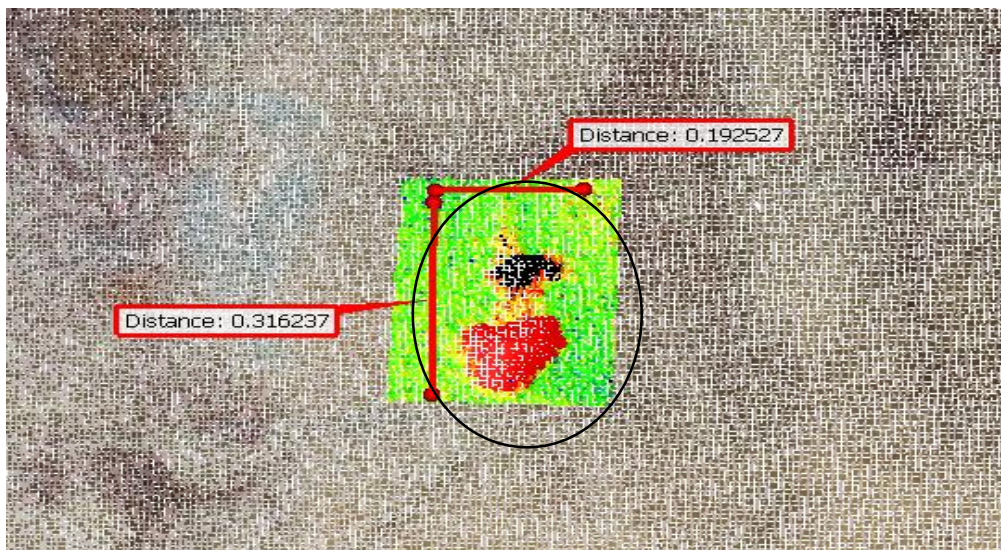
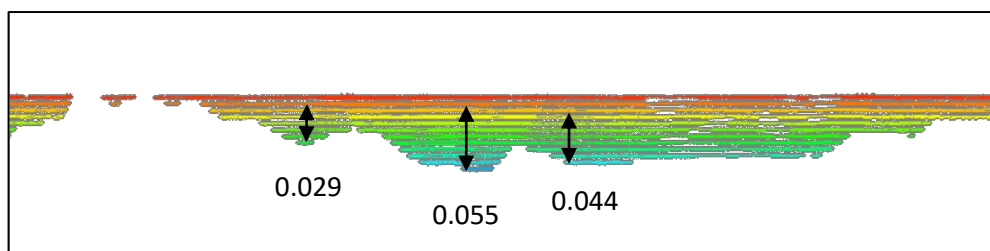
| Element Name | Observation | Location of Distress | Photo No. | Units | Distress Details | | | Area of Repair (Sq.m/ RMT/ m3) |
|---|---|---|---|---|---|---|---|---|
| Wing Wall | Damage | | 1 | M | 0.31 | 0.44 | 0.044 | 0.0025 |

**1. Wing wall damage observed on LHS Abutment 1, measuring 0.31 m in length and 0.19 m in width, Depth ranges from 0.029 m (min) to 0.055 m (max), with an average depth of 0.044 m. The calculated volume of the distress is 0.0025 m<sup>3</sup>.**

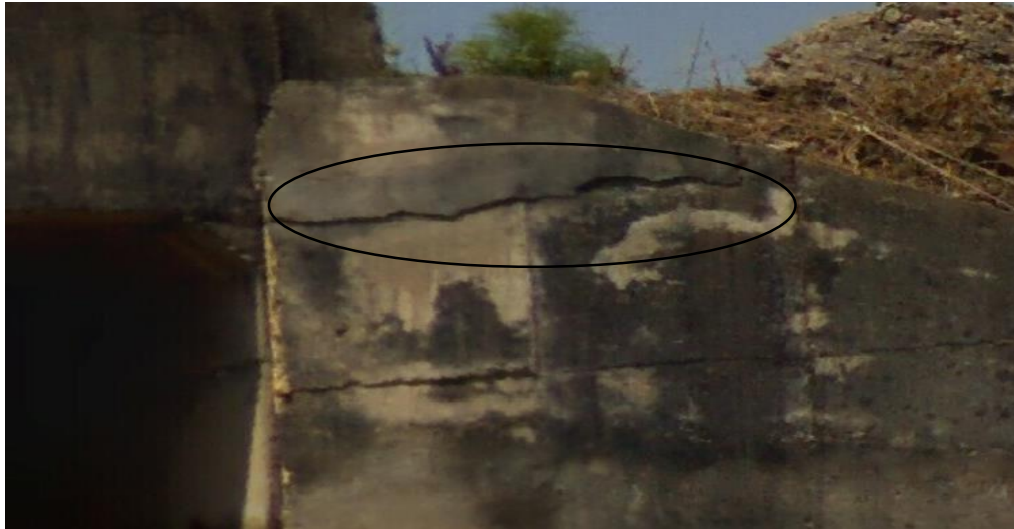
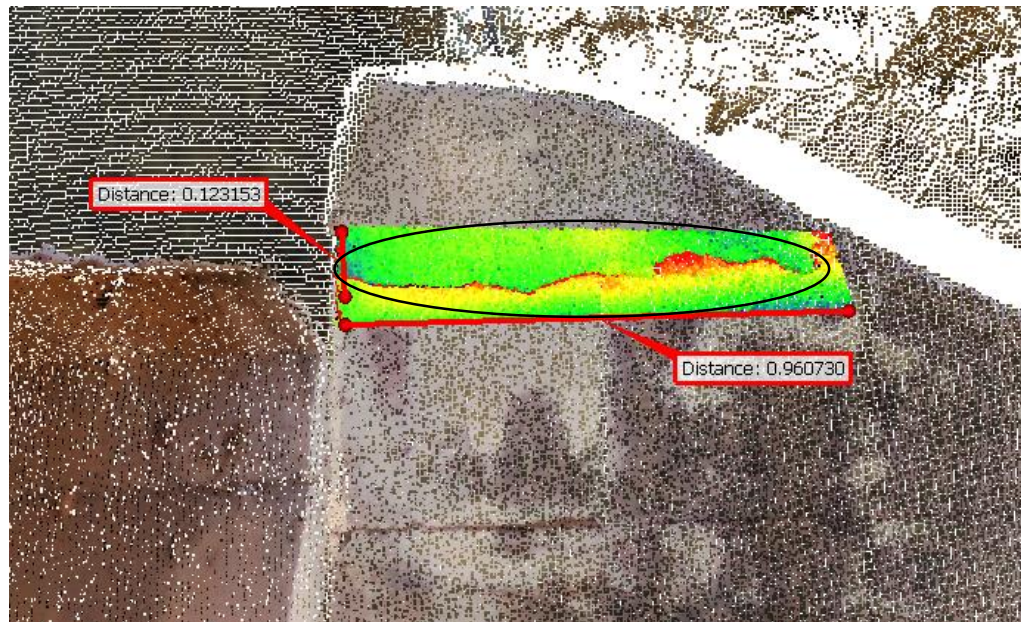
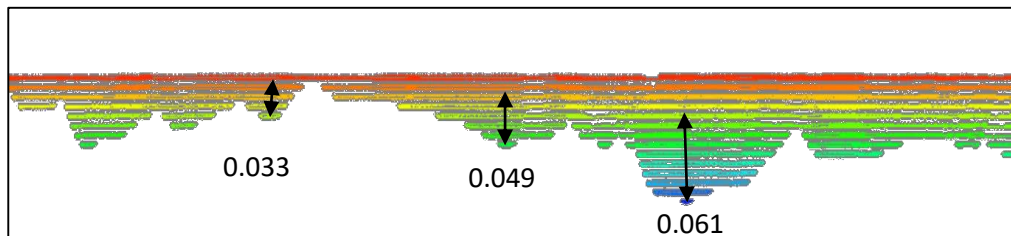
| Element Name | Observation | Location of Distress | Photo No. | Units | Distress Details | | | Area of Repair (Sq.m/ RMT/ m3) |
|---|---|---|---|---|---|---|---|---|
| Wing Wall | Damage | | 2 | M | 0.96 | 0.12 | 0.049 | 0.0056 |

**2. Wing wall damage observed on LHS Abutment 1, measuring 0.96 m in length and 0.12 m in width, Depth ranges from 0.033 m (min) to 0.071 m (max), with an average depth of 0.049 m. The calculated volume of the distress is 0.0056 m<sup>3</sup>.**

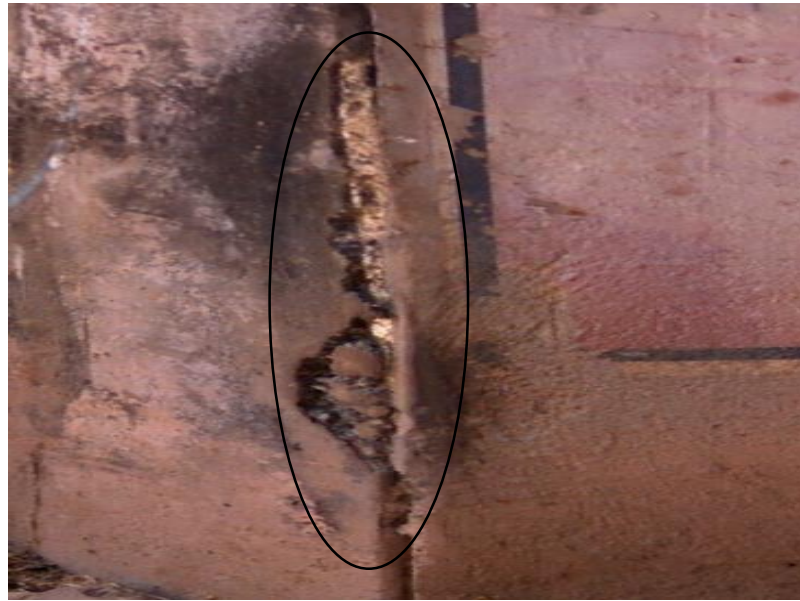
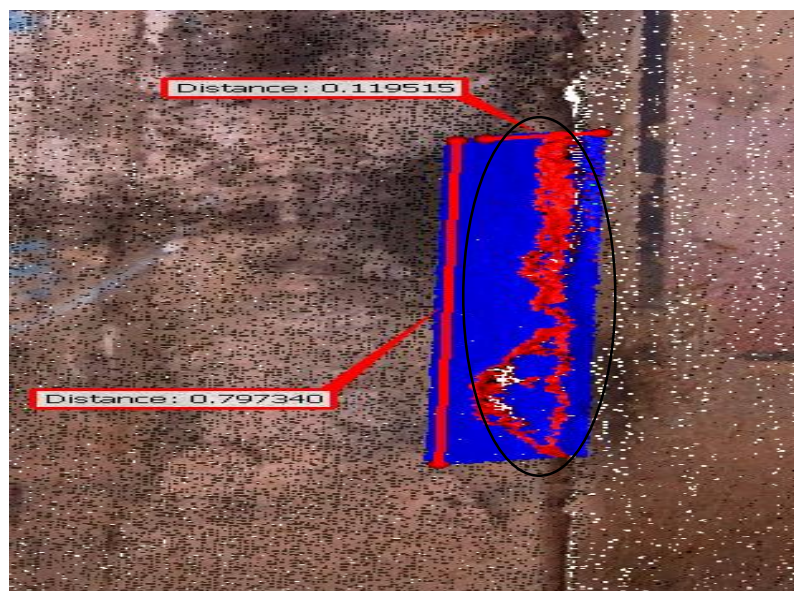
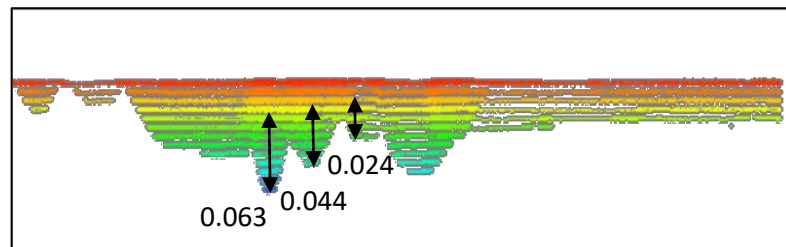
| Element Name | Observation | Location of Distress | Photo No. | Units | Distress Details | | | Area of Repair (Sq.m/ RMT/ m3) |
|---|---|---|---|---|---|---|---|---|
| Wing Wall | Damage | | 3 | M | 0.79 | 0.11 | 0.044 | 0.0038 |

**3. Wing wall damage observed on LHS Abutment 2, measuring 0.79 m in length and 0.11 m in width, Depth ranges from 0.024 m (min) to 0.073 m (max), with an average depth of 0.044 m. The calculated volume of the distress is 0.0038 m<sup>3</sup>.**

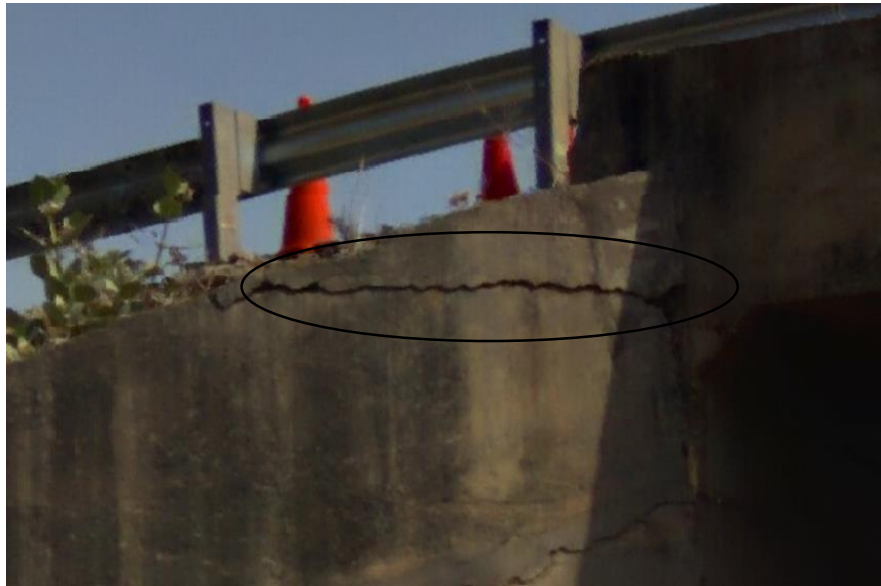
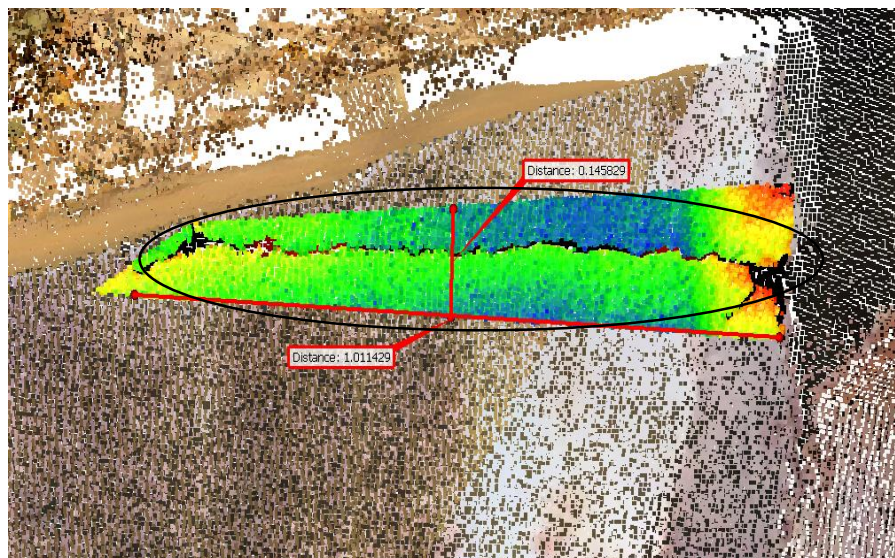
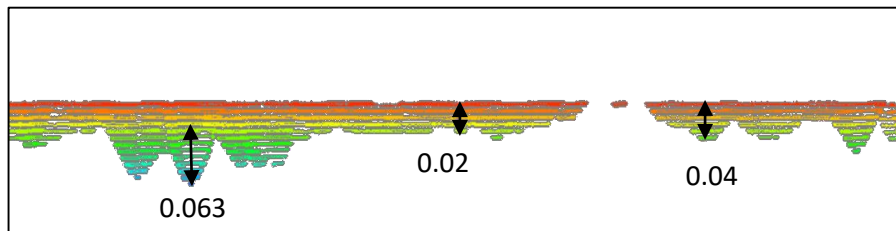
| Element Name | Observation | Location of Distress | Photo No. | Units | Distress Details | | | Area of Repair (Sq.m/ RMT/ m3) |
|---|---|---|---|---|---|---|---|---|
| Wing Wall | Damage | | 4 | M | 1.01 | 0.14 | 0.041 | 0.0057 |

**4. Wing wall damage observed on RHS Abutment 2, measuring 1.01 m in length and 0.14 m in width, Depth ranges from 0.024 m (min) to 0.063 m (max), with an average depth of 0.041m. The calculated volume of the distress is 0.0057 m<sup>3</sup>.**
