# **LIDAR Inspection Report of VUP ch.958+250**

**Bridge Chainage:** 958+250 (CKRP)

- **Bridge No:** -
- **Chainage:** 958+250
- **Structure type:** VUP

- **CKRP:** Chittorgarh to kota
- **State:** Rajasthan NH 27
- **Zone:** RJ-06

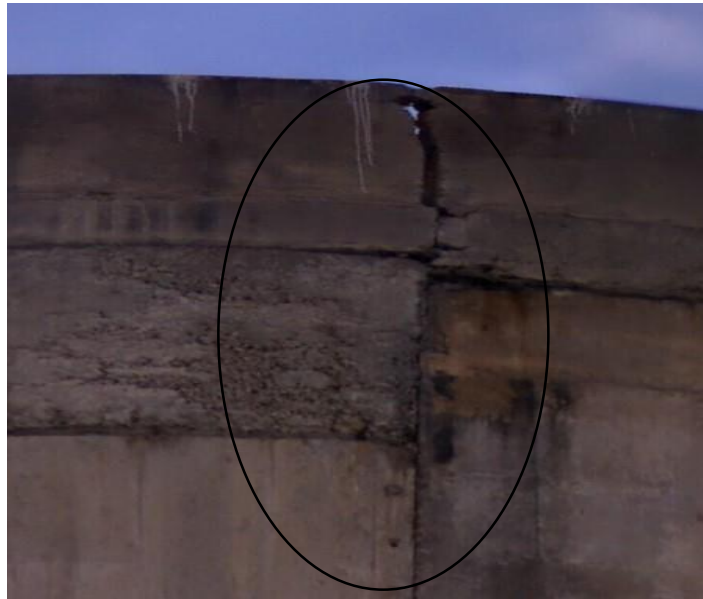
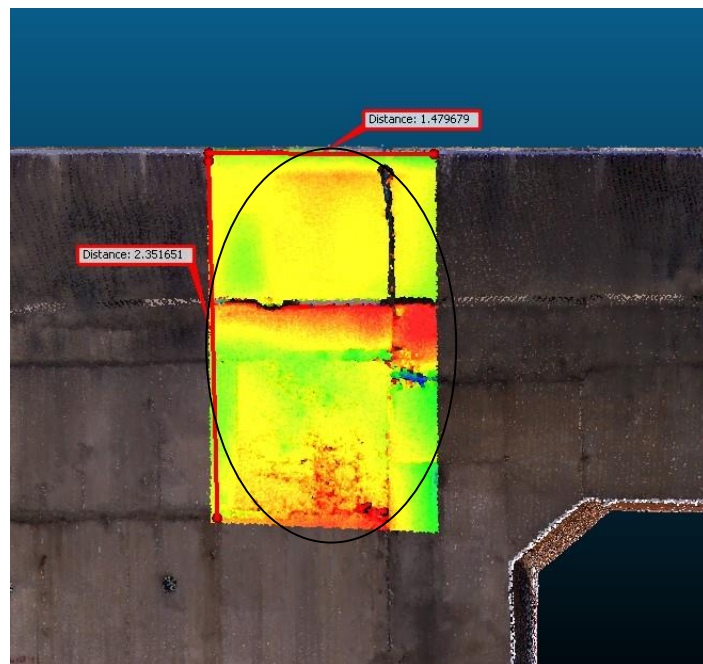
| Element Name | Observation | Location of Distress | Photo No. | Units | Distress Details | | | Area of Repair (Sq.m/R MT/m3) |
|---|---|---|---|---|---|---|---|---|
| A2 Parapet wall | Damage | - | 1 | M | 1.47 | 2.35 | - | 3.454 |

**1.Parapet wall damage observed on LHS A2, measuring 1.47 m in length and 2.35 m in width, covering an area of 3.454 m<sup>2</sup>.**
