# **LIDAR Inspection Report of Slab Culvert ch.959+100**

**Bridge No:** Slab Culvert

**Bridge Chainage:** 959 + 100 (CKRP)

- **CKRP:** Chittorgarh to kota
- **State:** Rajasthan NH 27
- **Zone:** RJ-06

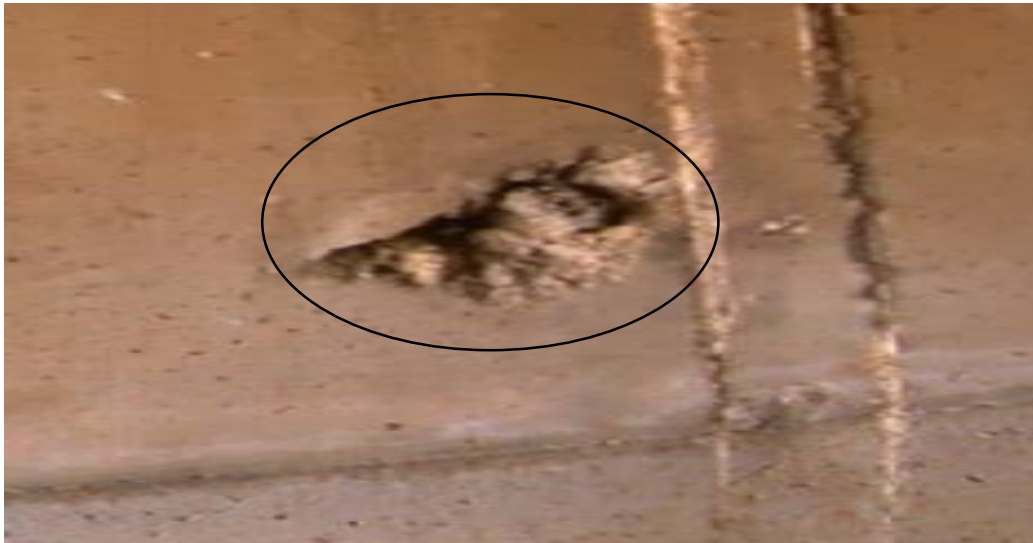
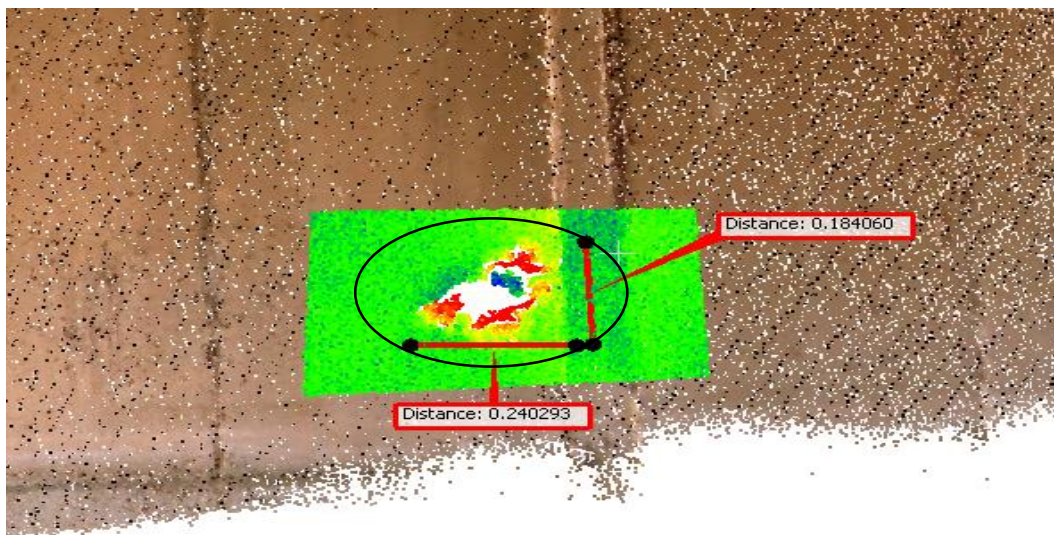
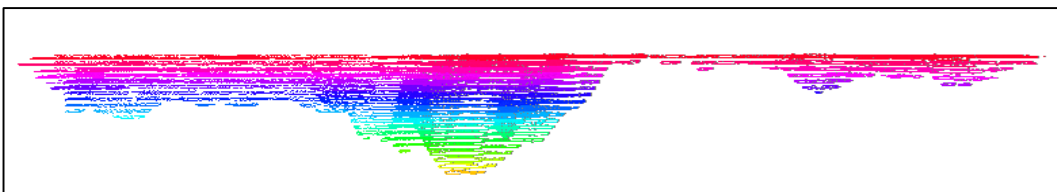
| Element Name | Observation | Location of Distress | Photo No. | Units | Distress Details | | | Area of Repair (Sq.m/R MT/m3) |
|---|---|---|---|---|---|---|---|---|
| Weep holes | Block | - | 1 | M | 0.24 | 0.18 | | 0.0432 |

1. Weep hole blockage observed, measuring 0.24 m in length and 0.18 m in width, covering an area of 0.0432 m<sup>2</sup>.
