# **LIDAR Inspection Report of Slab Culvert ch.960+745**

**Bridge Chainage:** 960+745

- **Bridge No:** -
- **Chainage:** 960+745
- **Structure type:** Slab Box Culvert

- **CKRP:** Chittorgarh to kota
- **State:** Rajasthan NH 27
- **Zone:** RJ-20

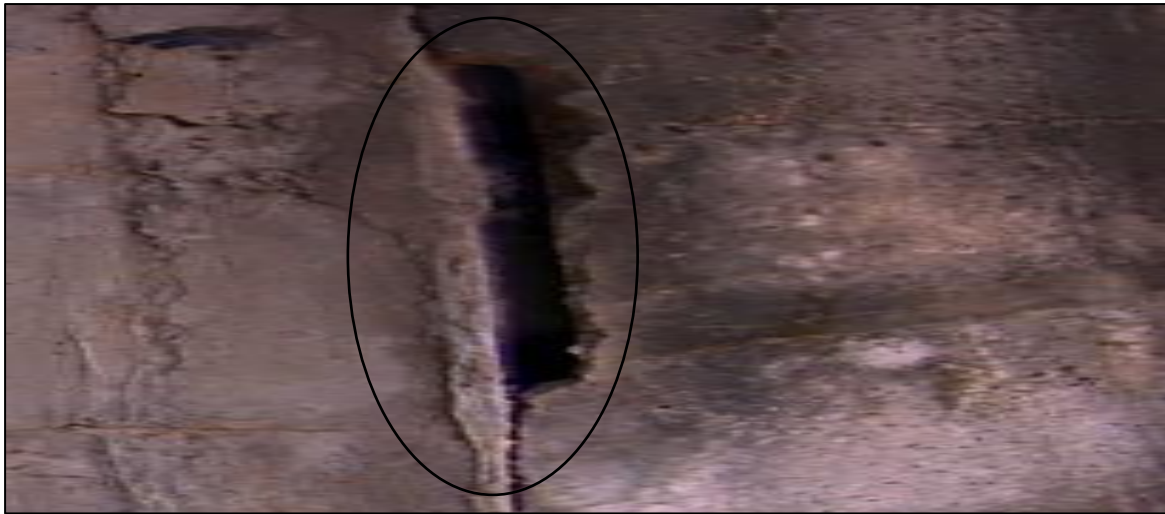
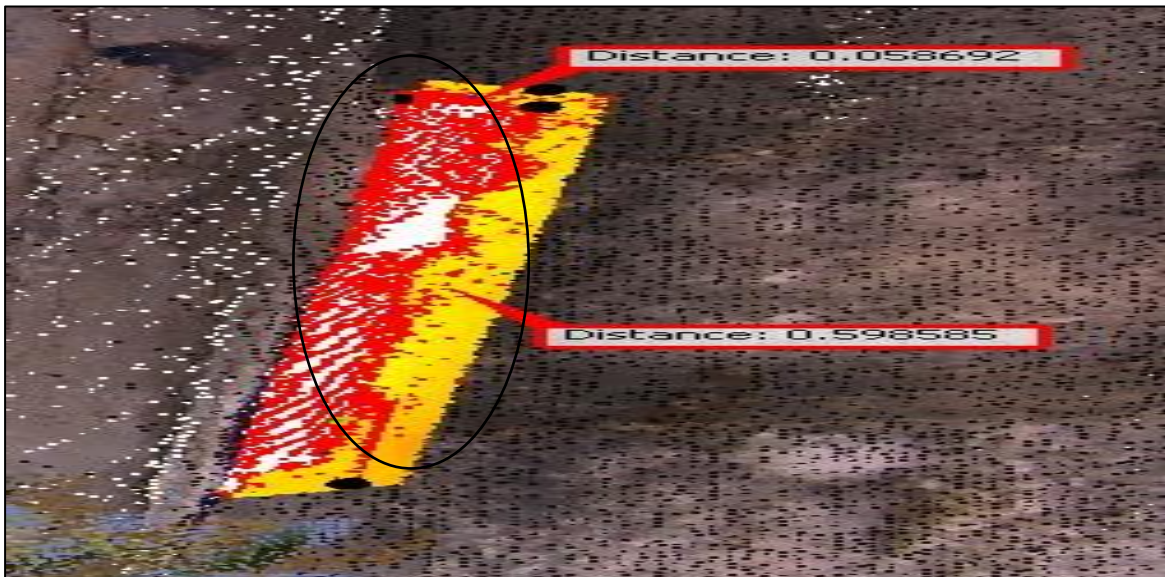
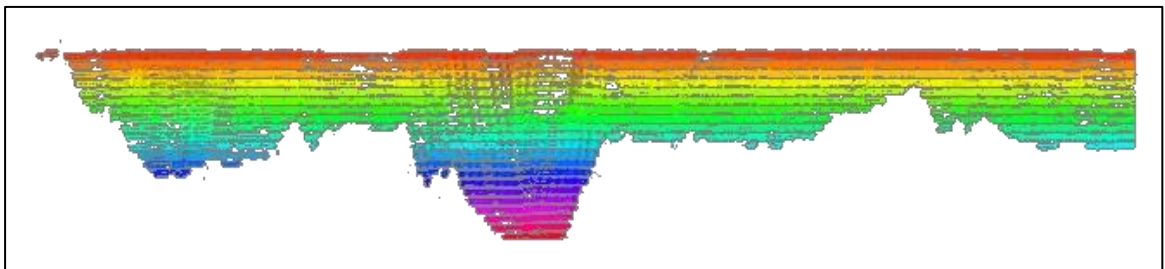
| Element Name | Observation | Location of Distress | Photo No. | Units | Distress Details | | | Area of Repair (Sq.m/R MT/m3) |
|---|---|---|---|---|---|---|---|---|
| Wing Wall | Damage | | 1 | Sq m | 0.5985 | 0.0586 | | 0.0350 |

- 1. Wing Wall Damage-1 observed on A1 (LHS), measuring 0.5985 m in length and 0.0586 m in width, covering an area of 0.0350 m<sup>2</sup>.**

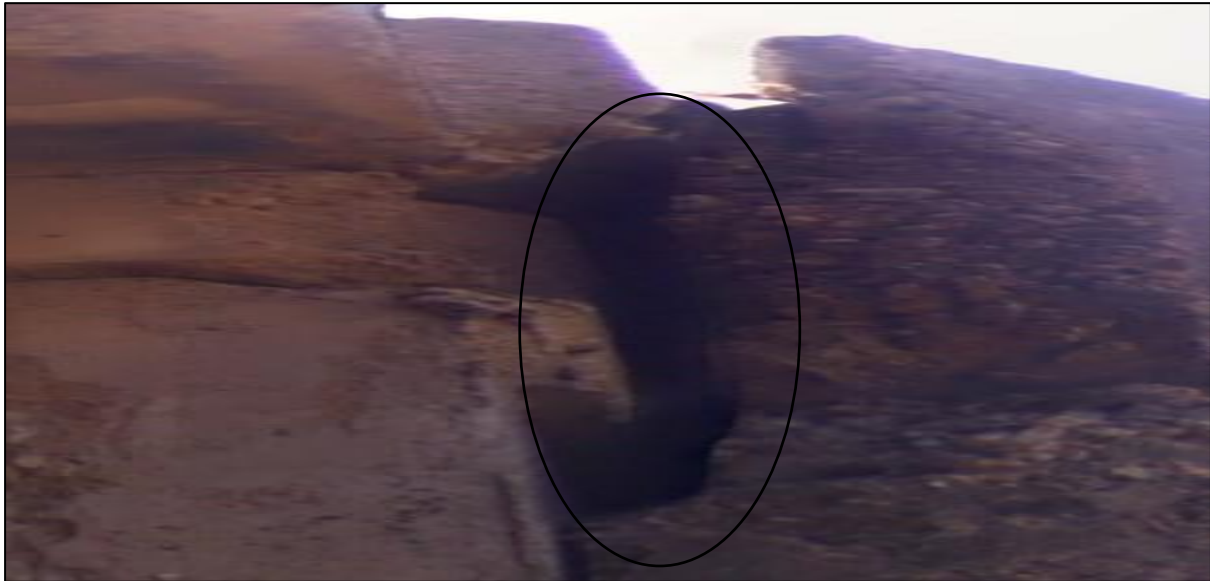
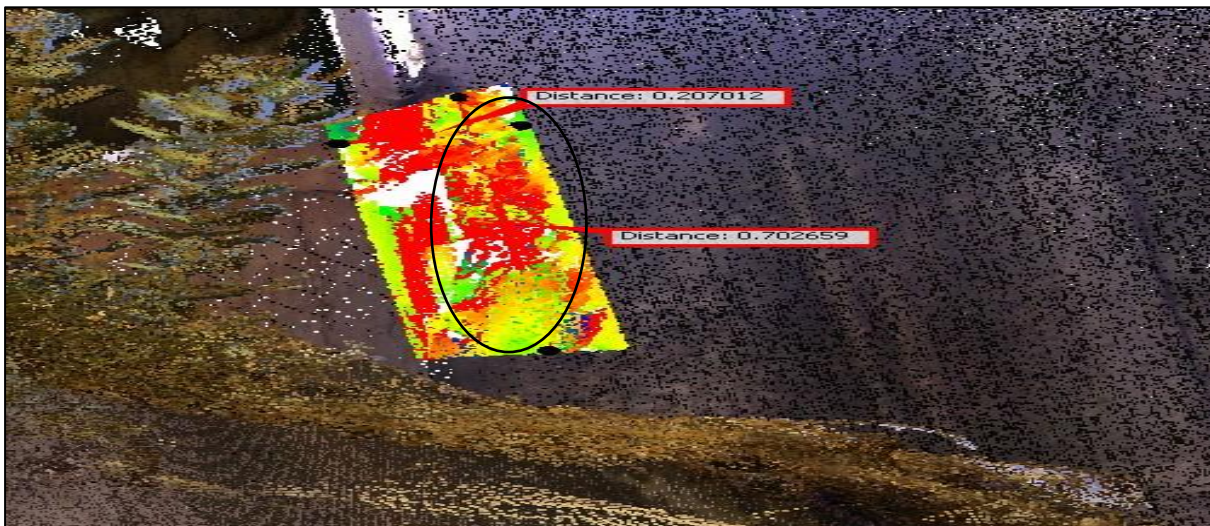
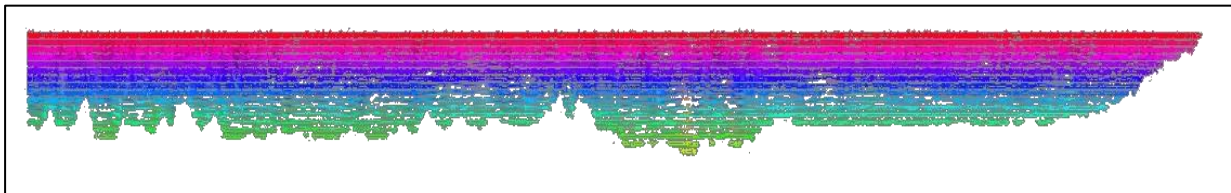
| Element Name | Observation | Location of Distress | Photo No. | Units | Distress Details | | | Area of Repair (Sq.m/R MT/m3) |
|---|---|---|---|---|---|---|---|---|
| Wing Wall | Damage | | 2 | Sq m | 0.7026 | 0.2070 | | 0.1454 |

**2.Wing Wall Damage-2 observed on A1 (LHS), measuring 0.7026 m in length and 0.2070 m in width, covering an area of 0.1454 m<sup>2</sup>.**

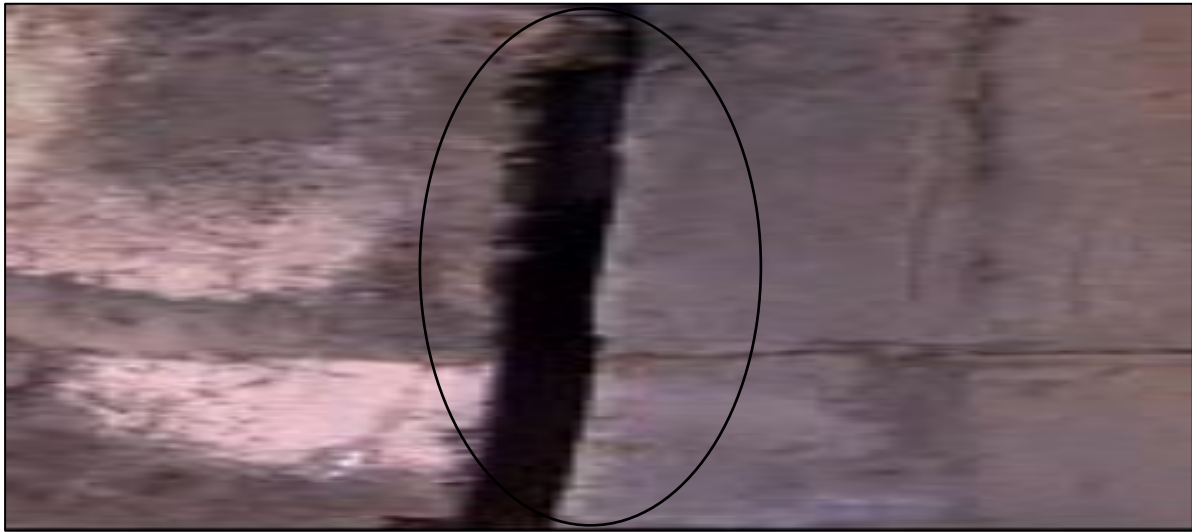
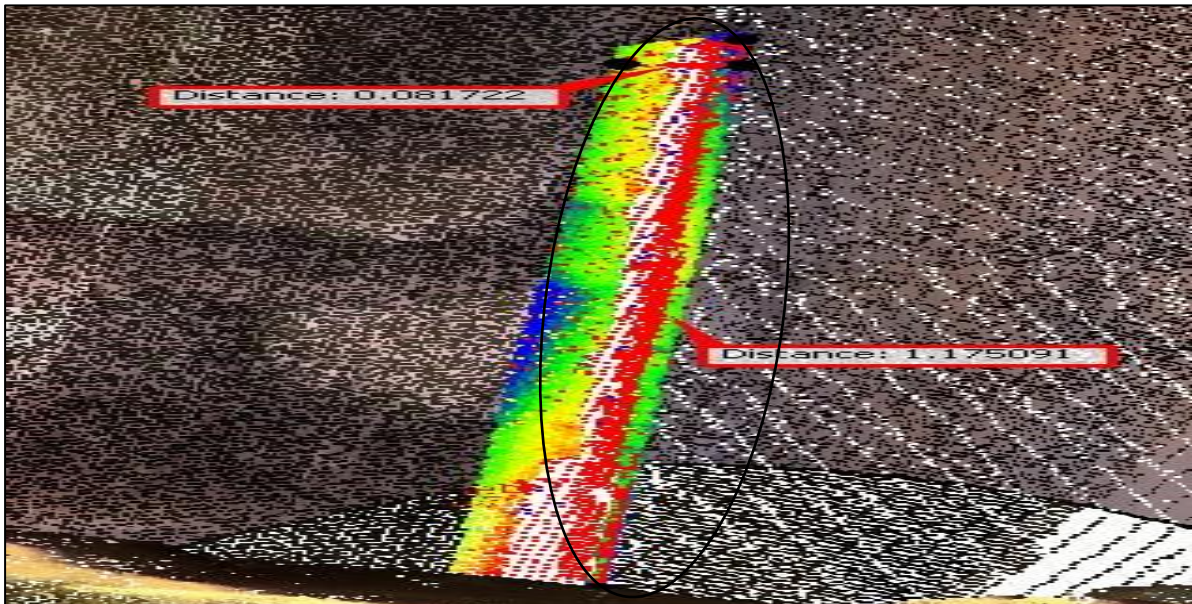
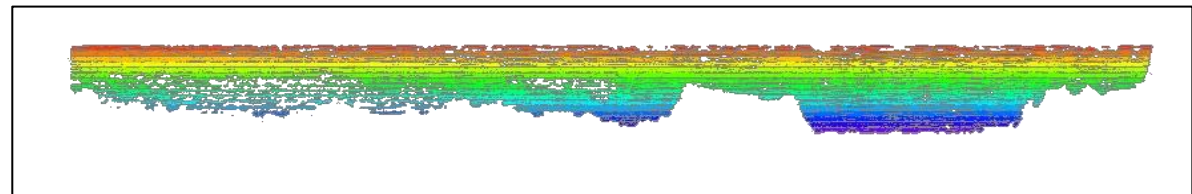
| Element Name | Observation | Location of Distress | Photo No. | Units | Distress Details | | | Area of Repair (Sq.m/R MT/m3) |
|---|---|---|---|---|---|---|---|---|
| Wing Wall | Damage | | 3 | Sq m | 1.1750 | 0.0817 | | 0.0959 |

**3. Wing Wall Damage Observed on A2 (LHS), measuring 1.1750 m in length and 0.0817 m in width, covering an area of 0.0959 m<sup>2</sup>.**
