# **LIDAR Inspection Report of MNB ch.965+680**

**Bridge No:** MNB - 966/1

**Bridge Chainage:** 965+680 (CKRP)

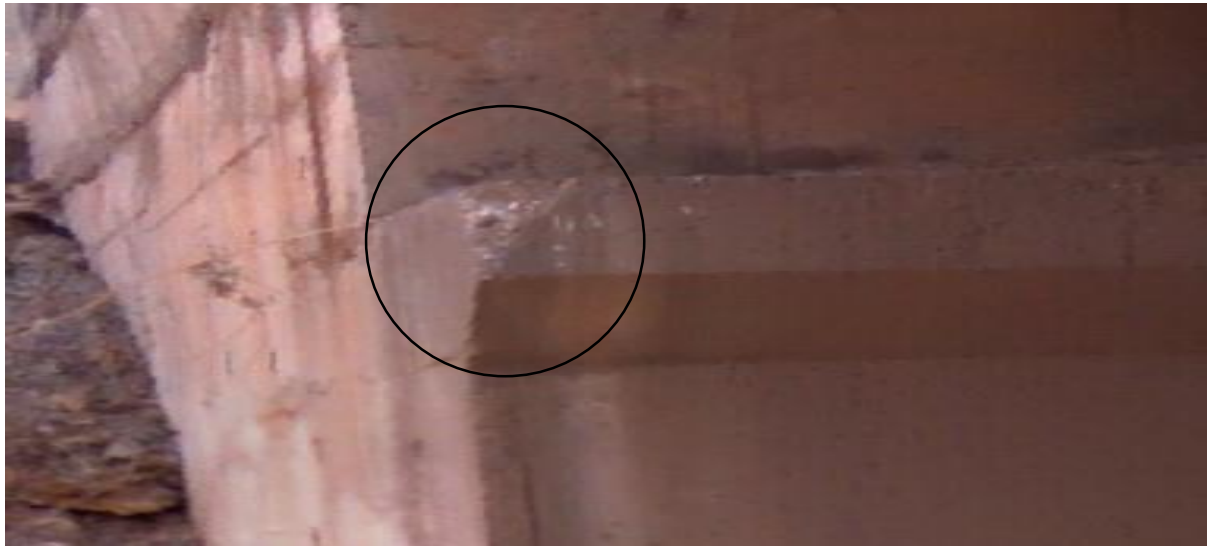
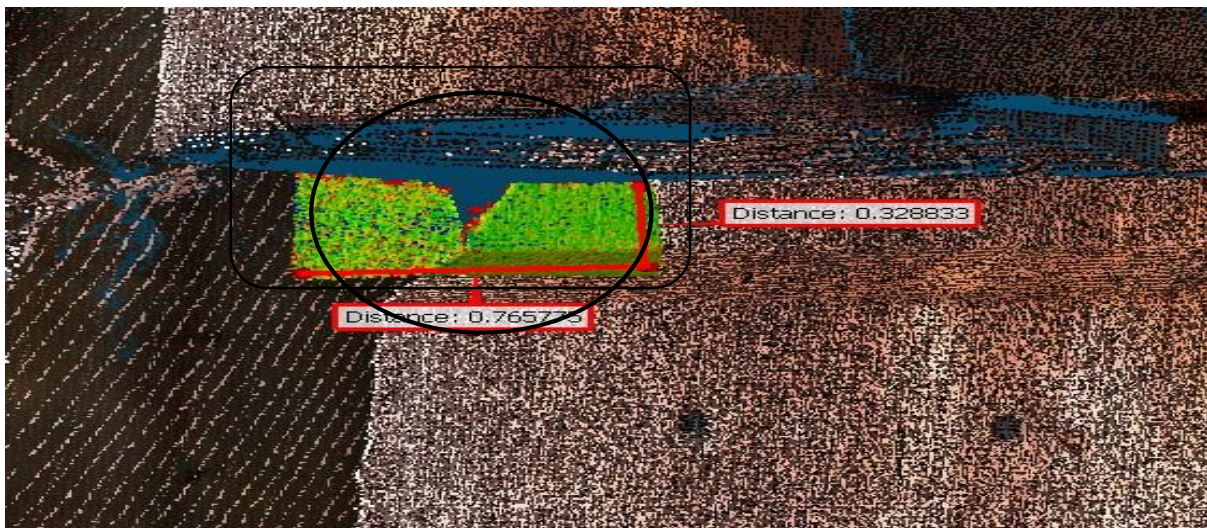
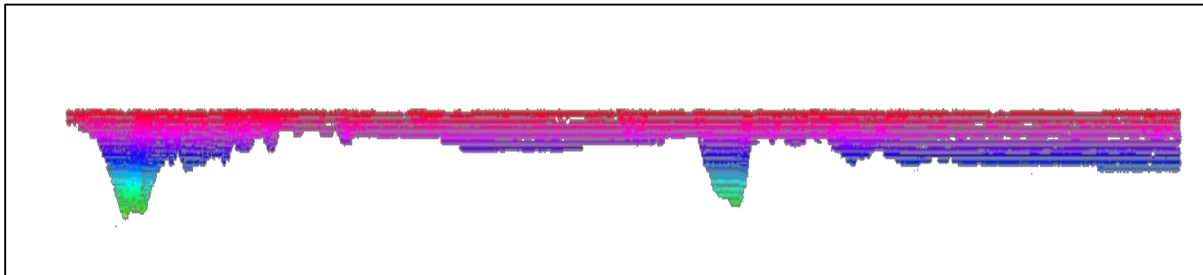
| Element Name | Observation | Location of Distress | Photo No. | Units | Distress Details | | | Area of Repair (Sq./RM T/m3) |
|---|---|---|---|---|---|---|---|---|
| Abutment 2 | Damage | | 1 | | 0.76 | 0.32 | | 0.2432 |

1. Damage area observed on LHS Abutment 2, measuring 0.76 m in length and 0.32 m in width, covering an area of 0.2432 m<sup>2</sup>.

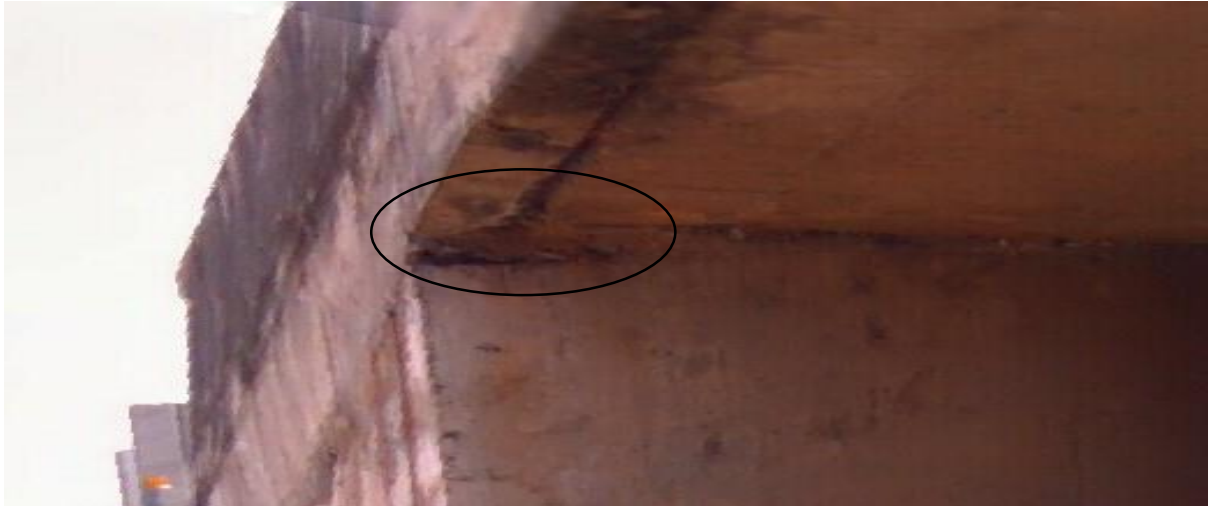
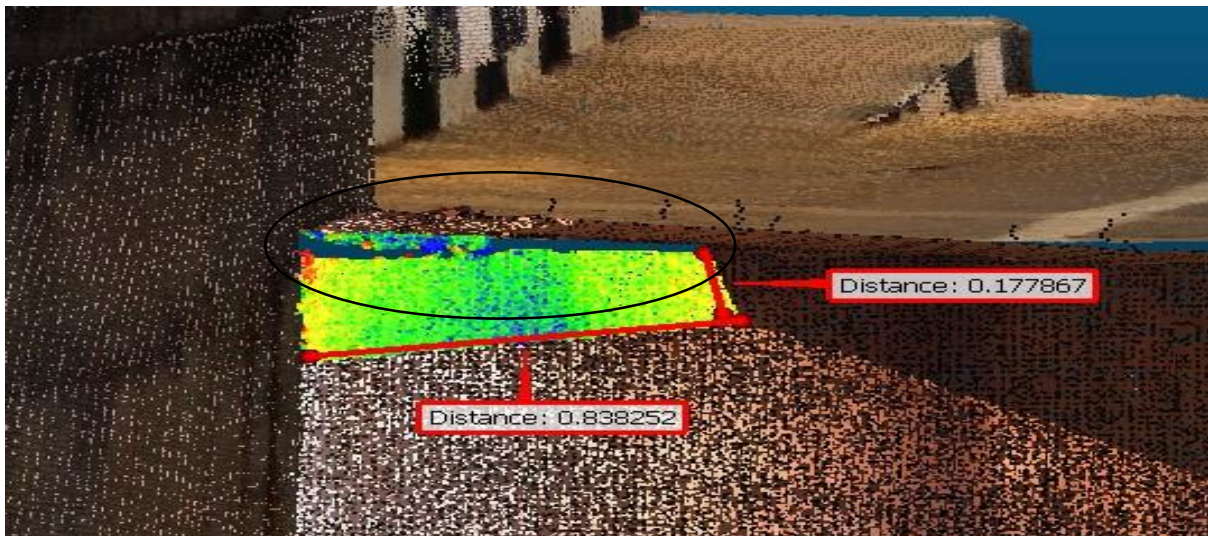
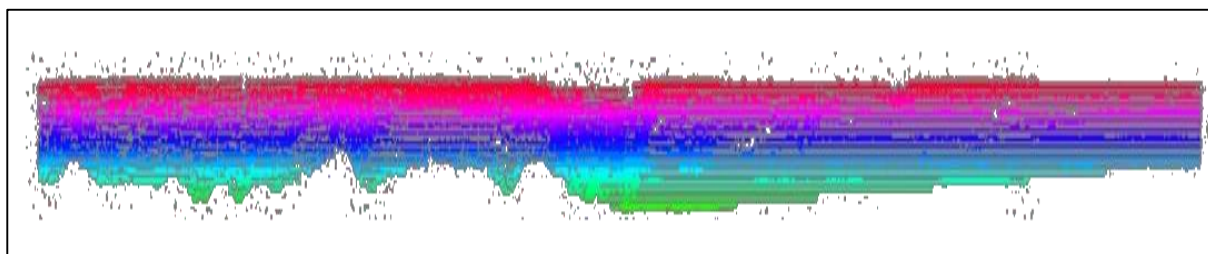
| Element Name | Observation | Location of Distress | Photo No. | Units | Distress Details | | | Area of Repair (Sq./RM T/m3) |
|---|---|---|---|---|---|---|---|---|
| Abutment 2 | Damage | | 2 | | 0.83 | 0.17 | | 0.1411 |

**2.Damaged area observed on LHS Abutment 2, measuring 0.83 m in length and 0.17 m in width, covering an area of 0.1411 m<sup>2</sup>**

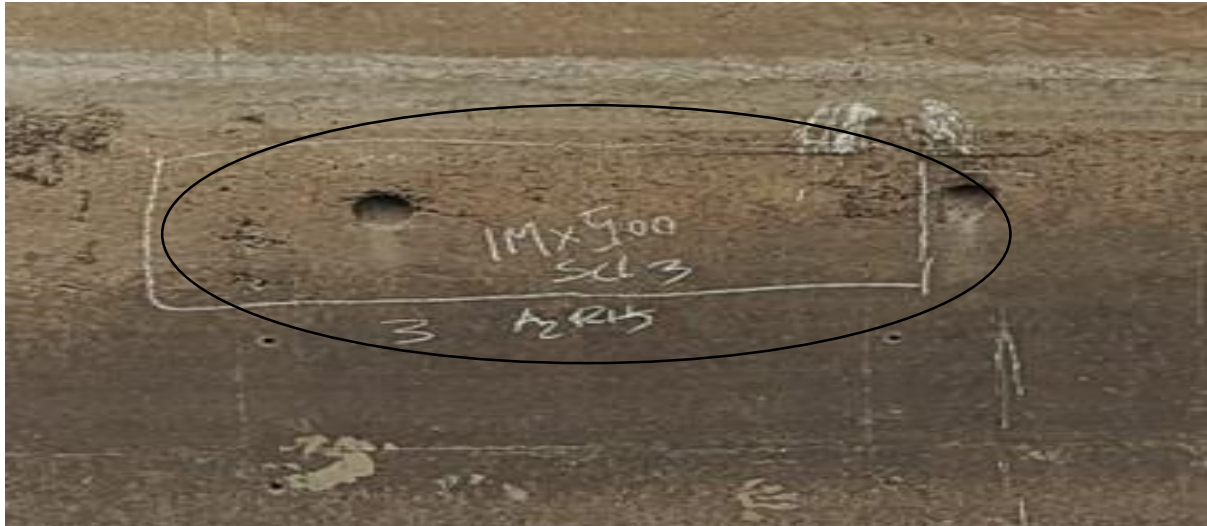
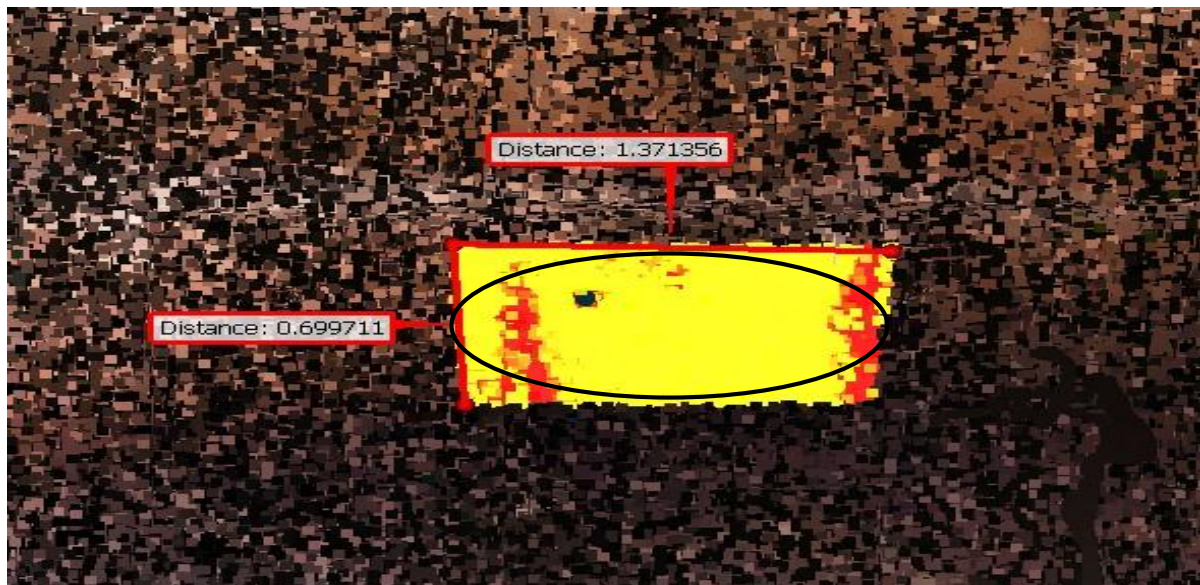
| Element Name | Observation | Location of Distress | Photo No. | Units | Distress Details | | | Area of Repair (Sq./RM T) |
|---|---|---|---|---|---|---|---|---|
| Abutment 2 | Scaling | | 3 | | 1.37 | 0.69 | | 0.9453 |

**3. Scaling observed on RHS Abutment 2, measuring 1.37 m in length and 0.69 m in width, covering an area of 0.9453 m<sup>2</sup>.**

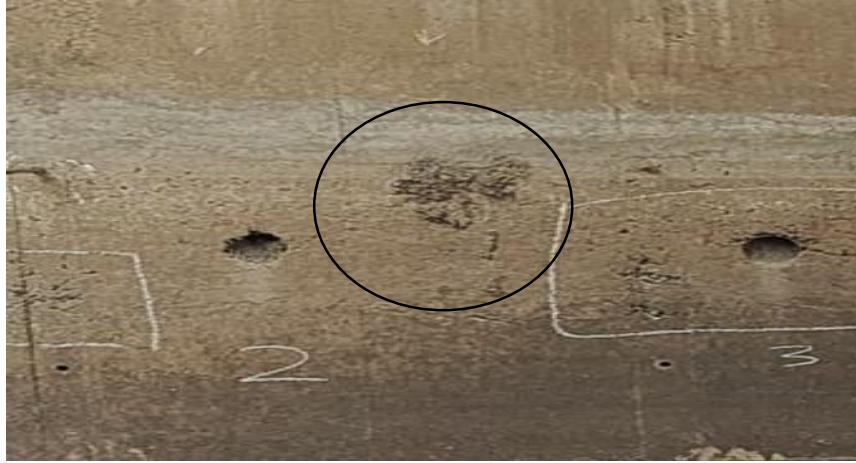
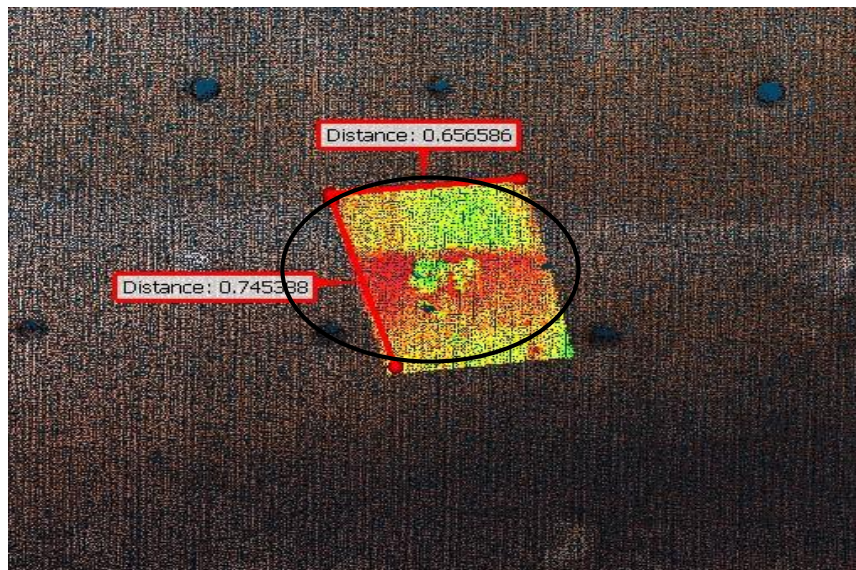
| Element Name | Observation | Location of Distress | Photo No. | Units | Distress Details | | | Area of Repair (Sq./RM T) |
|---|---|---|---|---|---|---|---|---|
| Abutment 2 | Scaling | | 4 | | 0.65 | 0.74 | | 0.481 |

**4. Scaling observed on RHS Abutment 2, measuring 0.65 m in length and 0.74 m in width, covering an area of 0.481 m<sup>2</sup>.**

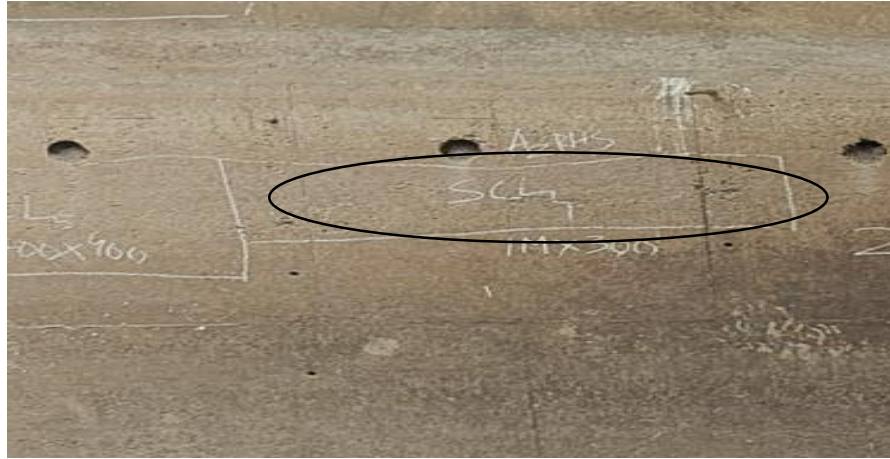
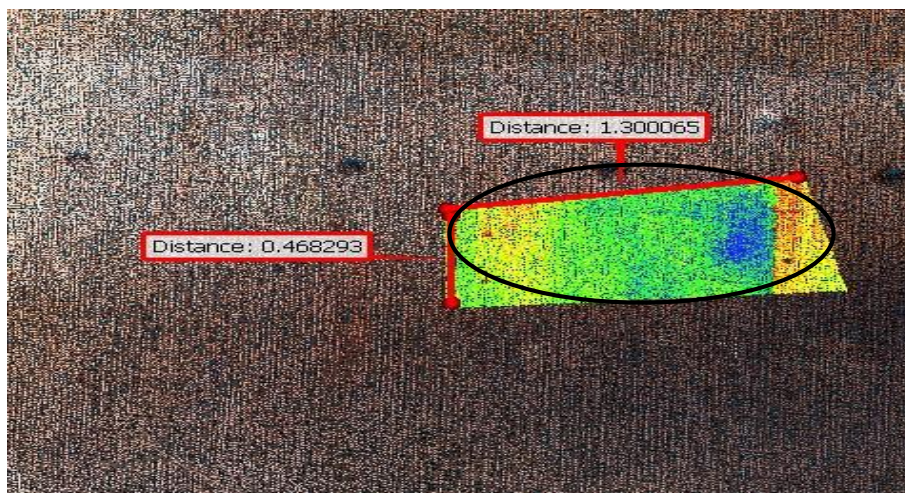
| Element Name | Observation | Location of Distress | Photo No. | Units | Distress Details | | | Area of Repair (Sq./RM T) |
|---|---|---|---|---|---|---|---|---|
| Abutment 2 | Scaling | | 5 | | 1.30 | 0.46 | | 0.598 |

**5. Scaling observed on RHS Abutment 2, measuring 1.30 m in length and 0.46 m in width, covering an area of 0.598 m<sup>2</sup>.**

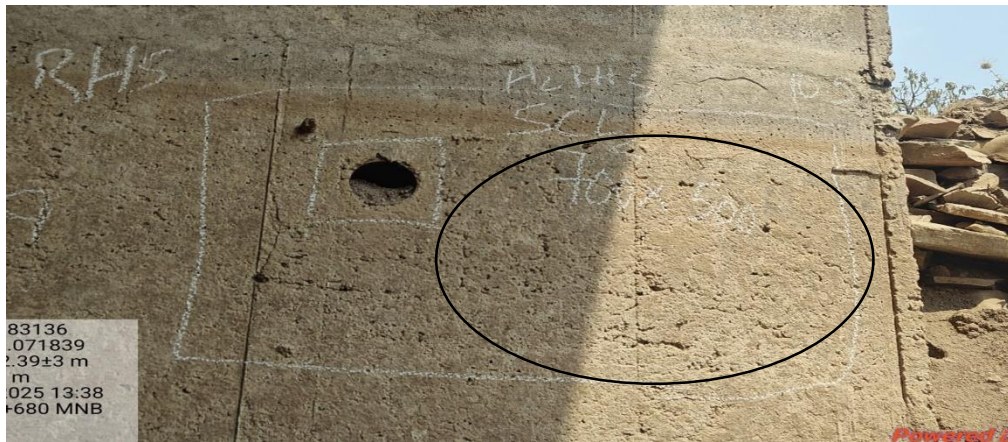
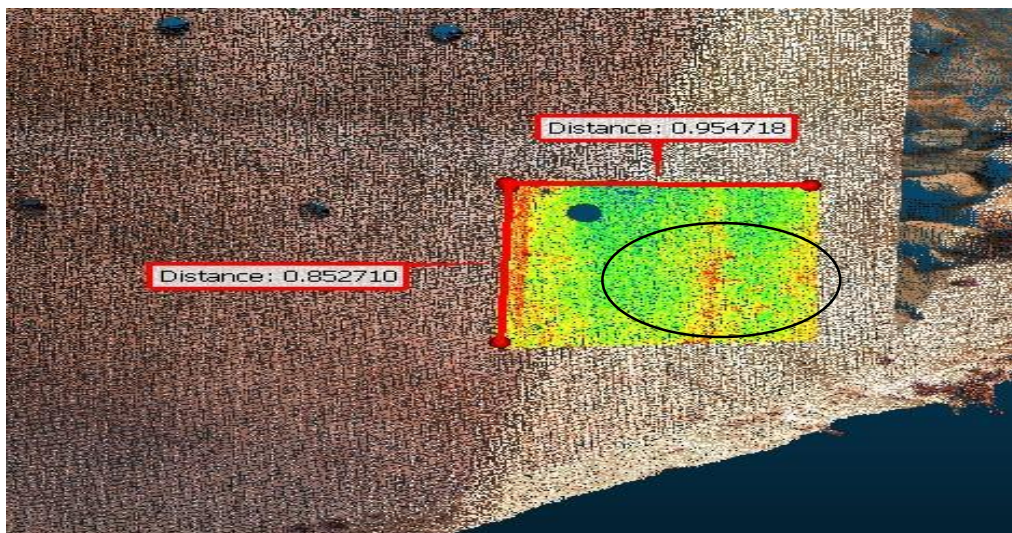
| Element Name | Observation | Location of Distress | Photo No. | Units | Distress Details | | | Area of Repair (Sq./RM T) |
|---|---|---|---|---|---|---|---|---|
| Abutment 2 | Scaling | | 6 | | 0.95 | 0.85 | | 0.8075 |

**6. Scaling observed on RHS Abutment 2, measuring 0.95 m in length and 0.85 m in width, covering an area of 0.8075 m<sup>2</sup>.**

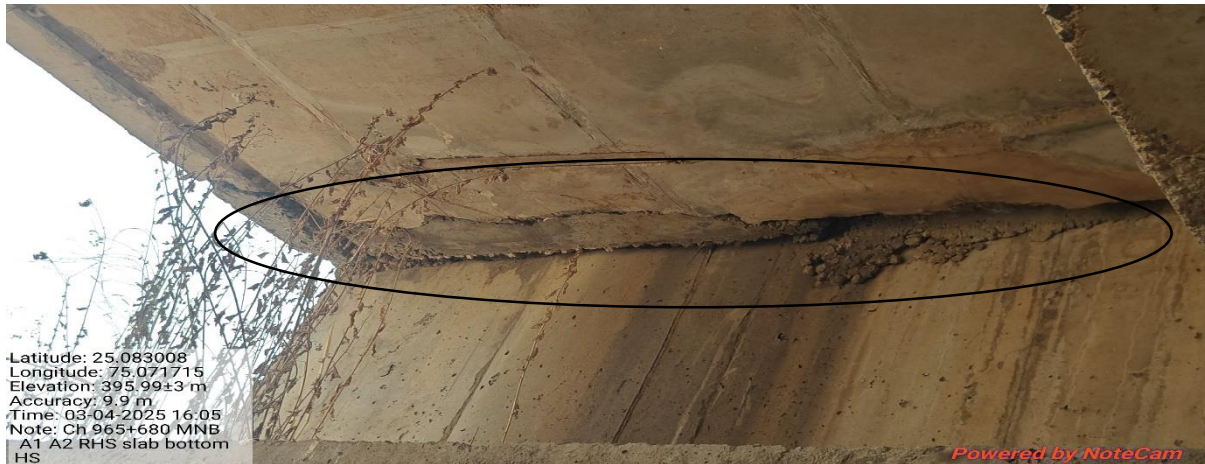
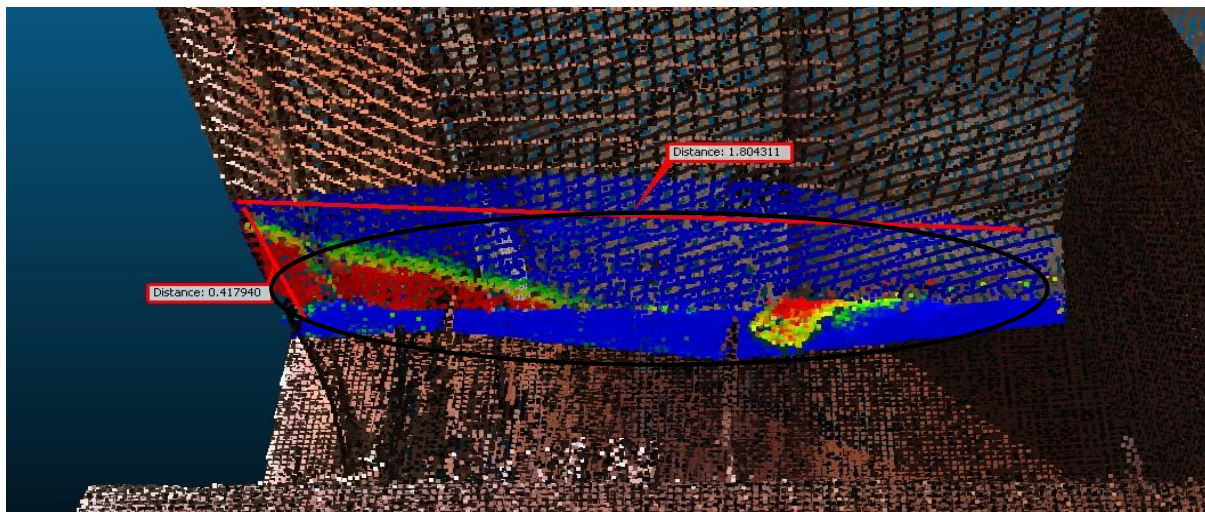
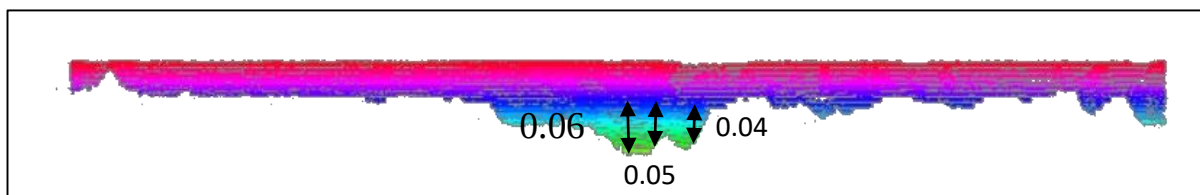
| Element Name | Observation | Location of Distress | Photo No. | Units | Distress Details | | | Area of Repair (Sq./RM T) |
|---|---|---|---|---|---|---|---|---|
| Abutment 1 2 Slab Bottom | Damage | | 7 | | 1.80 | 0.41 | 0.05 | 0.045 |

**7. Slab bottom damage observed between Abutment 1 and Abutment 2 on RHS, measuring 1.80 m in length and 0.41 m in width, Depth ranges from 0.04 (min) to 0.06 m (max), with an average depth of 0.055 m. The calculated volume of the distress is 0.045.**
