# **LIDAR Inspection Report of MNB ch.967+030**

**Bridge No:** MNB - 967/1

**Bridge Chainage:** 967+030 (CKRP)

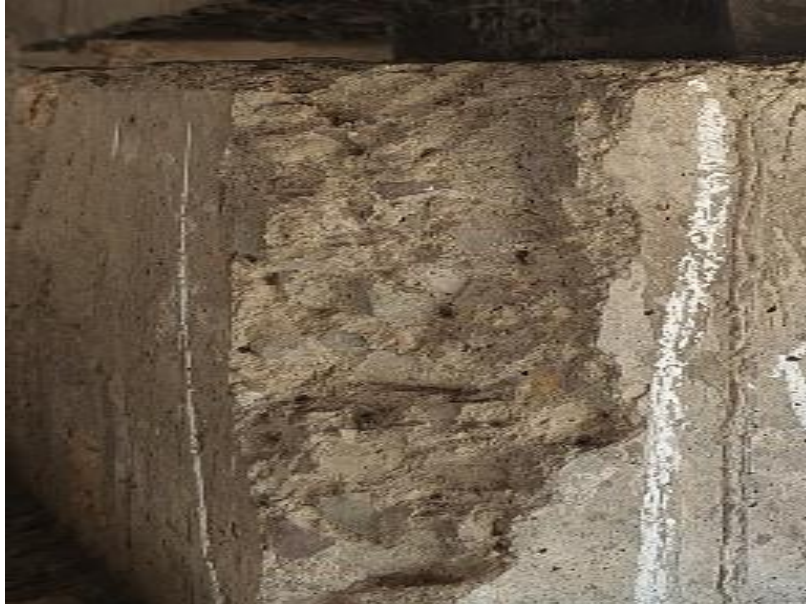
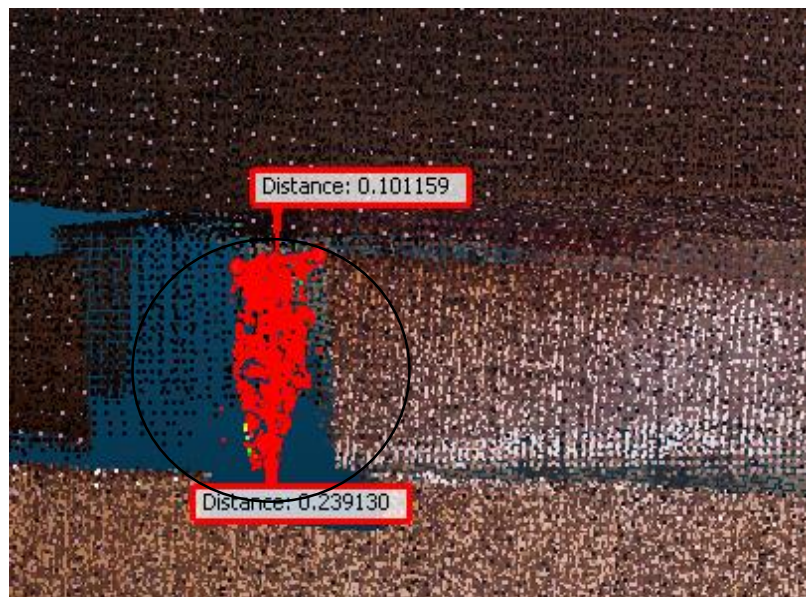
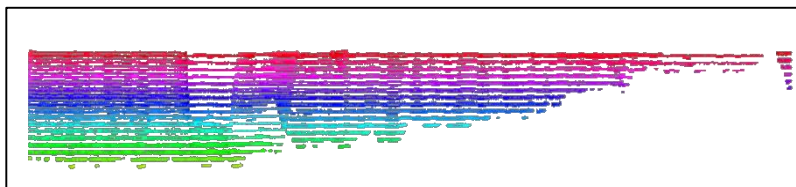
| Element Name | Observation | Location of Distress | Photo No. | Units | Distress Details | | | Area of Repair (Sq./RM T/m3) |
|---|---|---|---|---|---|---|---|---|
| Abutment 1 | Damage | | 1 | | 0.23 | 0.10 | | 0.023 |

1. Damage observed on LHS A1 B3, measuring 0.23 m in length and 0.10 m in width, covering an area of 0.023 m<sup>2</sup>.

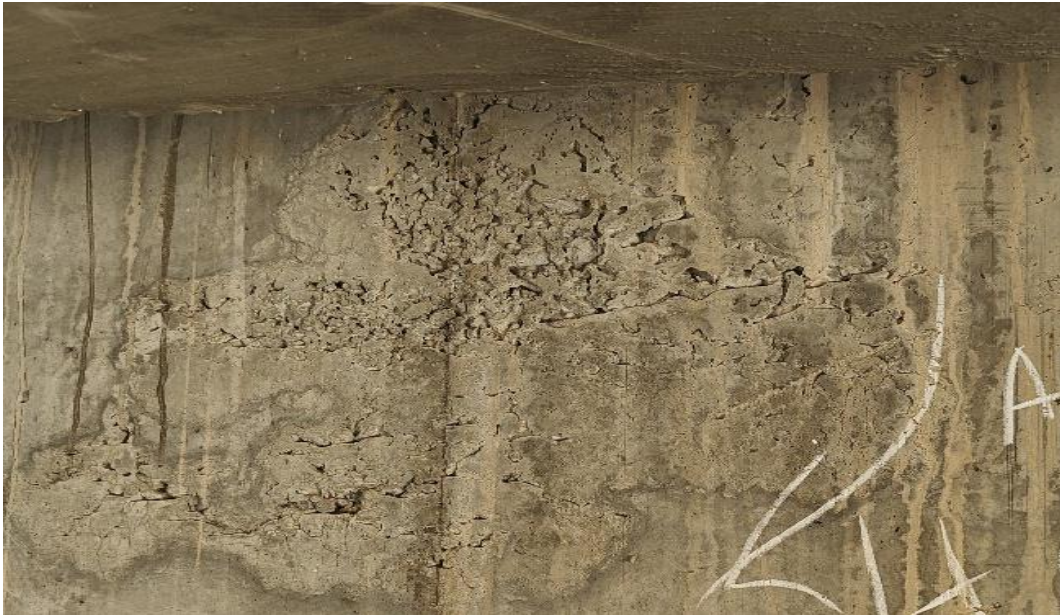
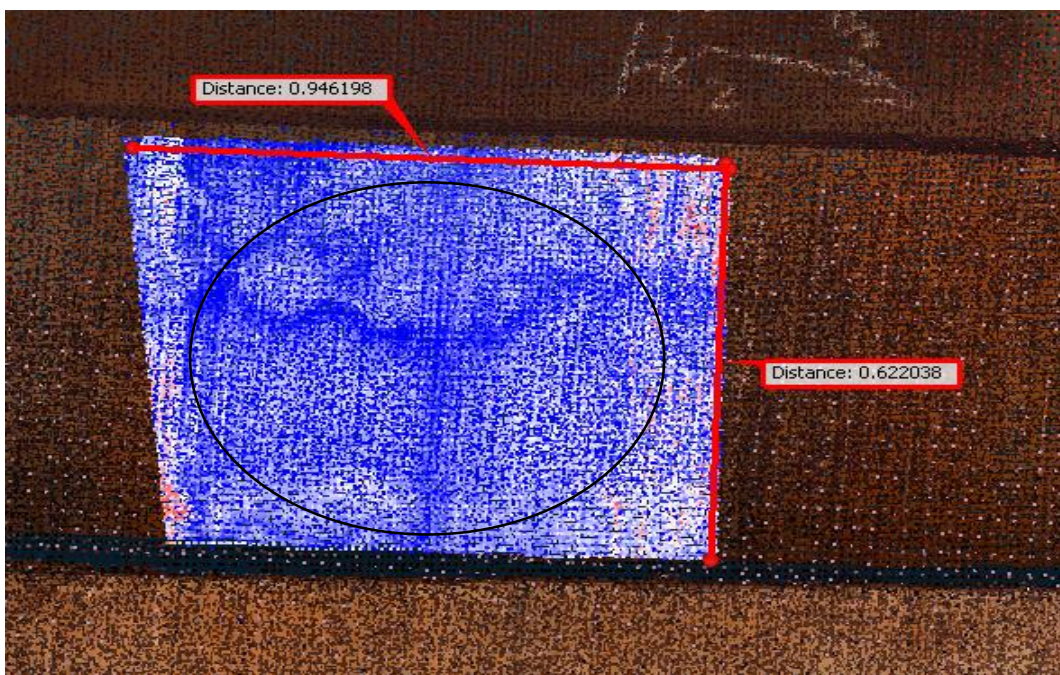
| Element Name | Observation | Location of Distress | Photo No. | Units | Distress Details | | | Area of Repair (Sq./RM T/m3) |
|---|---|---|---|---|---|---|---|---|
| Dirt Wall | Honeycombing | | 2 | | 0.95 | 0.62 | | 0.589 |

2. Honeycombing observed on LHS A1 dirt wall , measuring 0.95 m in length and 0.62 m in width, covering an area of 0.589 m<sup>2</sup>

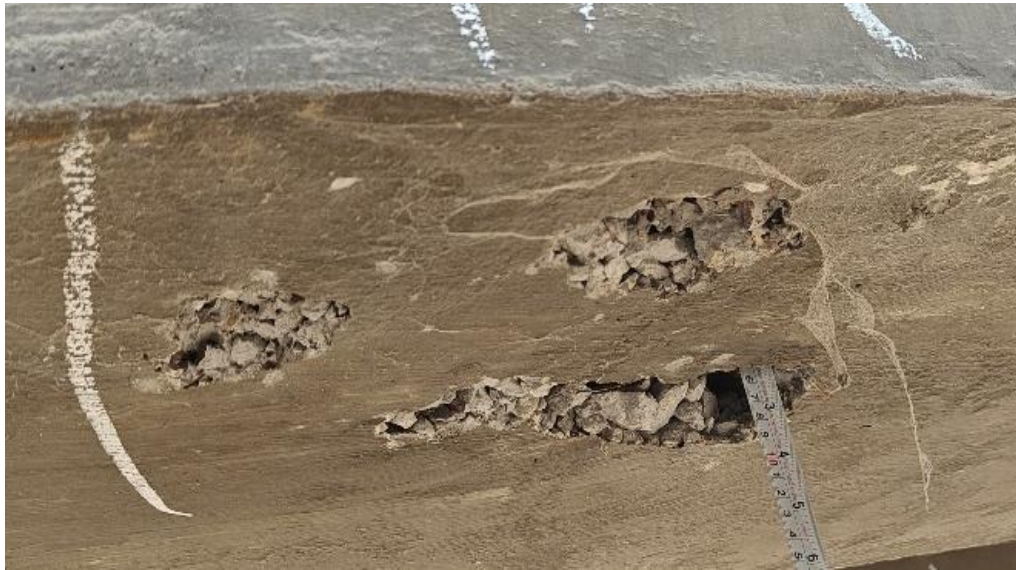
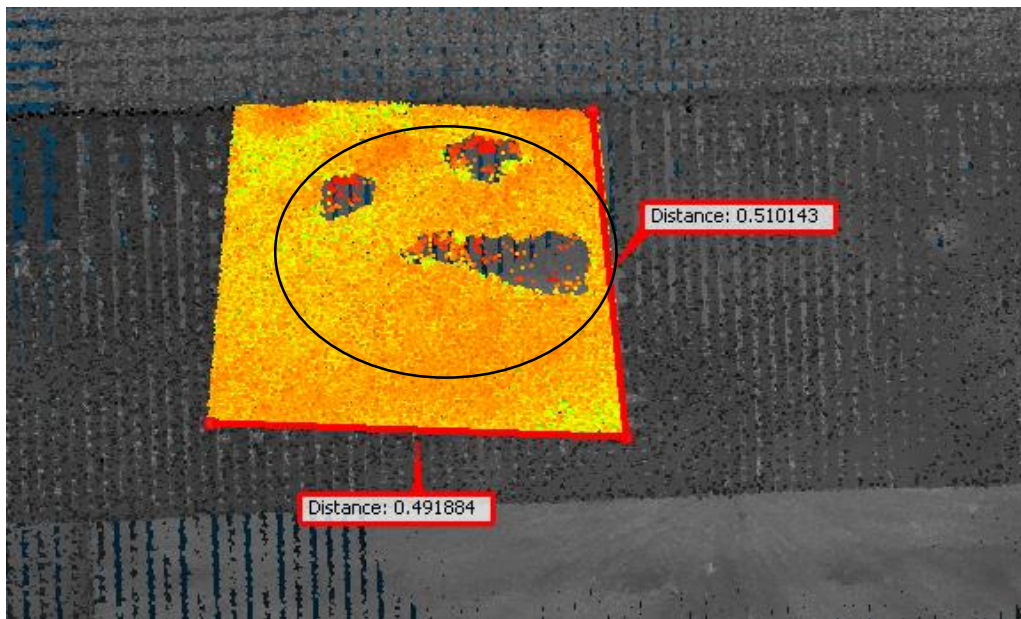
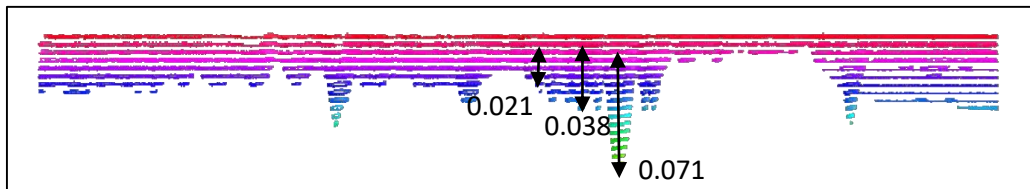
| Element Name | Observation | Location of Distress | Photo No. | Units | Distress Details | | | Area of Repair (Sq./RM T/m3) |
|---|---|---|---|---|---|---|---|---|
| Girder 1 | Hollow Section | | 3 | | 0.49 | 0.51 | 0.038 | 0.0094 |

3. **Honeycombing observed on the Left Hand Side (LHS) at A1-P1 G1, measuring 0.49 m in length and 0.51 m in width. Depth ranges from 0.021 m (min) to 0.071 m (max), with an average depth of 0.038 m. The calculated volume of the distress is 0.0094 m<sup>3</sup>.**

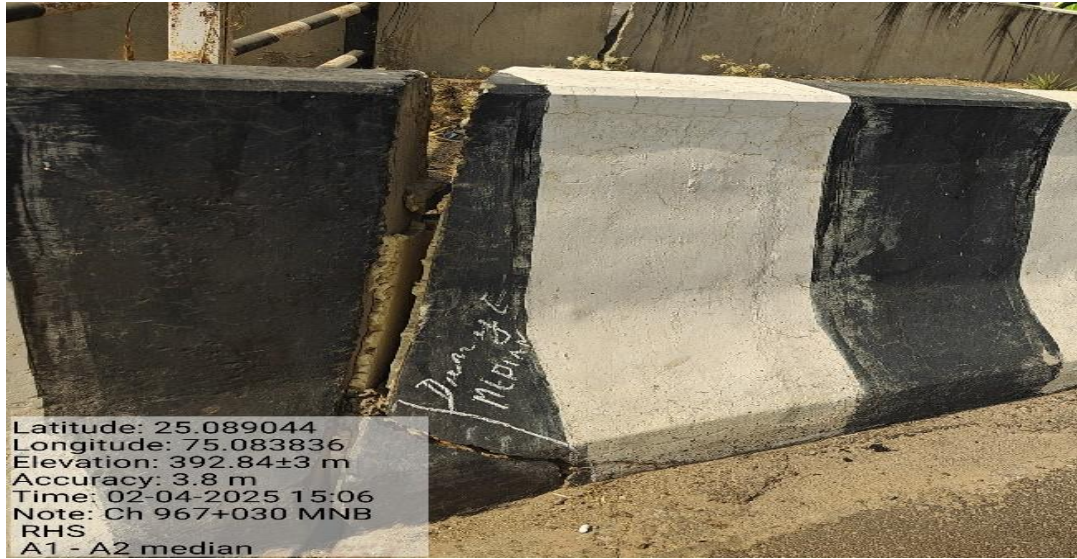
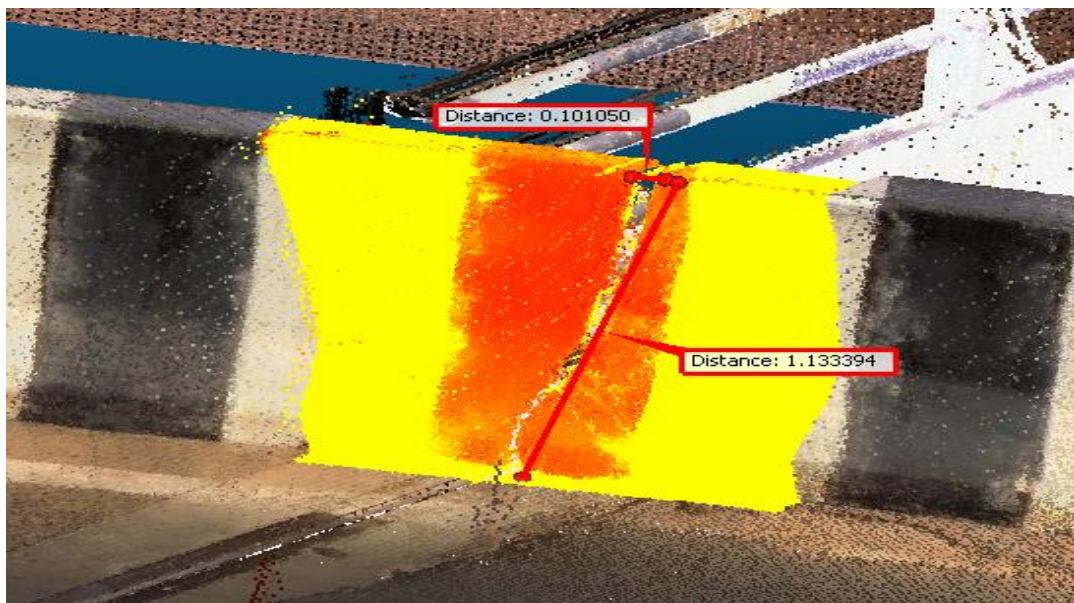
| Element Name | Observation | Location of Distress | Photo No. | Units | Distress Details | | | Area of Repair (Sq./RM T/m3) |
|---|---|---|---|---|---|---|---|---|
| Crash Barrier | Damage | | 4 | | 1.13 | 0.10 | | 0.113 |

4. Damage observed on median side crash barrier between A1-A2, measuring 1.13 m in length and 0.10 m in width, covering an area of 0.113 m<sup>2</sup>.

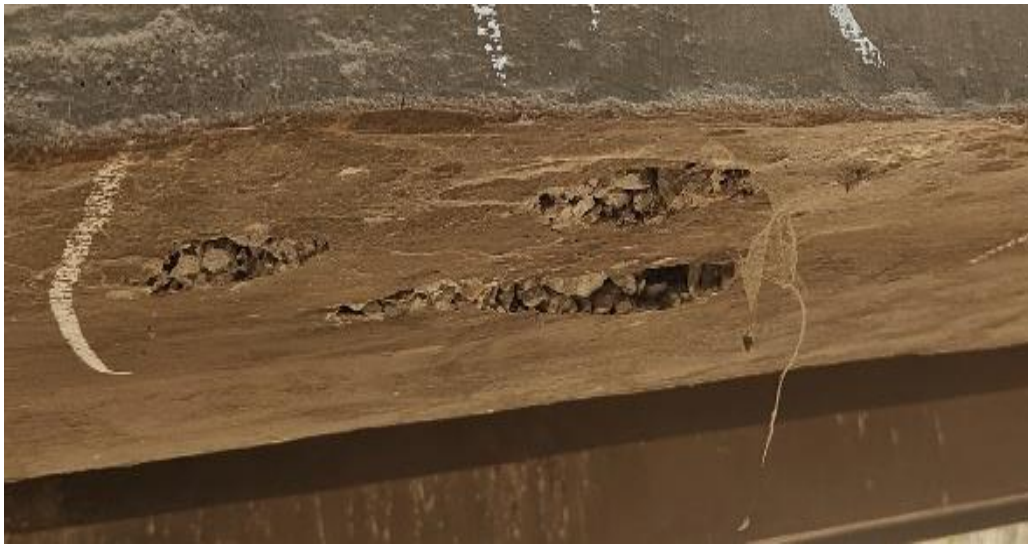
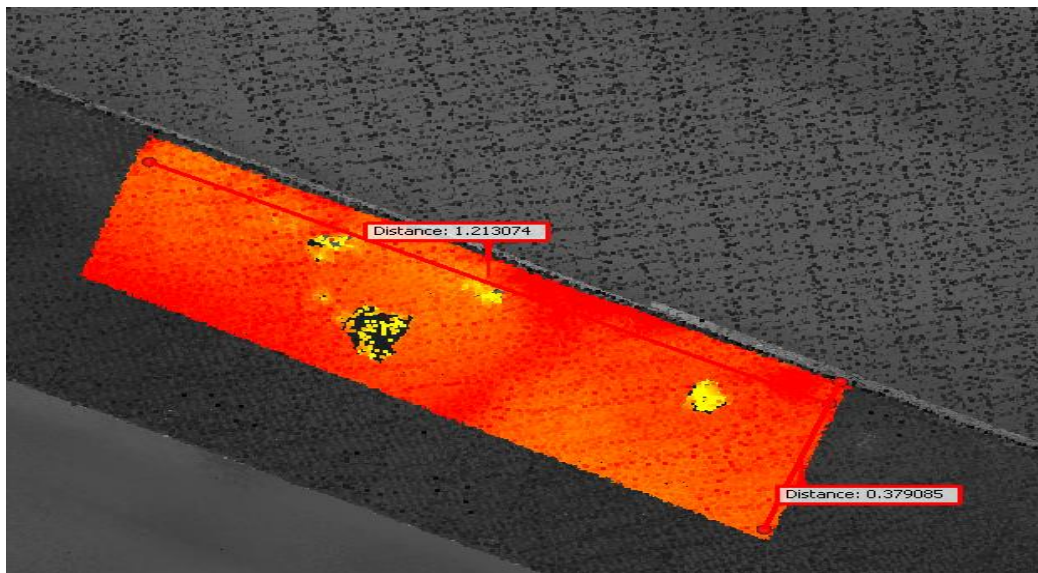
| Element Name | Observation | Location of Distress | Photo No. | Units | Distress Details | | | Area of Repair (Sq./RM T/m3) |
|---|---|---|---|---|---|---|---|---|
| Girder 1 | Hollow Section | | 5 | | 1.21 | 0.37 | 0.043 | 0.0192 |

5. **Hollow section observed on the Left Hand Side (LHS) at A1-P1 G1, measuring 1.21 m in length and 0.37 m in width. Depth ranges from 0.032 m (min) to 0.072 m (max), with an average depth of 0.043 m. The calculated volume of the distress is 0.192 m<sup>3</sup>.**

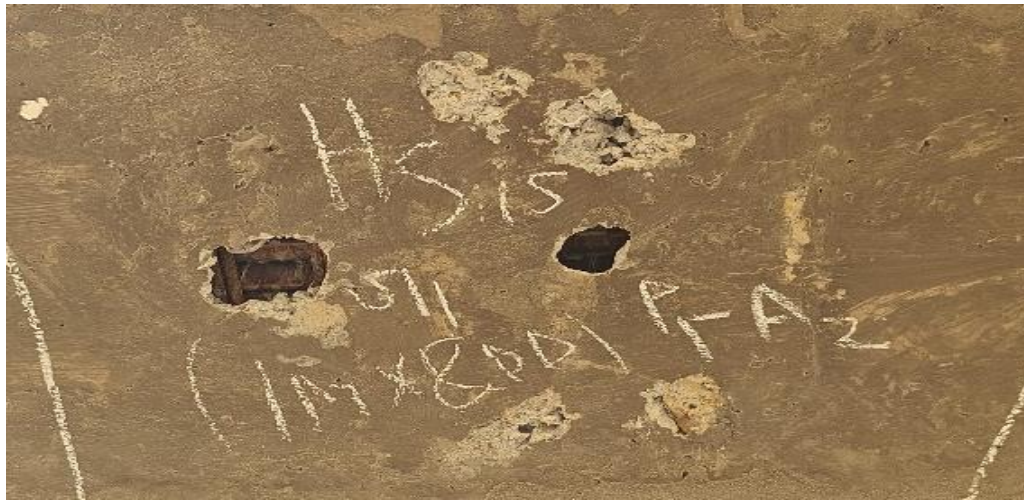
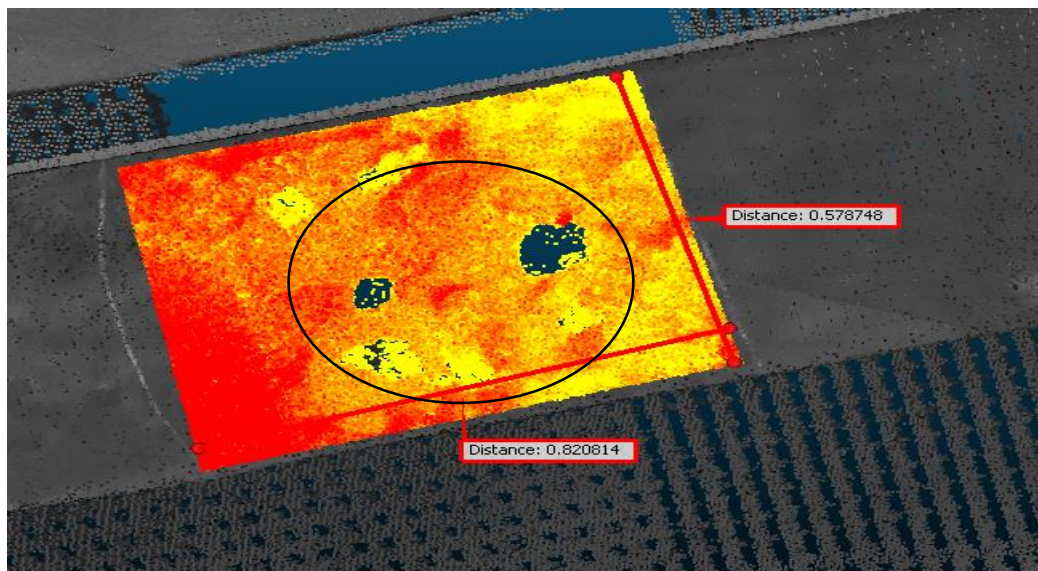
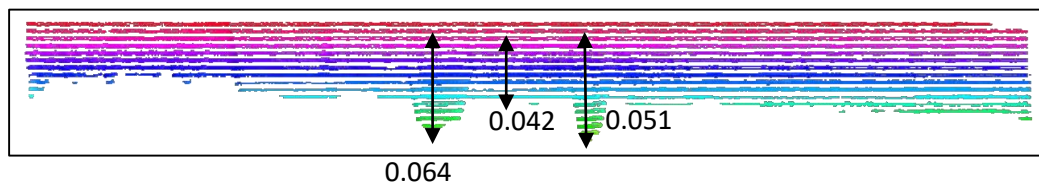
| Element Name | Observation | Location of Distress | Photo No. | Units | Distress Details | | | Area of Repair (Sq./RM T/m3) |
|---|---|---|---|---|---|---|---|---|
| Girder 1 | Hollow Section | | 6 | | 0.82 | 0.57 | 0.051 | 0.0238 |

6. **Hollow section observed on LHS P1-A2 G1, measuring 0.82 m in length and 0.57 m in width. Depth ranges from 0.042 m (min) to 0.064 m (max), with an average depth of 0.051 m. The calculated volume of the distress is 0.0238 m<sup>3</sup>.**

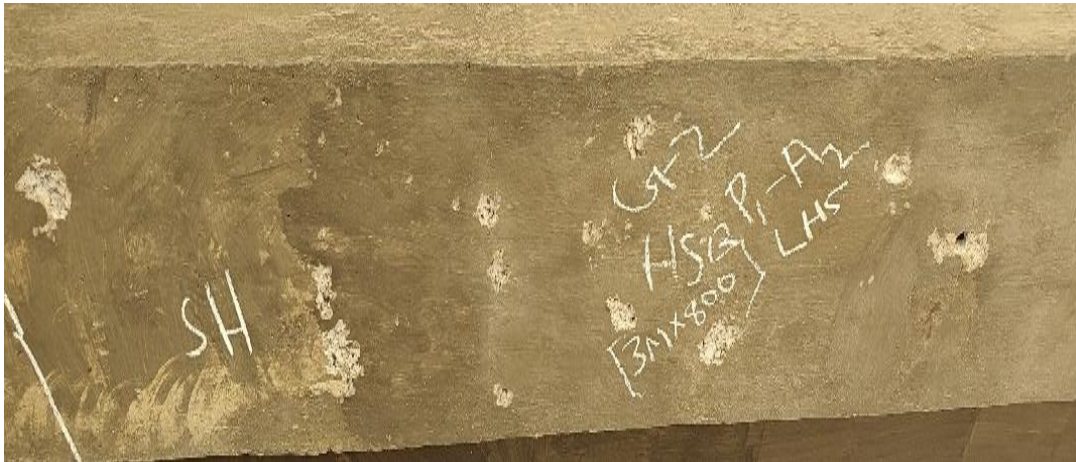
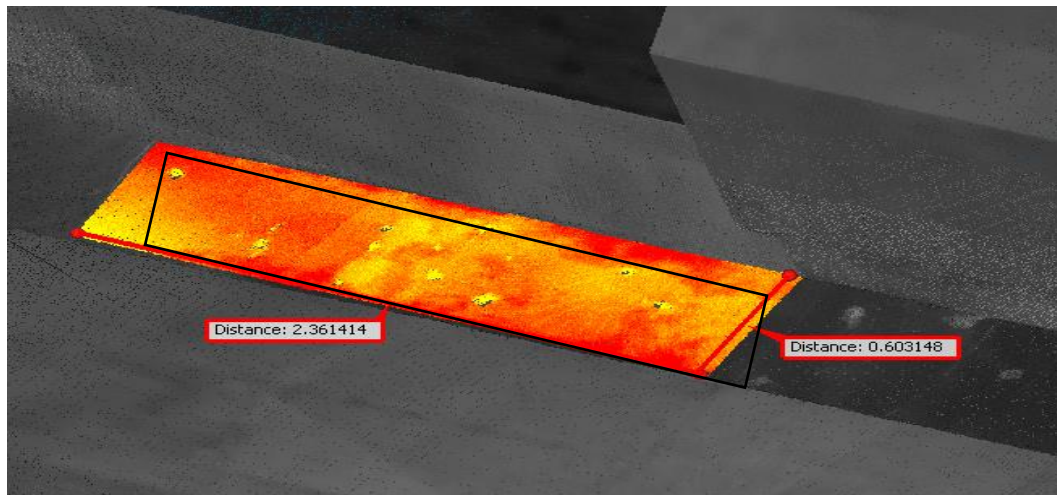
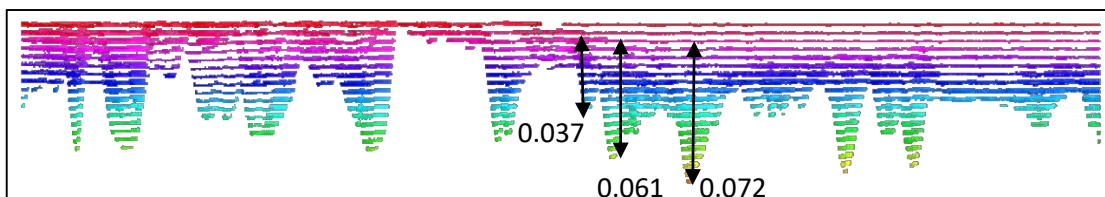
| Element Name | Observation | Location of Distress | Photo No. | Units | Distress Details | | | Area of Repair (Sq./RM T/m3) |
|---|---|---|---|---|---|---|---|---|
| Girder 2 | Hollow Section | | 7 | | 2.36 | 0.60 | 0.061 | 0.0863 |

- 7. Hollow section observed on the Left Hand Side (LHS) at P1-A2 HS 12, measuring 2.36 m in length and 0.60 m in width. Depth ranges from 0.037 m (min) to 0.072 m (max), with an average depth of 0.061 m. The calculated volume of the distress is 0.0863 m<sup>3</sup>.**

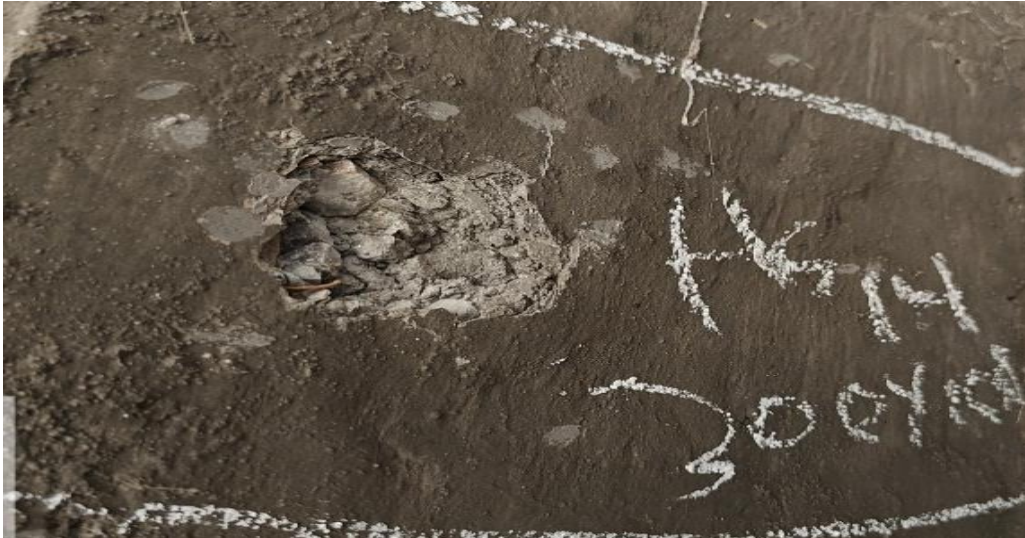
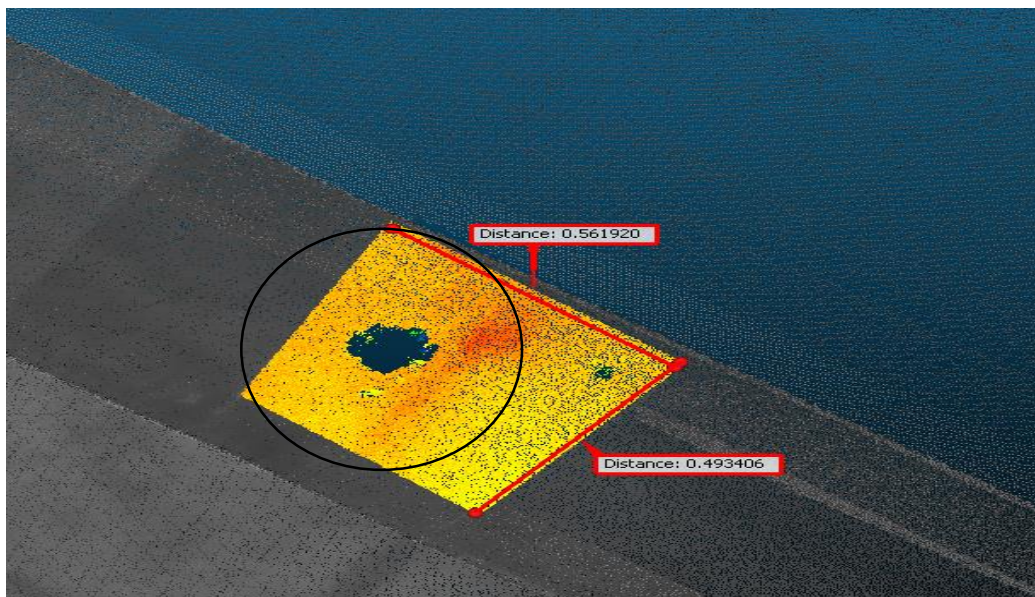
| Element Name | Observation | Location of Distress | Photo No. | Units | Distress Details | | | Area of Repair (Sq./RM T/m3) |
|---|---|---|---|---|---|---|---|---|
| Girder 3 | Hollow Section | | 8 | | 0.56 | 0.49 | 0.041 | 0.0112 |

8. **Hollow section observed on the Left Hand Side (LHS) at P1-A2, measuring 0.56 m in length and 0.49 m in width. Depth ranges from 0.029 m (min) to 0.052 m (max), with an average depth of 0.041 m. The calculated volume of the distress is 0.0112 m<sup>3</sup>.**

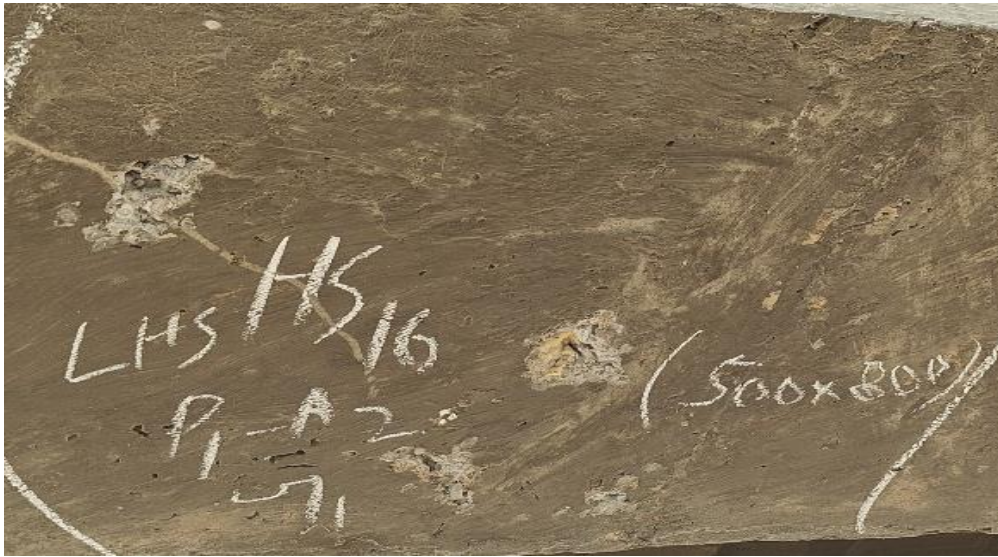
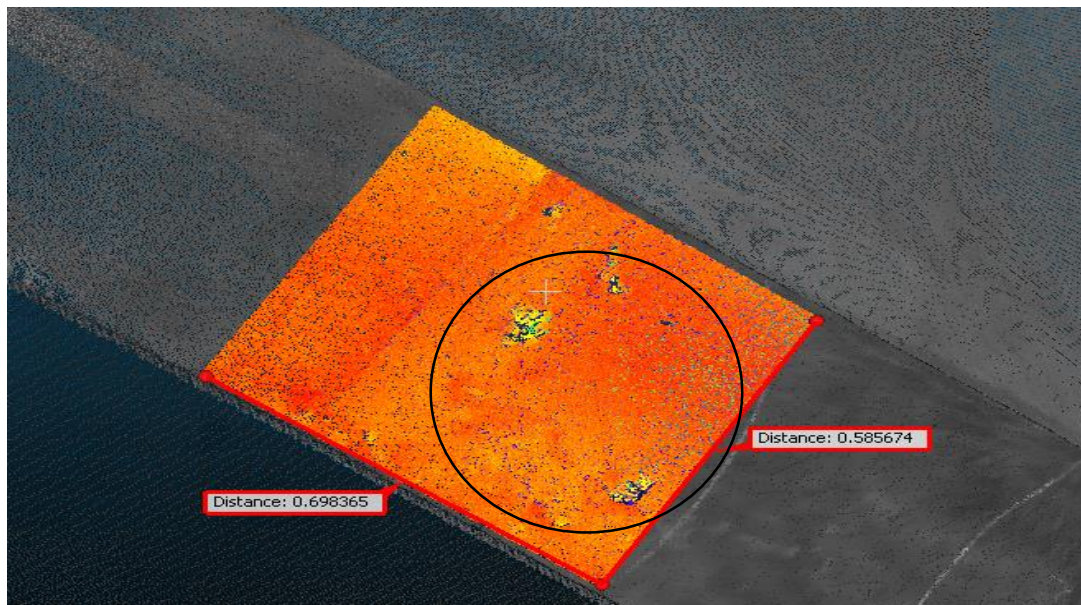
| Element Name | Observation | Location of Distress | Photo No. | Units | Distress Details | | | Area of Repair (Sq./RM T/m3) |
|---|---|---|---|---|---|---|---|---|
| Girder 1 | Hollow Section | | 9 | | 0.69 | 0.58 | 0.037 | 0.0148 |

9. **Hollow section observed on the Left Hand Side (LHS) at P1-A2, measuring 0.69 m in length and 0.58 m in width. Depth ranges from 0.027 m (min) to 0.043 m (max), with an average depth of 0.037 m. The calculated volume of the distress is 0.0148 m<sup>3</sup>.**

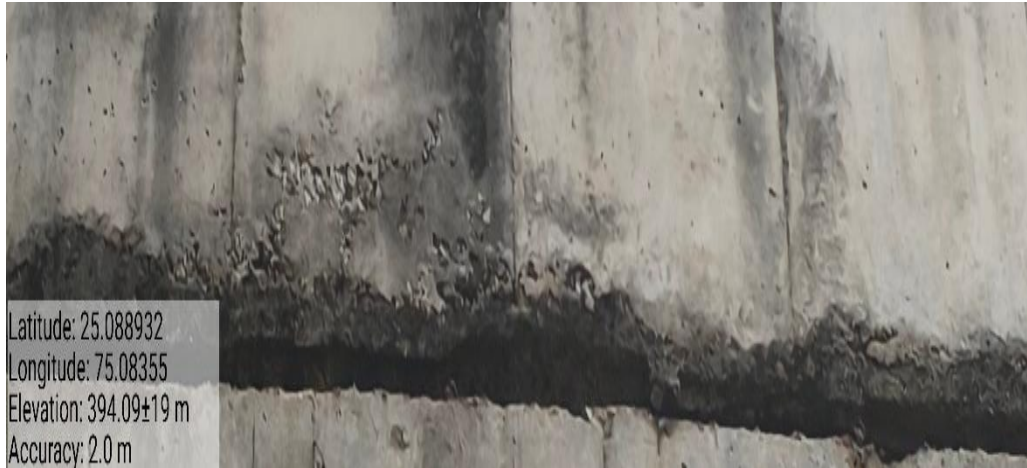
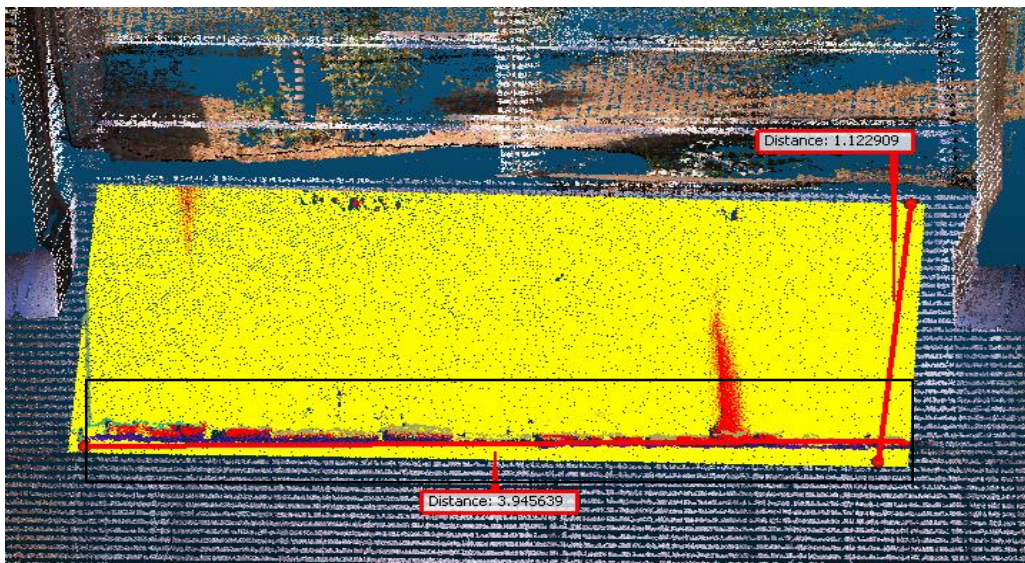
| Element Name | Observation | Location of Distress | Photo No. | Units | Distress Details | | | Area of Repair (Sq./RM T/m3) |
|---|---|---|---|---|---|---|---|---|
| Median Top | Honeycombing | | 10 | | 3.94 | 1.12 | | 4.41 |

**10. Honeycombing observed on RHS A1 median top, measuring 3.94 m in length and 1.12 m in width, covering an area of 4.4128 m<sup>2</sup>.**

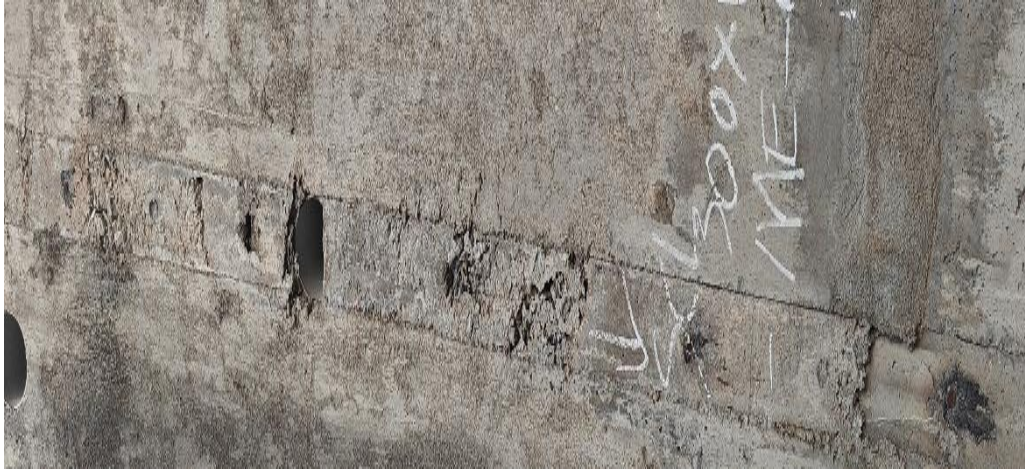
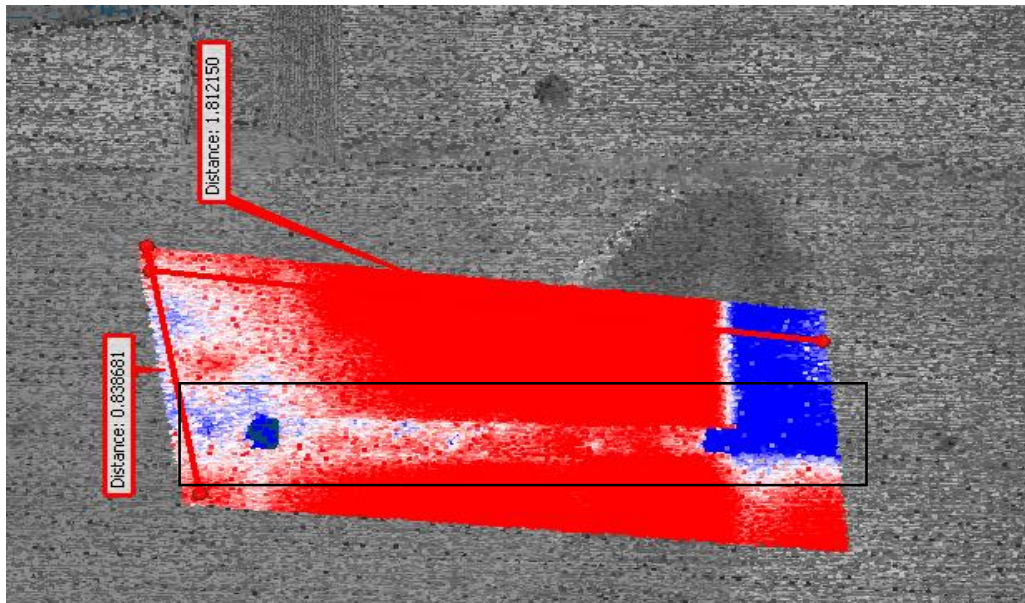
| Element Name | Observation | Location of Distress | Photo No. | Units | Distress Details | | | Area of Repair (Sq./RM T/m3) |
|---|---|---|---|---|---|---|---|---|
| Median | Scaling | | 11 | | 1.81 | 0.83 | | 1.50 |

**11. Scaling observed on A2 median, measuring 1.81 m in length and 0.83 m in width, covering an affected area of approximately 1.502 m<sup>2</sup>.**

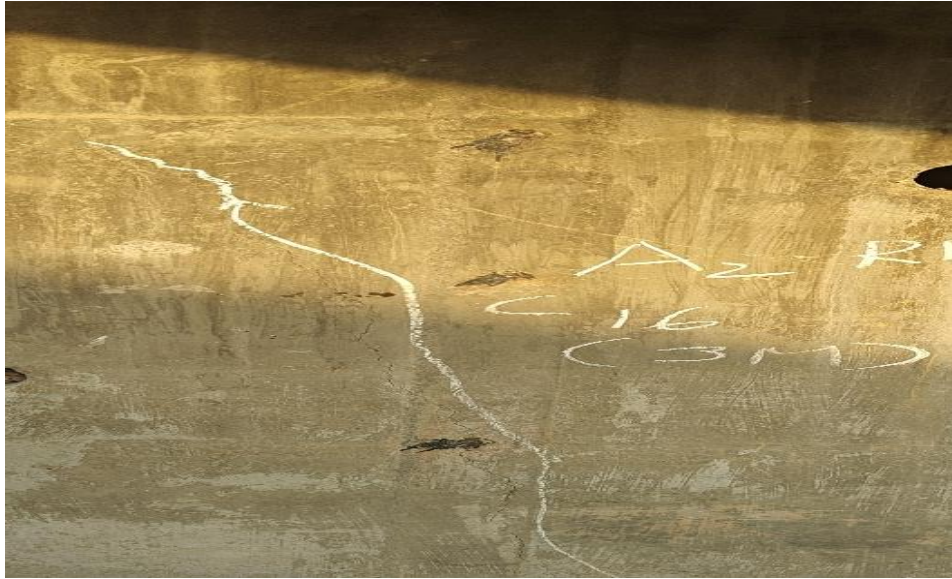
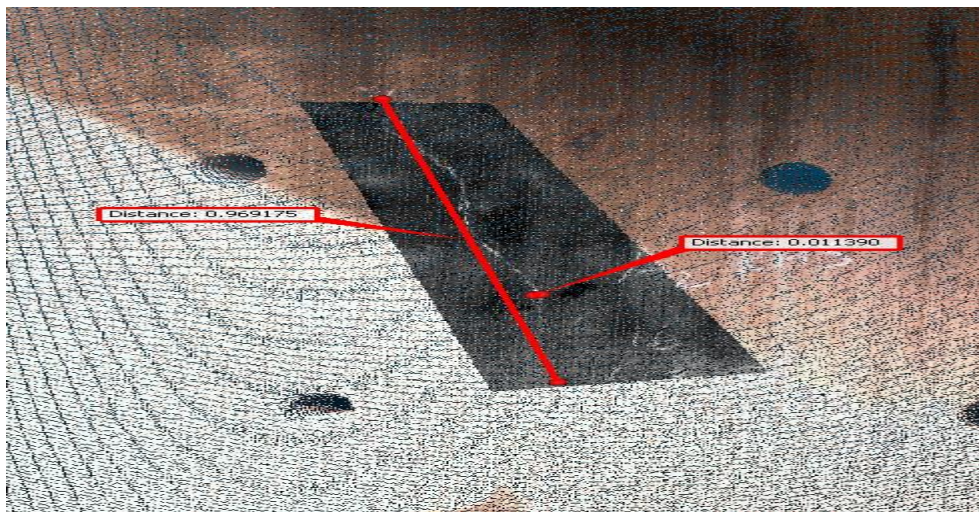
| Element Name | Observation | Location of Distress | Photo No. | Units | Distress Details | | | Area of Repair (Sq./RM T/m3) |
|---|---|---|---|---|---|---|---|---|
| Abutment 2 | Crack | | 12 | | 0.96 | 0.01 | | 0.009 |

- 12. Crack observed on A2 RHS, measuring 0.96 m in length and 0.01 m in width, covering an affected area of approximately 0.0096 m<sup>2</sup>.**

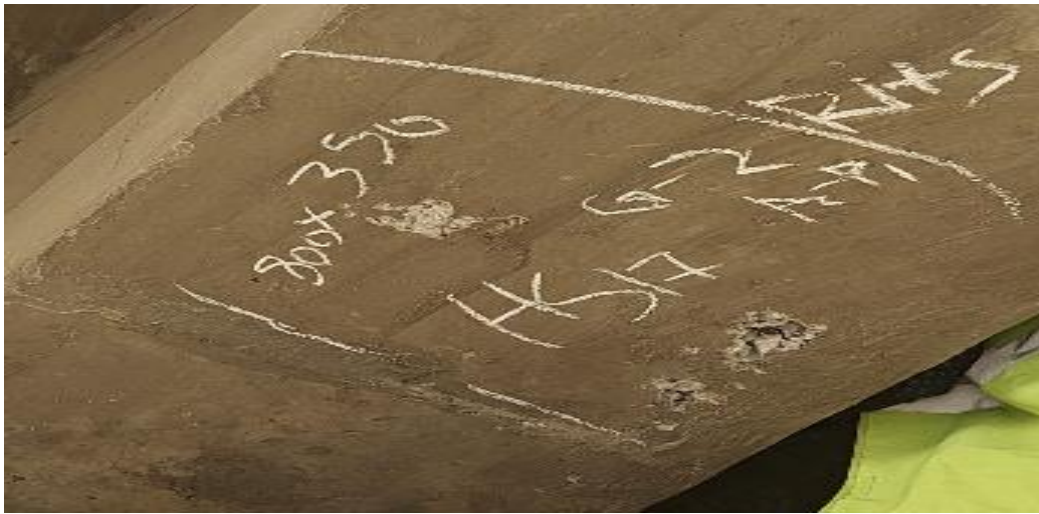
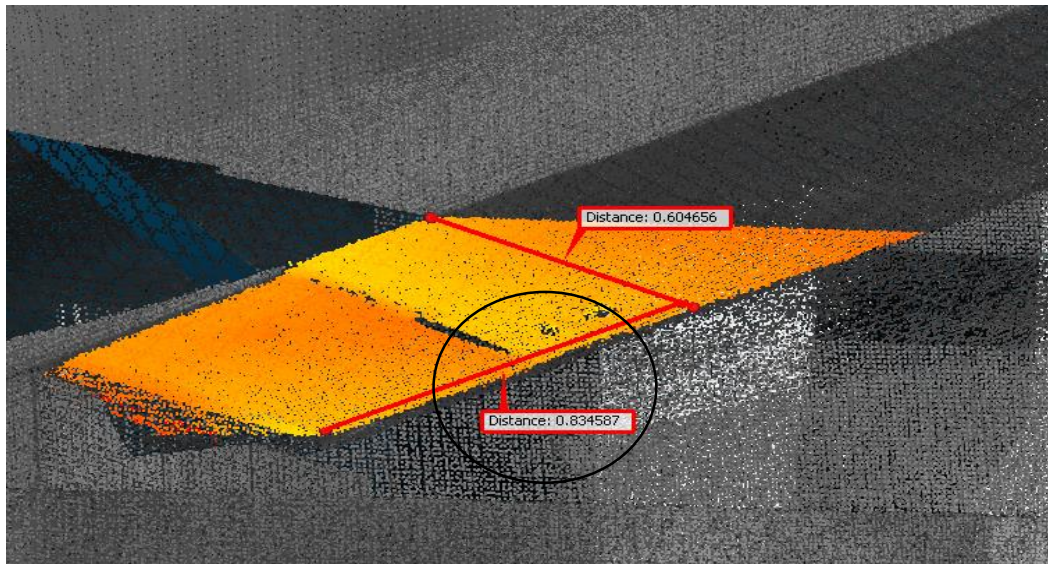
| Element Name | Observation | Location of Distress | Photo No. | Units | Distress Details | | | Area of Repair (Sq./RM T/m3) |
|---|---|---|---|---|---|---|---|---|
| Abutment 2 | Hollow Section | | 13 | | 0.83 | 0.60 | 0.034 | 0.0169 |

13. Hollow section observed on A2 RHS, measuring 0.83 m in length and 0.60 m in width. Depth ranges from 0.021 m (min) to 0.038 m (max), with an average depth of 0.034 m. The calculated volume of the distress is 0.0169 m<sup>3</sup>.

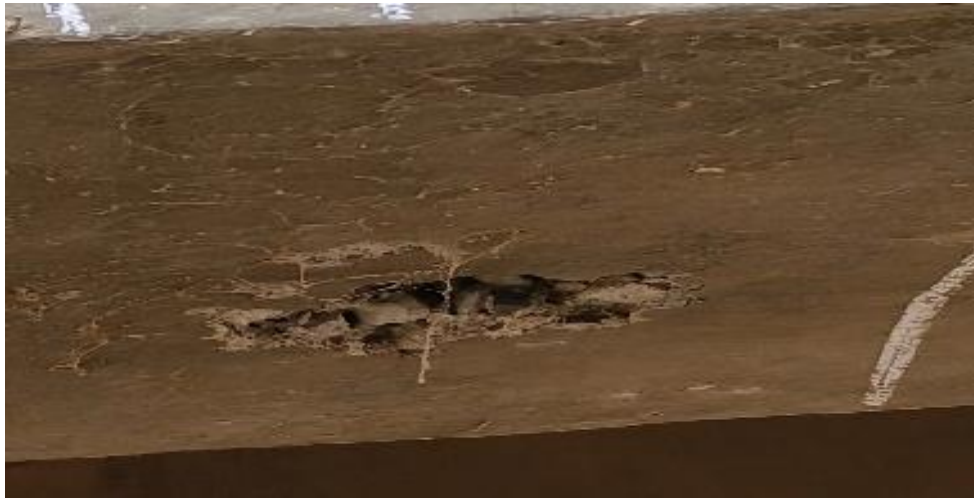
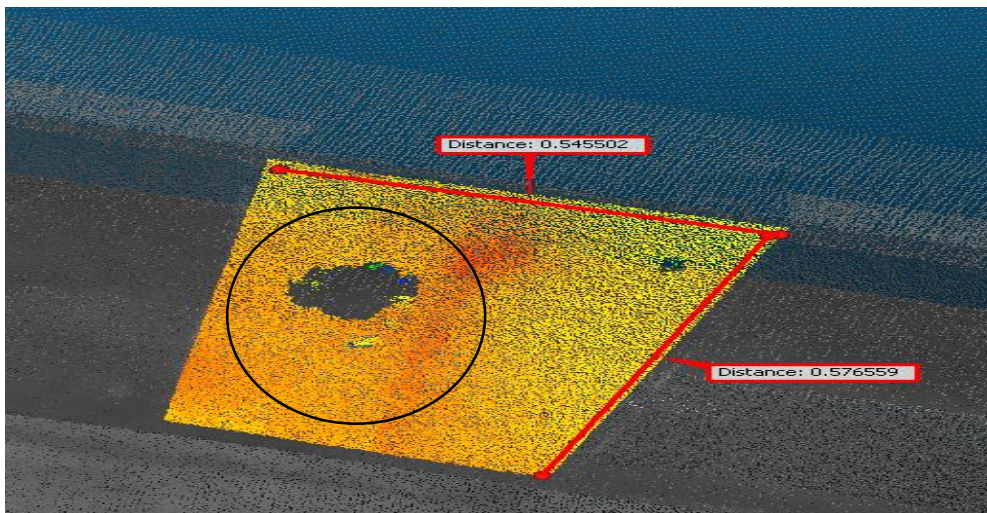
| Element Name | Observation | Location of Distress | Photo No. | Units | Distress Details | | | Area of Repair (Sq./RM T/m3) |
|---|---|---|---|---|---|---|---|---|
| Girder 3 | Hollow Section | | 14 | | 0.54 | 0.57 | 0.029 | 0.0089 |

14. Hollow section observed on RHS P1-A2 G3, measuring 0.54 m in length and 0.57 m in width. Depth ranges from 0.024 m (min) to 0.038 m (max), with an average depth of 0.029 m. The calculated volume of the distress is 0.0089 m<sup>3</sup>.
