# LIDAR Inspection Report of **Box Culvert** ch.967+165

**Bridge Chainage:** 967 + 165 (CKRP)

# **CH: 967+165 – BOX CULVERT**

**DISTRESS PHOTOS**

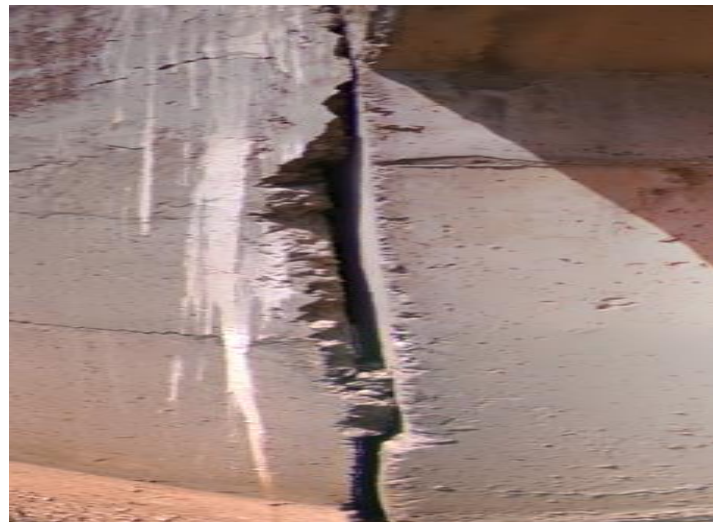
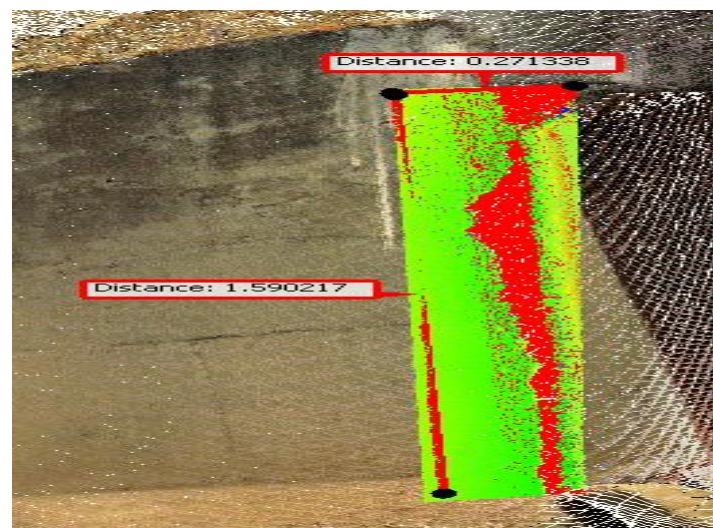
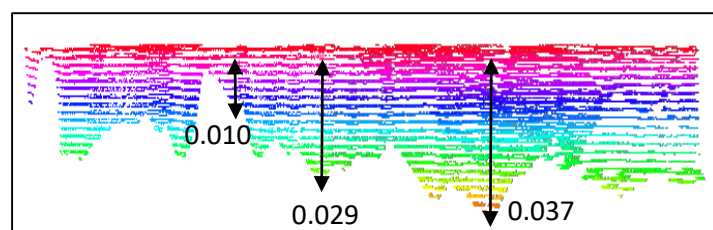
| Element Name | Observation | Location of Distress | Photo No. | Units | Distress Details | | | Area of Repair (Sq.m/R MT/m3) |
|---|---|---|---|---|---|---|---|---|
| Wing wall | Corner Damage | | 1 | M | 1.59 | 0.27 | 0.029 | 0.0124 |

1. Abutment to wing wall corner damage observed on LHS A1, measuring 1.59 m in length and 0.27 m in width, Depth ranges from 0.010 m (min) to 0.037 m (max), with an average depth of 0.029 m. The calculated volume of the distress is 0.0124 m<sup>3</sup>

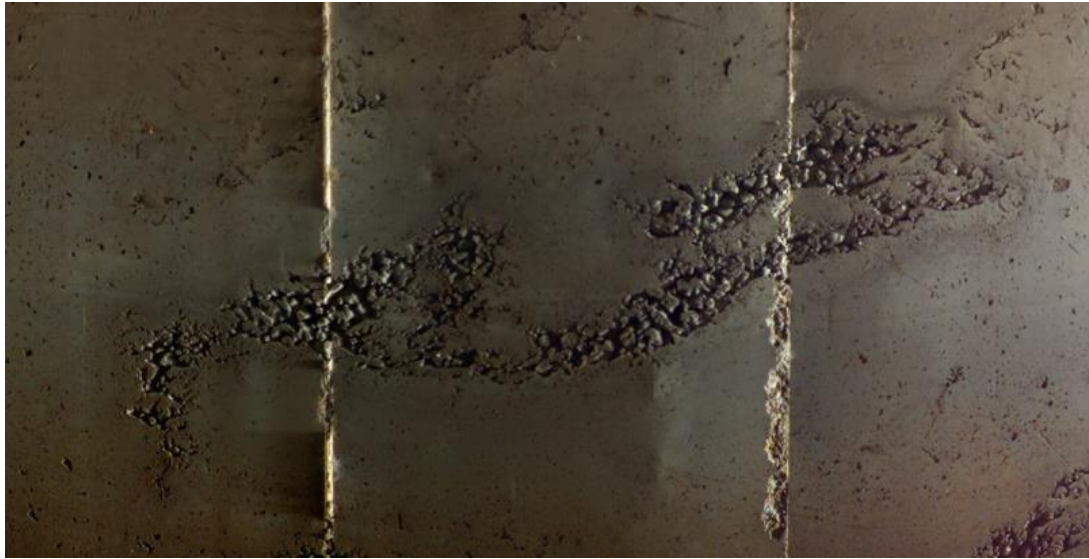
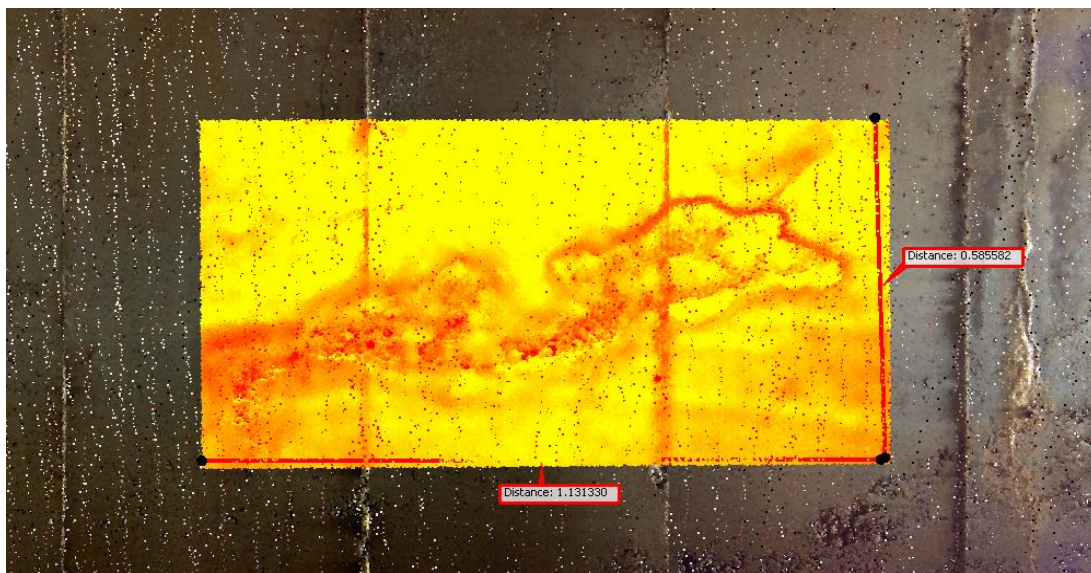
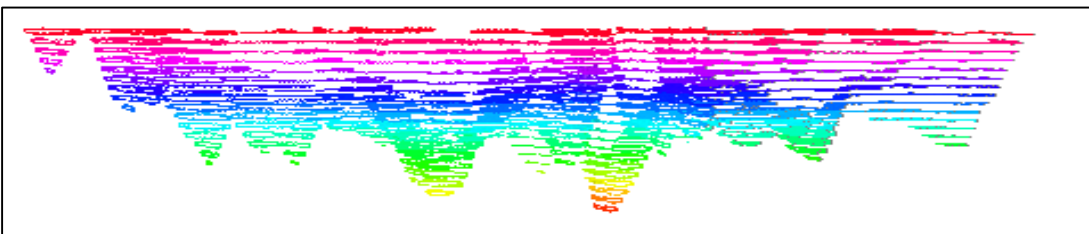
| Element Name | Observation | Location of Distress | Photo No. | Units | Distress Details | | | Area of Repair (Sq.m/R MT/m3) |
|---|---|---|---|---|---|---|---|---|
| Abutment | Honeycombing | | 1 | M | 1.13 | 0.58 | | 0.655 |

- 2. Honeycombing observed on abutment, measuring 1.13 m in length and 0.58 m in width, covering an area of 0.66 m<sup>2</sup>.**

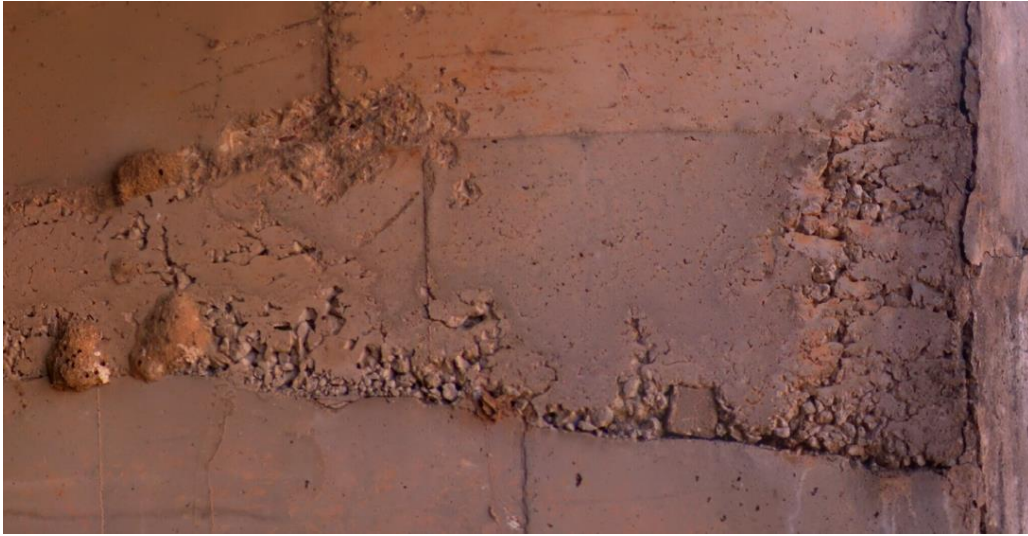
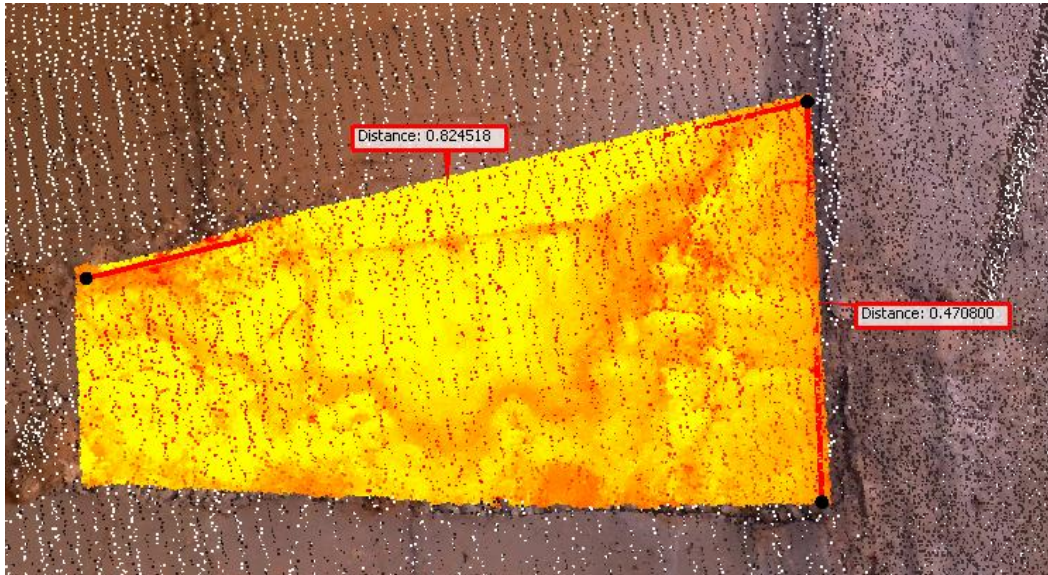
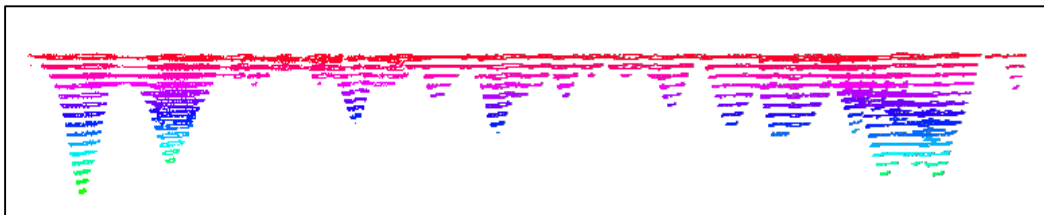
| Element Name | Observation | Location of Distress | Photo No. | Units | Distress Details | | | Area of Repair (Sq.m/R MT/m3) |
|---|---|---|---|---|---|---|---|---|
| Abutment | Honeycombing | | 1 | M | 0.82 | 0.47 | | 0.385 |

- 3. Honeycombing observed on abutment wall corner, measuring 0.82 m in length and 0.47 m in width, covering an area of 0.39 m<sup>2</sup>.**
