# **LIDAR Inspection Report of Slab Culvert ch.967+930**

**Bridge No:** Slab Culvert

**Bridge Chainage:** 967 + 930 (CKRP)

# **CH: 967+930 – SLAB CULVERT**

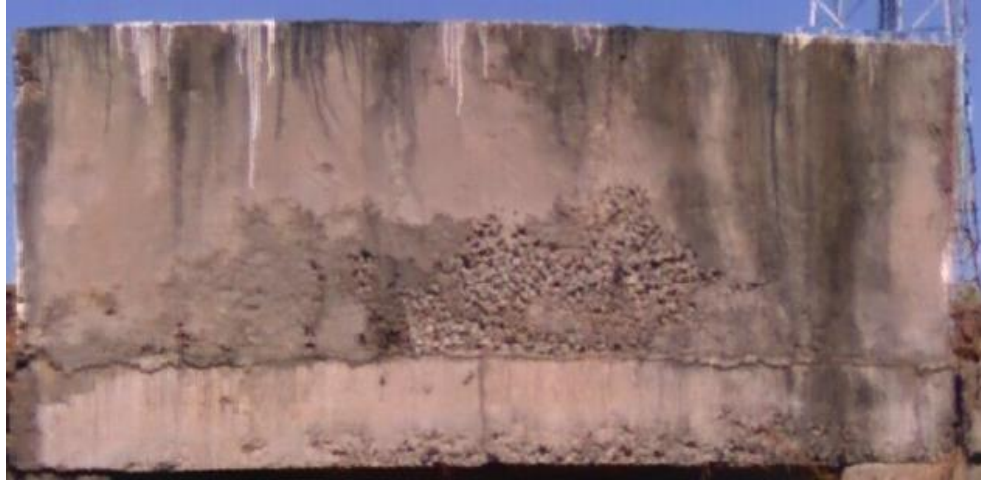
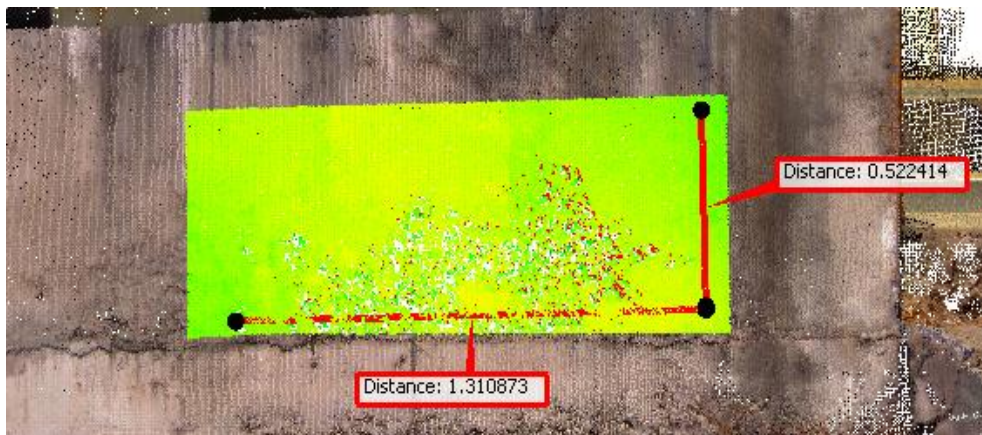
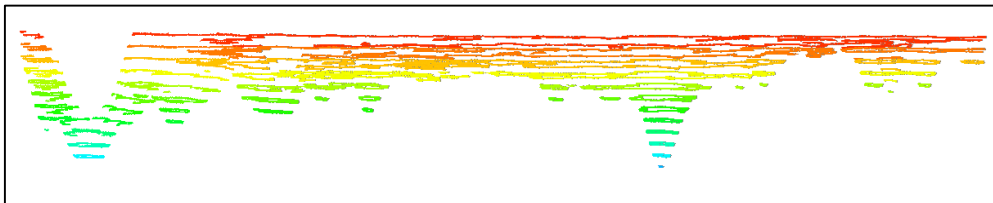
| Element Name | Observation | Location of Distress | Photo No. | Units | Distress Details | | | Area of Repair<br>(Sq.m/R<br>MT/m3) |
|---|---|---|---|---|---|---|---|---|
| Parapet Wall | Honeycombing | | 1 | M | 0.31 | 0.52 | | 0.681 |

1. Honeycombing observed on parapet wall, measuring 1.31 m in length and 0.52 m in width, covering an area of 0.681 m<sup>2</sup>.
