# **LIDAR Inspection Report of MNB ch.968+730**

**Bridge No:**969/1

**Bridge Chainage:** 968+730

- **CKRP:** Chittorgarh to kota
- **State:** Rajasthan NH 27
- **Zone:** RJ-20

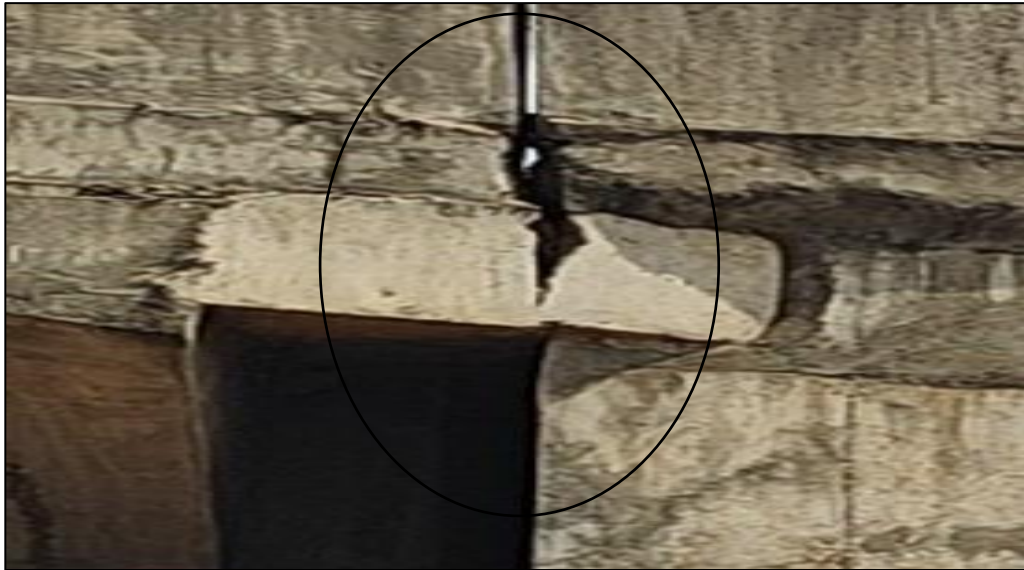
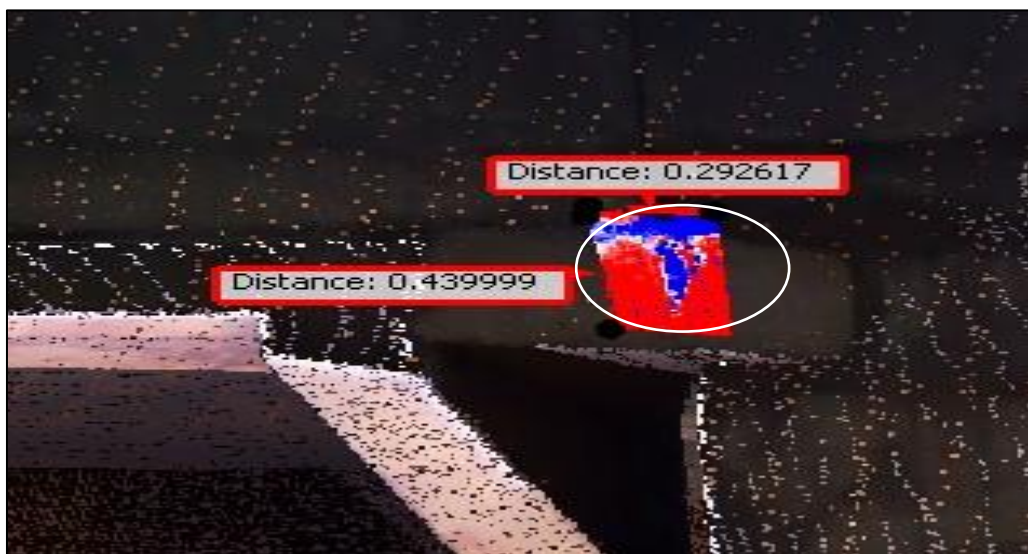
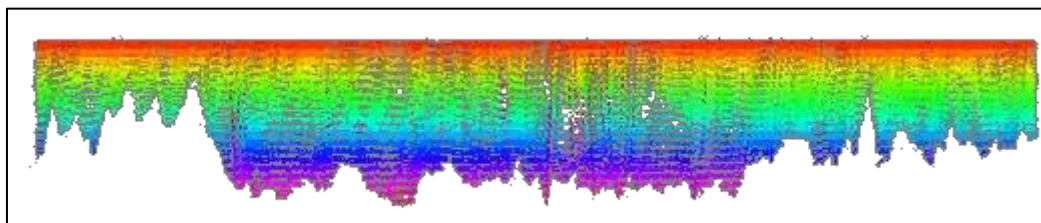
| Element Name | Observation | Location of Distress | Photo No. | Units | Distress Details | | | Area of Repair (Sq./RMT /m3) |
|---|---|---|---|---|---|---|---|---|
| Abutment 1 | Expansion Joint Gap | - | 1 | Sq m | 0.4399 | 0.2926 | - | 0.1287 |

1. Expansion Joint Gap observed on A1 (LHS), measuring 0.4399 m in length and 0.2926 m in width, covering an area of 0.1287 m<sup>2</sup>.
