# **LIDAR Inspection Report of Slab Culvert ch.968+920**

**Bridge Chainage:** 968 + 920 (CKRP)

- **CKRP:** Chittorgarh to kota
- **State:** Rajasthan NH 27
- **Zone:** RJ-06

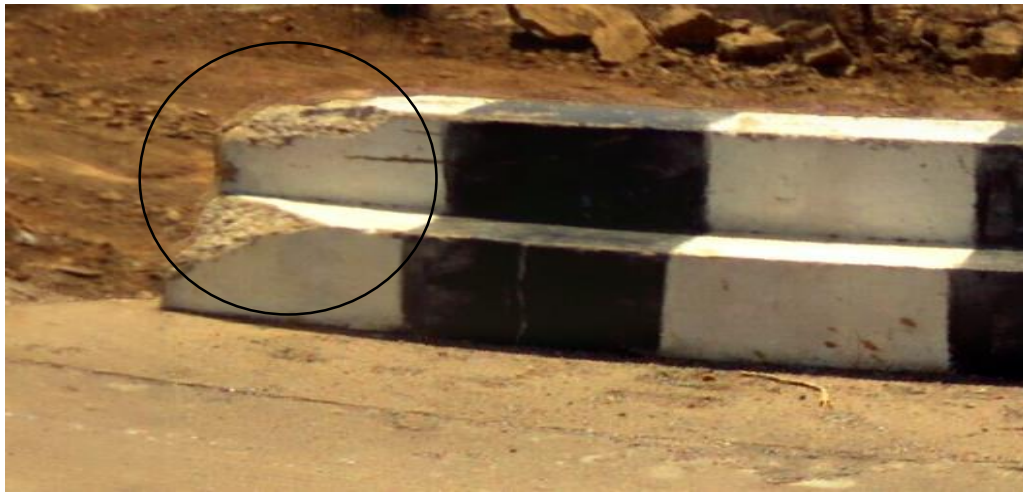
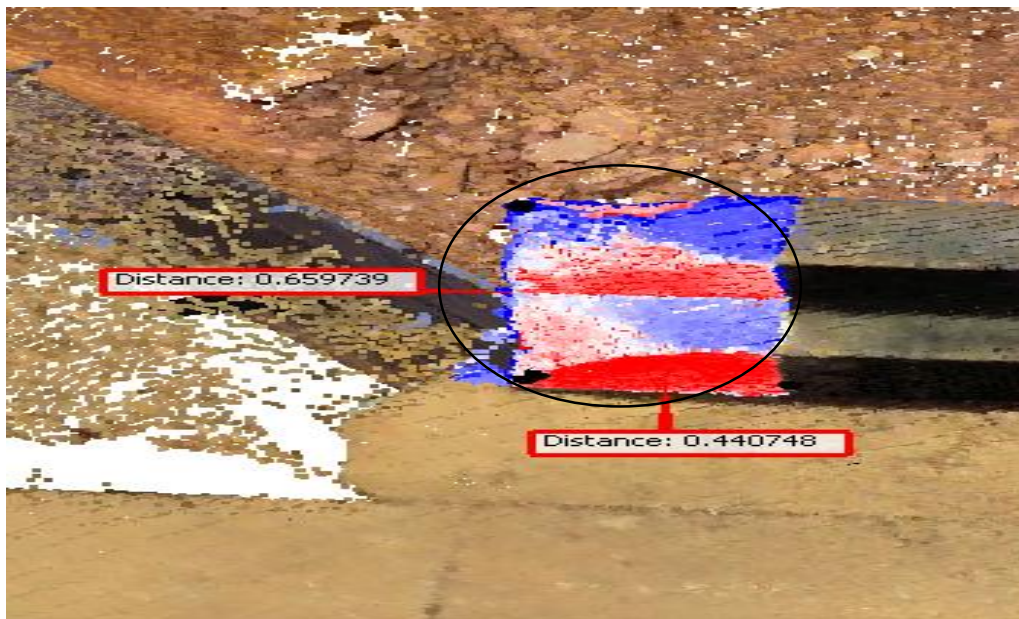
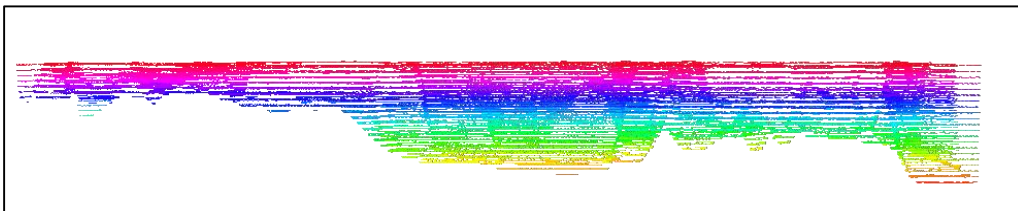
| Element Name | Observation | Location of Distress | Photo No. | Units | Distress Details | | | Area of Repair (Sq.m/R MT/m3) |
|---|---|---|---|---|---|---|---|---|
| Parapet | Damage | | 1 | M | 0.65 | 0.44 | | 0.286 |

1. Damage observed on Parapet, measuring 0.65 m in length and 0.44 m in width, covering an area of 0.286 m<sup>2</sup>.

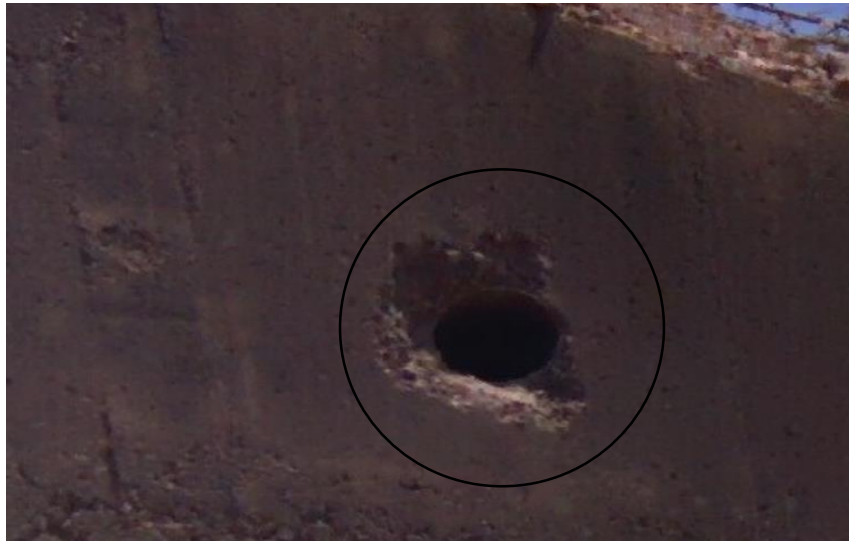
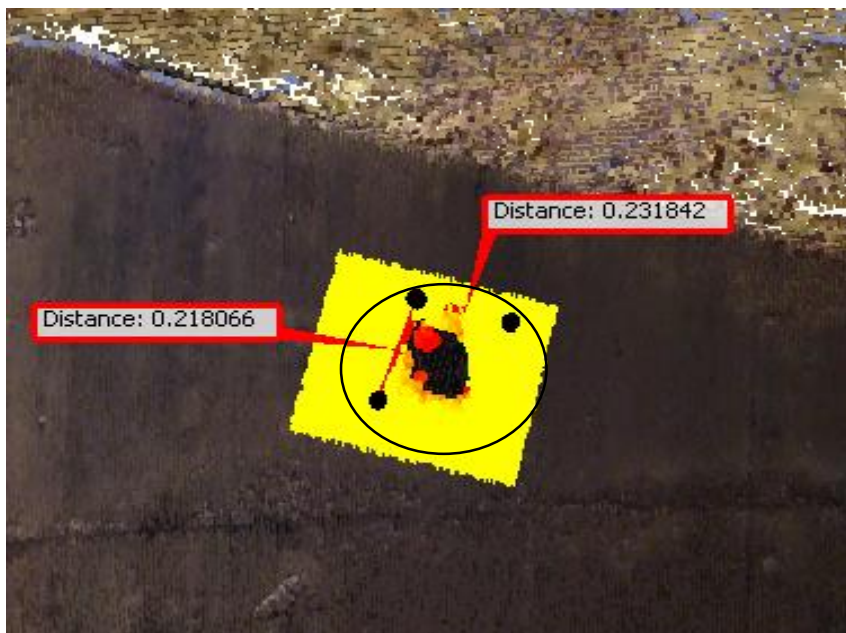
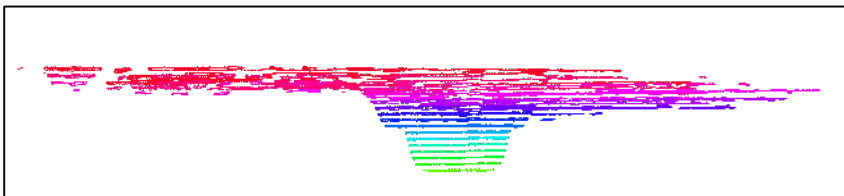
| Element Name | Observation | Location of Distress | Photo No. | Units | Distress Details | | | Area of Repair (Sq.m/R MT/m3) |
|---|---|---|---|---|---|---|---|---|
| Wing Wall weep hole | Damage | | 1 | M | 0.23 | 0.21 | | 0.048 |

| Sl. No. | Description | Distress Notation | Observation | Location | | Distress Details | | | Area of Repair |
|---|---|---|---|---|---|---|---|---|---|
| 18 | Weep Holes | | Damage | | | | | | |

- 2. Weep hole damage observed on LHS wing wall, measuring 0.23 m in length and 0.21 m in width, covering an area of 0.0483 m<sup>2</sup>.**
