# **LIDAR Inspection Report of MNB ch.969+900**

**Bridge No:** MNB - 970/1

**Bridge Chainage:** 969+900 (CKRP)

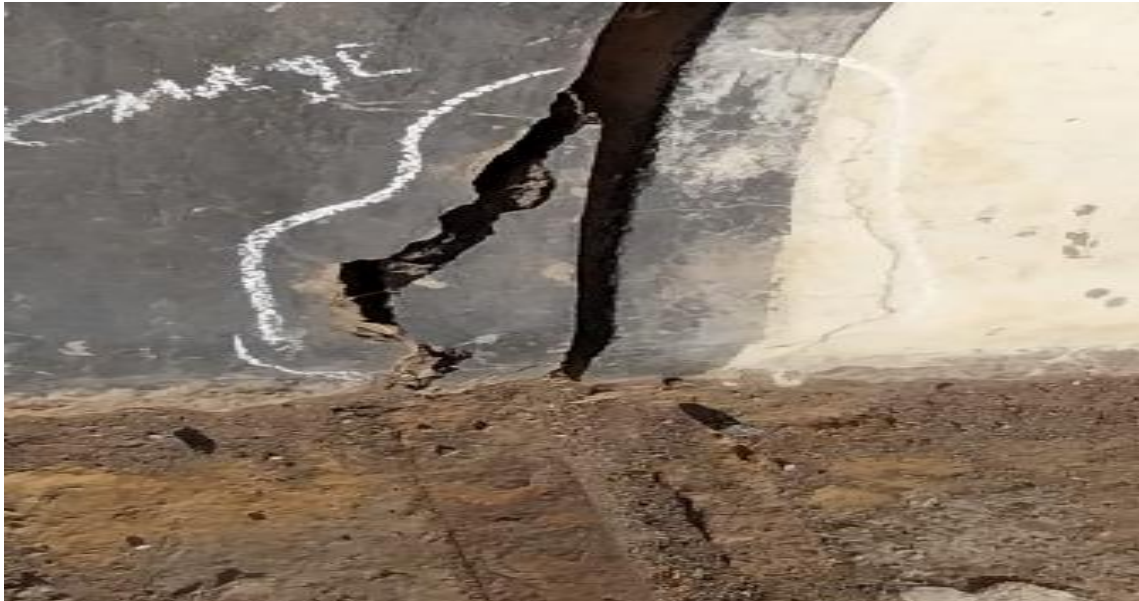
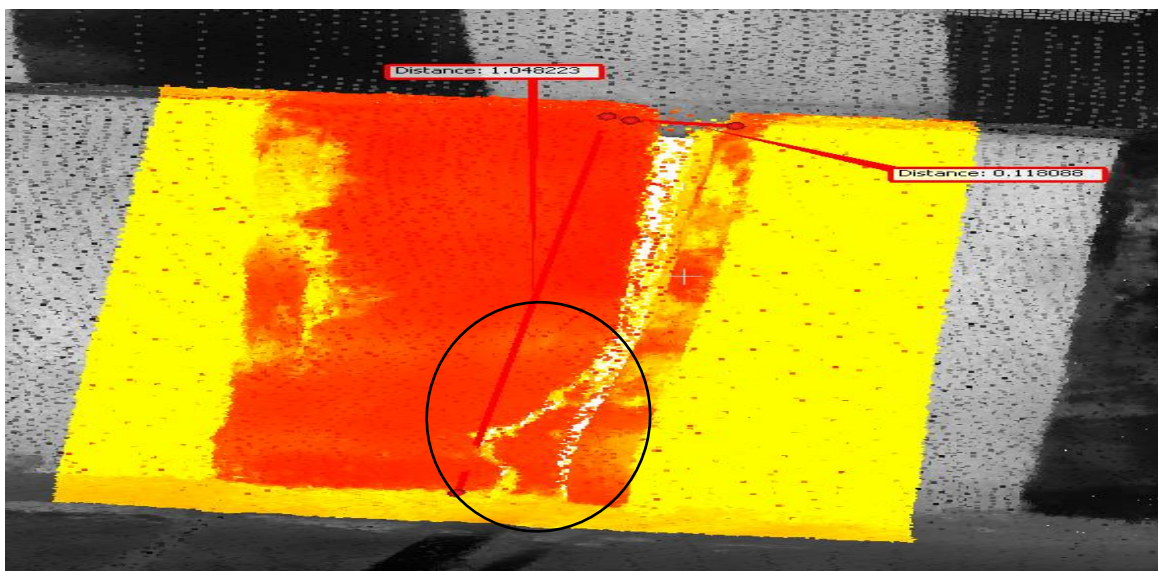
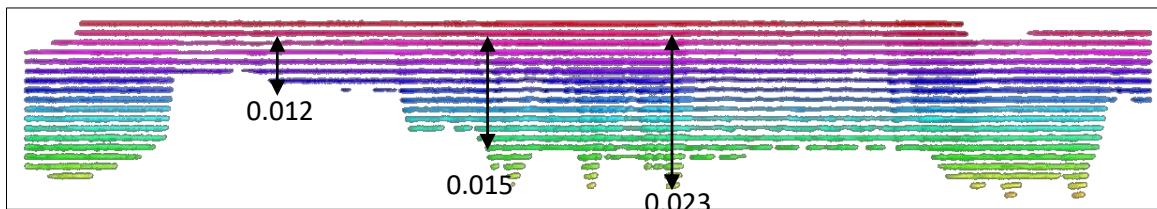
| Element Name | Observation | Location of Distress | Photo No. | Units | Distress Details | | | Area of Repair (Sq.m/R MT/m3) |
|---|---|---|---|---|---|---|---|---|
| Median crash barrier | Damage | - | 1 | M | 1.04 | 0.11 | 0.015 | 0.0017 |

1. Crash barrier damaged on median side (LHS): distress measures 1.04 m in length and 0.11 m in width. Depth ranges from 0.012 m (min) to 0.023 m (max), with an average depth of 0.015 m. The calculated volume of the distress is 0.0017 m<sup>3</sup>

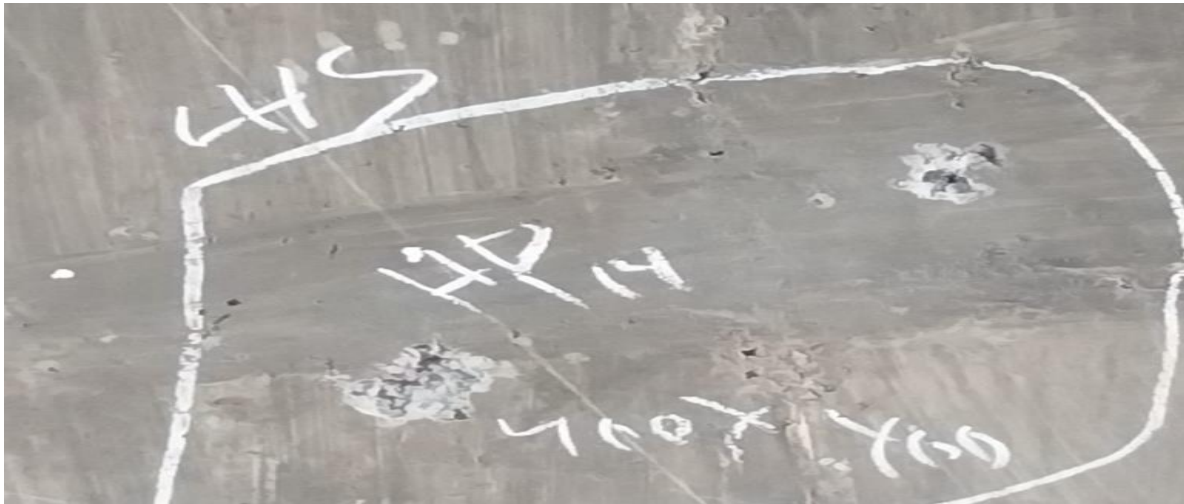
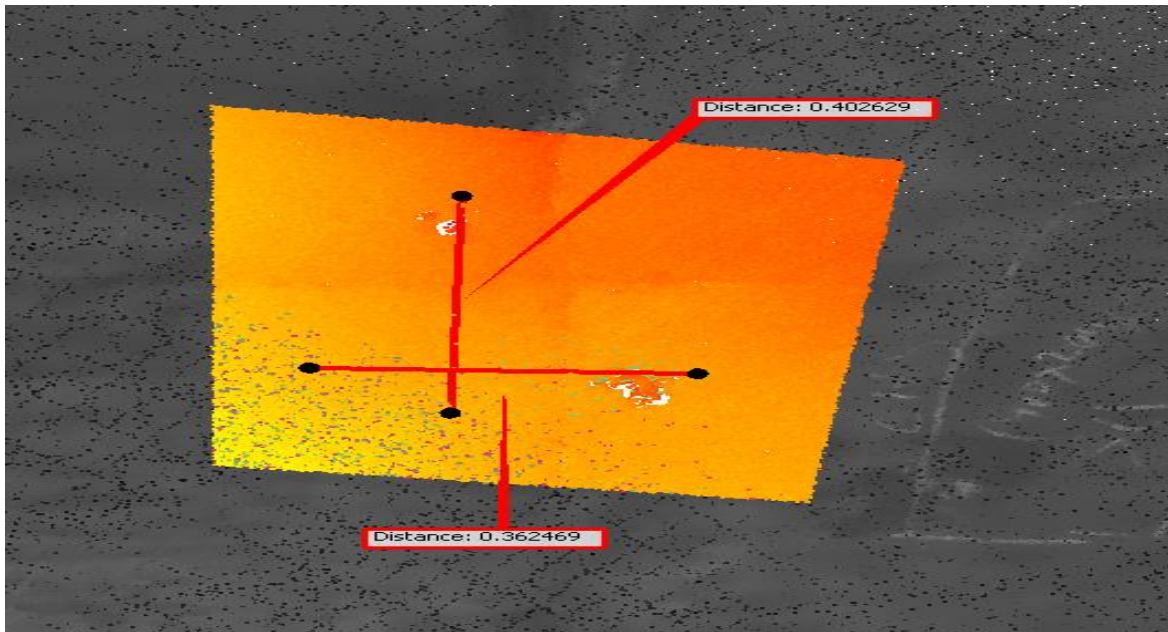
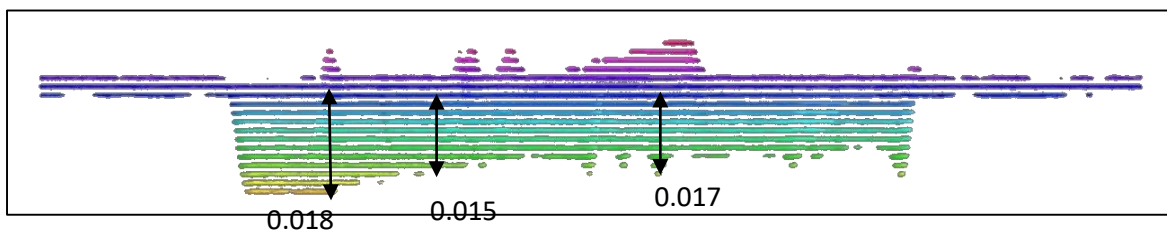
| Element Name | Observation | Location of Distress | Photo No. | Units | Distress Details | | | Area of Repair (Sq.m/R MT/m3) |
|---|---|---|---|---|---|---|---|---|
| Deck slab | Hollow pocket | - | 2 | M | 0.36 | 0.40 | 0.017 | 0.0024 |

2. **Hollow pocket observed at slab bottom between A1–A2 span (LHS), measuring 0.36 m in length and 0.40 m in width. Depth ranges from 0.015 m (min) to 0.018 m (max), with an average depth of 0.017 m. The calculated volume of the distress is 0.0024 m<sup>3</sup>.**

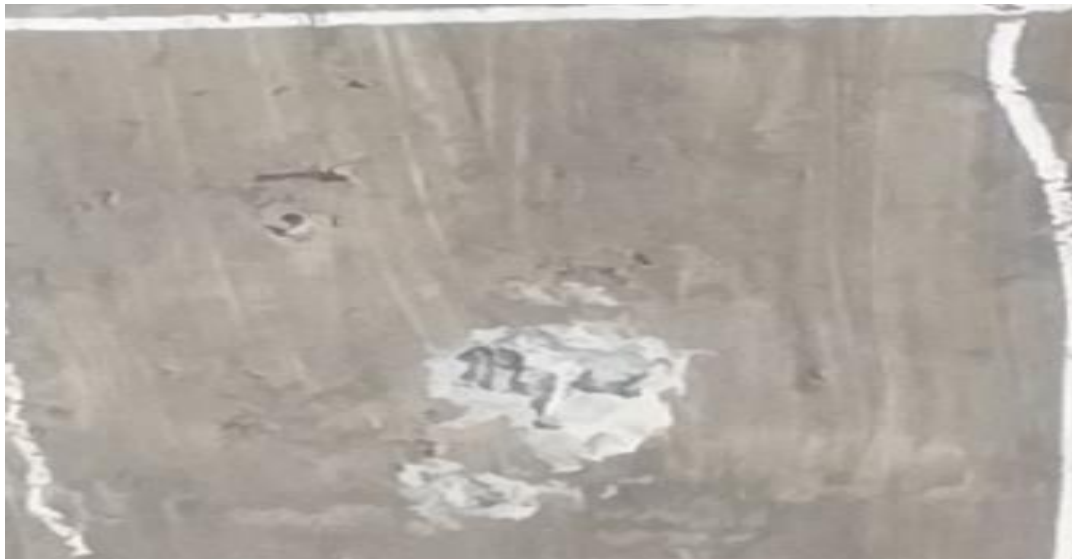
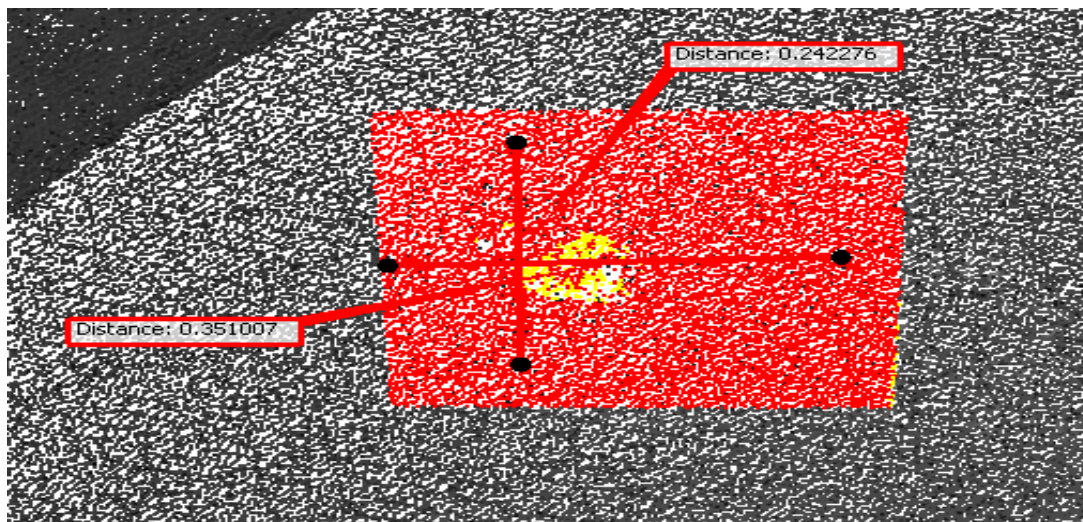
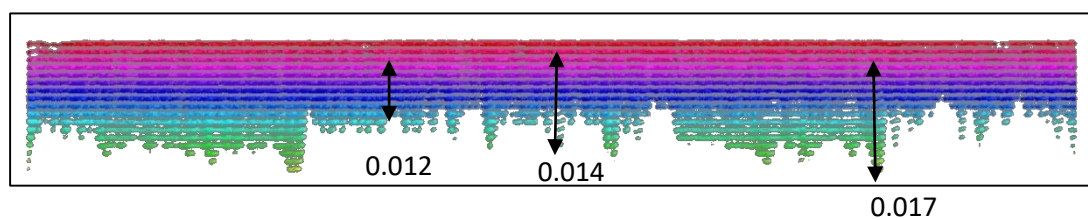
| Element Name | Observation | Location of Distress | Photo No. | Units | Distress Details | | | Area of Repair (Sq.m/R MT/m3) |
|---|---|---|---|---|---|---|---|---|
| Deck slab | Hollow pocket | - | 3 | M | 0.35 | 0.24 | 0.014 | 0.0017 |

3. **Hollow pocket-2 observed at slab bottom between A1–A2 span (LHS), measuring 0.35 m in length and 0.24 m in width. Depth ranges from 0.012 m (min) to 0.017 m (max), with an average depth of 0.014 m. The calculated volume of the distress is 0.0017 m<sup>3</sup>.**

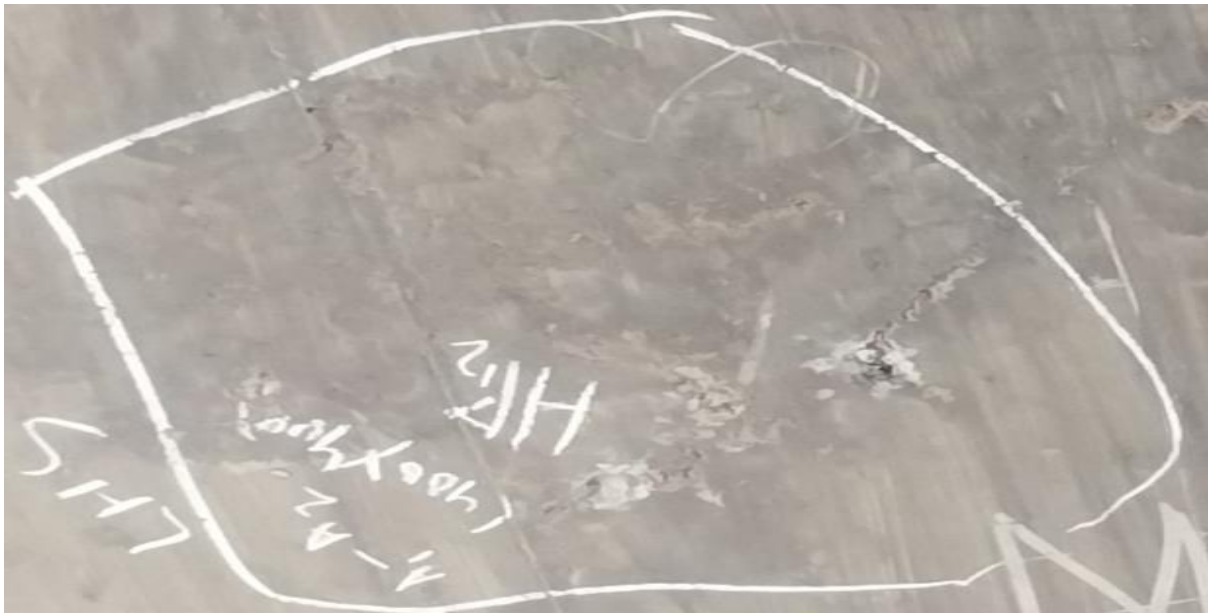
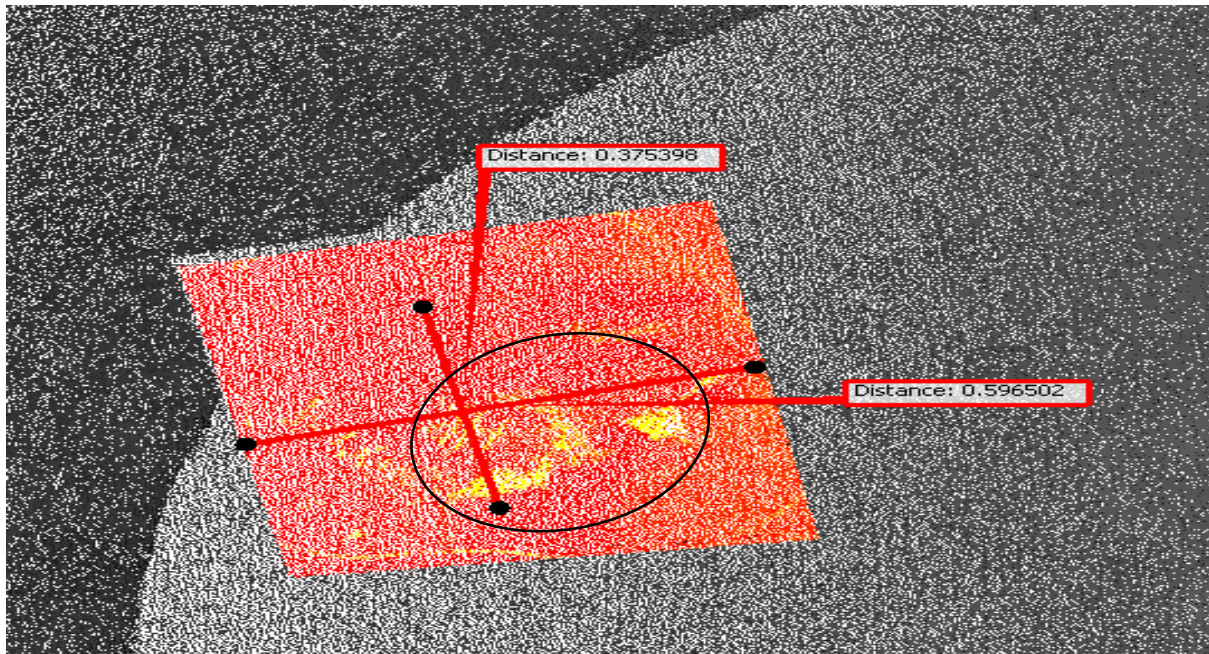
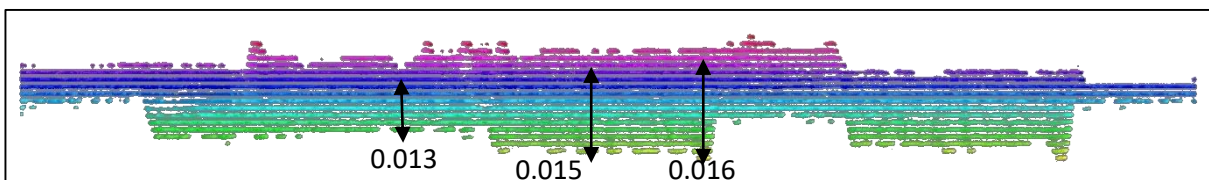
| Element Name | Observation | Location of Distress | Photo No. | Units | Distress Details | | | Area of Repair (Sq.m/R MT/m3) |
|---|---|---|---|---|---|---|---|---|
| Deck slab | Hollow pocket | - | 4 | M | 0.37 | 0.59 | 0.016 | 0.0034 |

4. Hollow pocket-3 observed at slab bottom between A1–A2 span (LHS), measuring 0.37 m in length and 0.59 m in width. Depth ranges from 0.013 m (min) to 0.016 m (max), with an average depth of 0.015 m. The calculated volume of the distress is 0.034 m<sup>3</sup>.

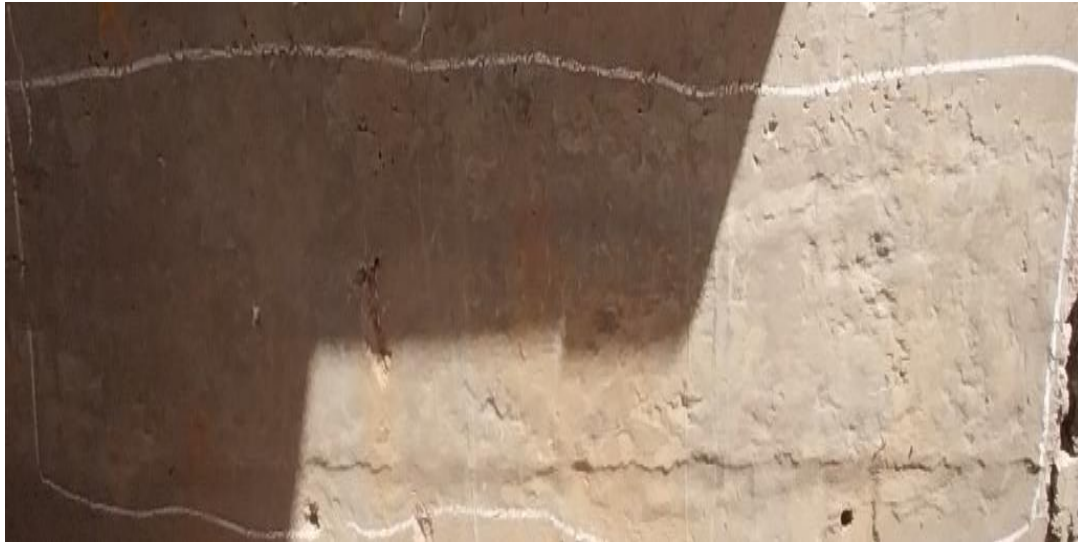
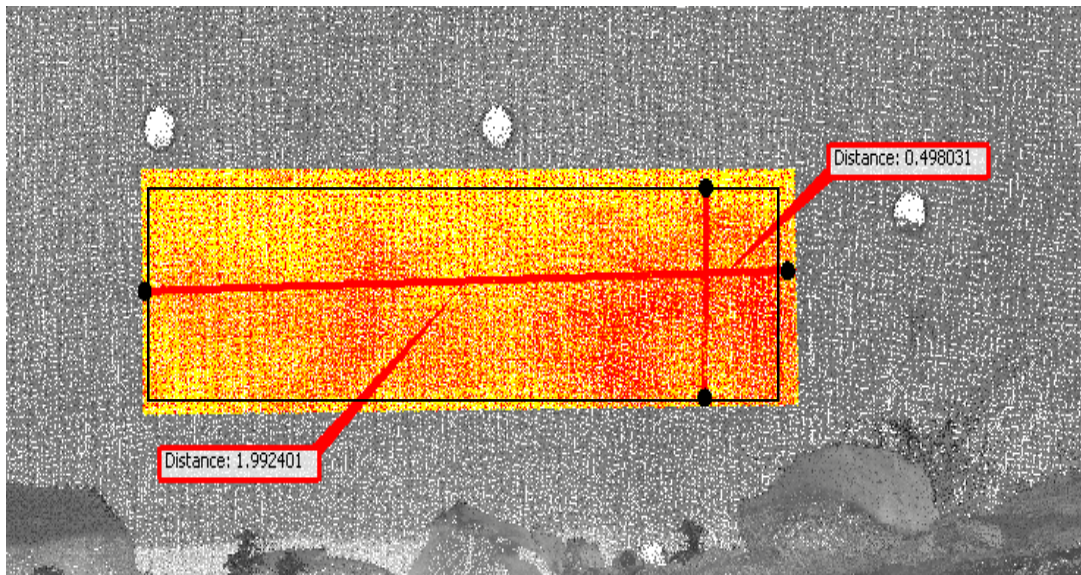
| Element Name | Observation | Location of Distress | Photo No. | Units | Distress Details | | | Area of Repair (Sq.m/R MT/m3) |
|---|---|---|---|---|---|---|---|---|
| Abutment 2 | Scaling | - | 5 | M | 1.99 | 0.49 | - | 0.975 |

5. **Scaling-1 observed at A2 (LHS), measuring 1.99 m in length, 0.49 m in width, covering an area of 0.975 m<sup>2</sup>.**

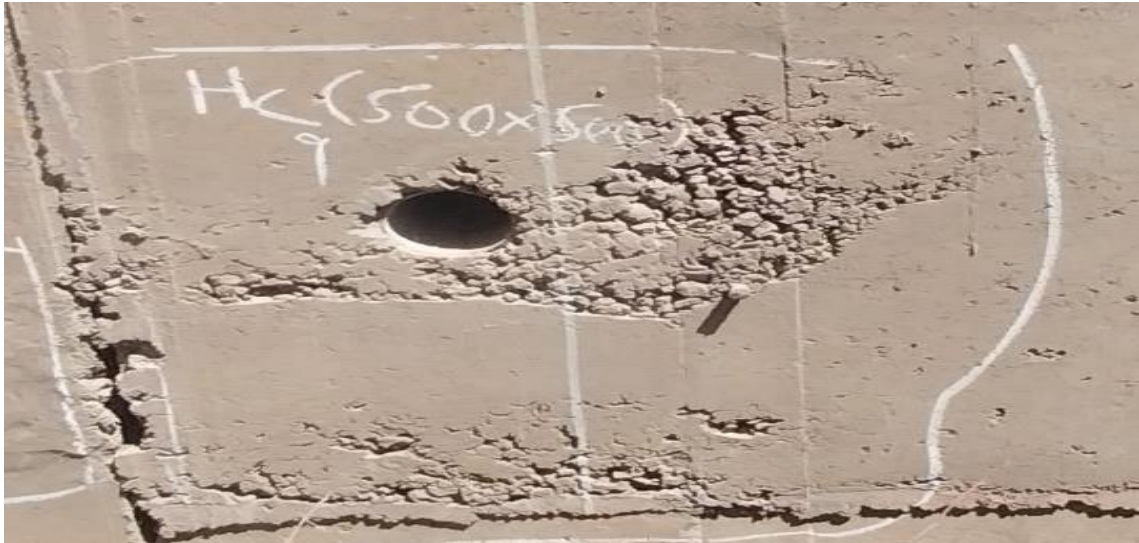
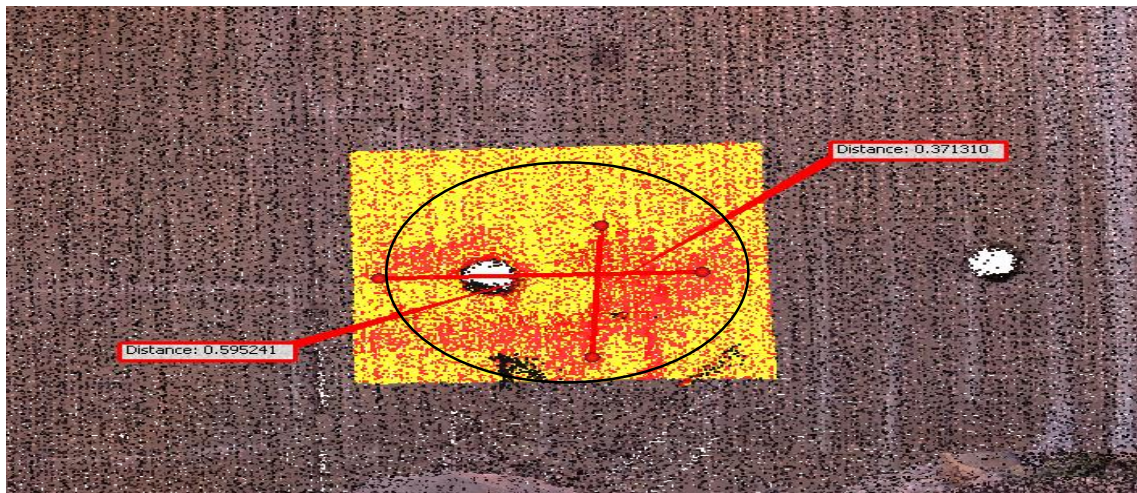
| Element Name | Observation | Location of Distress | Photo No. | Units | Distress Details | | | Area of Repair (Sq.m/R MT/m3) |
|---|---|---|---|---|---|---|---|---|
| Abutment 2 | Honeycombing | - | 6 | M | 0.59 | 0.37 | - | 0.218 |

6. **Honeycombing-1 observed at A2 median (LHS), measuring 0.59 m in length, 0.37 m in width, with an affected area of 0.218 m<sup>2</sup>.**

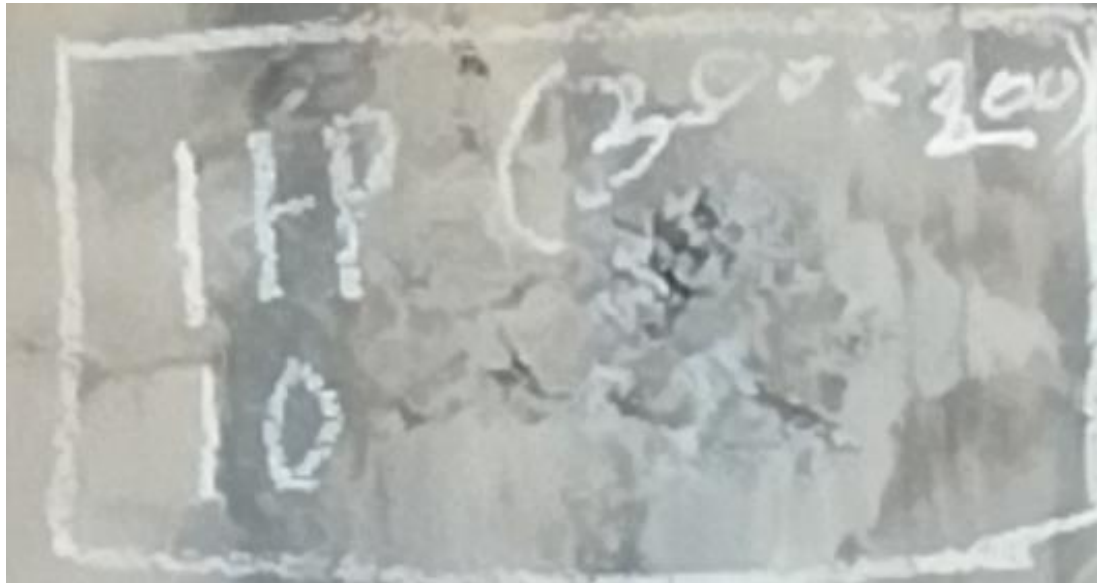
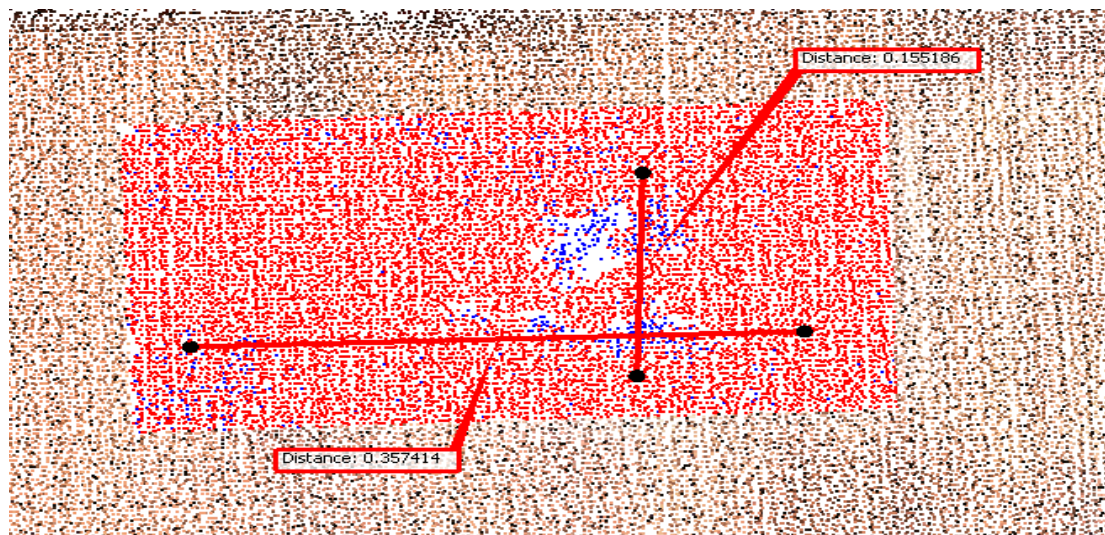
| Element Name | Observation | Location of Distress | Photo No. | Units | Distress Details | | | Area of Repair (Sq.m/R MT/m3) |
|---|---|---|---|---|---|---|---|---|
| Abutment 1 | Hollow pocket | - | 7 | M | 0.35 | 0.15 | 0.017 | 0.0008 |

7. **Hollow pocket-4 observed at A1 (LHS), measuring 0.35 m in length and 0.15 m in width. Depth ranges from 0.013 m (min) to 0.017 m (max), with an average depth of 0.015 m. The calculated volume of the distress is 0.0008 m<sup>3</sup>.**

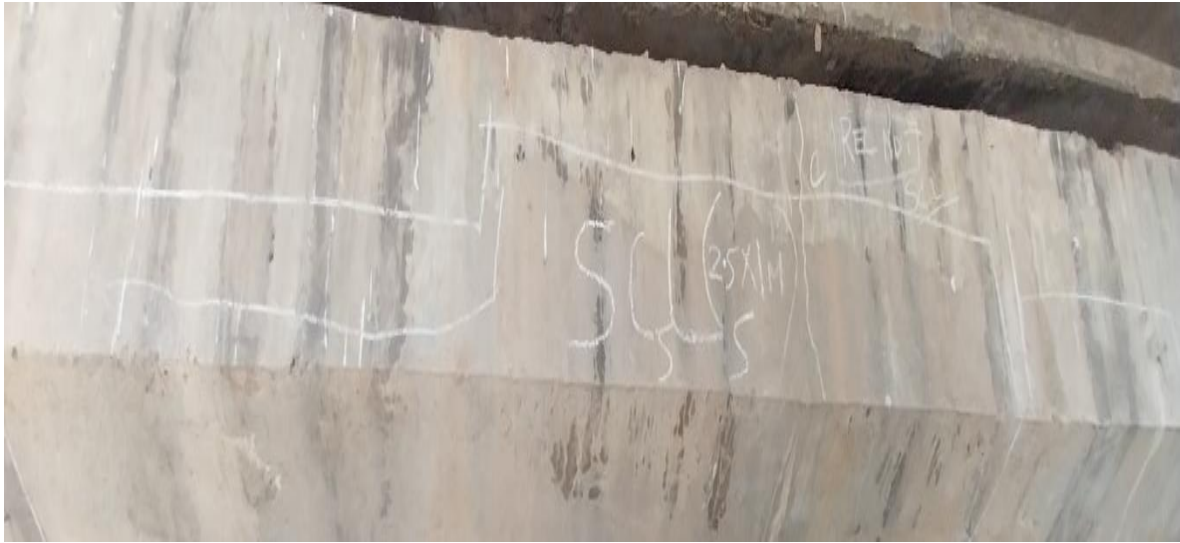
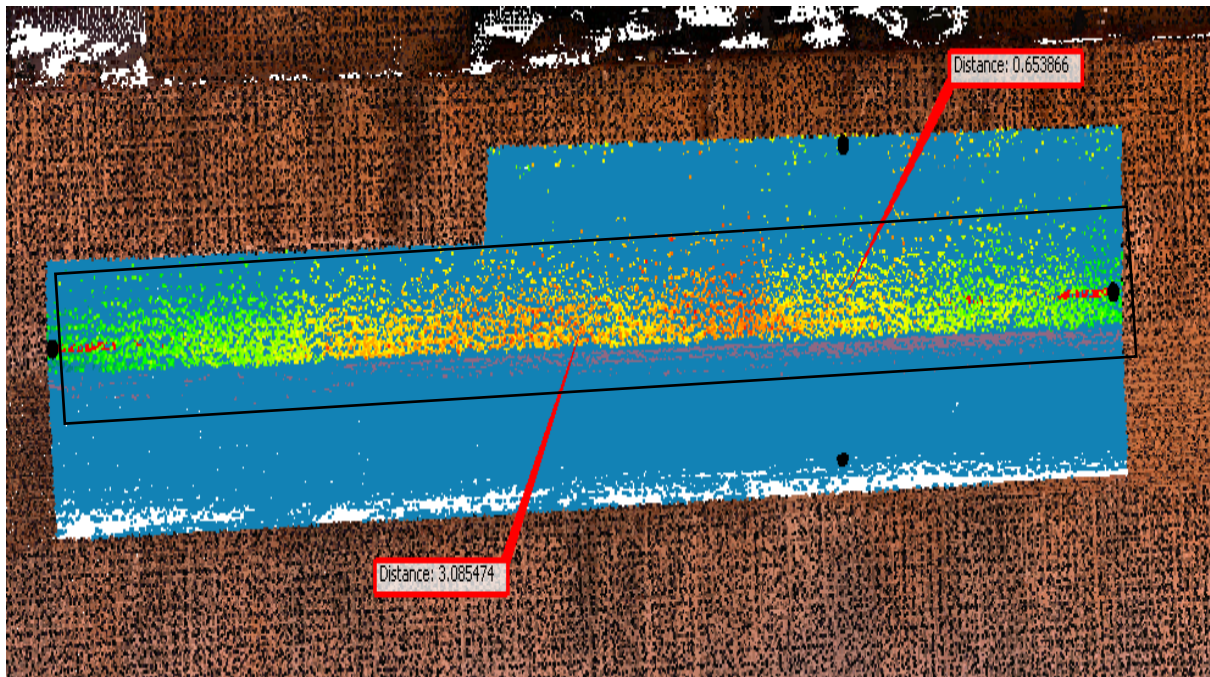
| Element Name | Observation | Location of Distress | Photo No. | Units | Distress Details | | | Area of Repair (Sq.m/R MT/m3) |
|---|---|---|---|---|---|---|---|---|
| Abutment 1 | Scaling | - | 8 | M | 3.08 | 0.65 | - | 2.002 |

8. **Scaling-2 observed at A1 (LHS), measuring 3.08 m in length and 0.65 m in width, covering an area of 2.002 m<sup>2</sup>.**

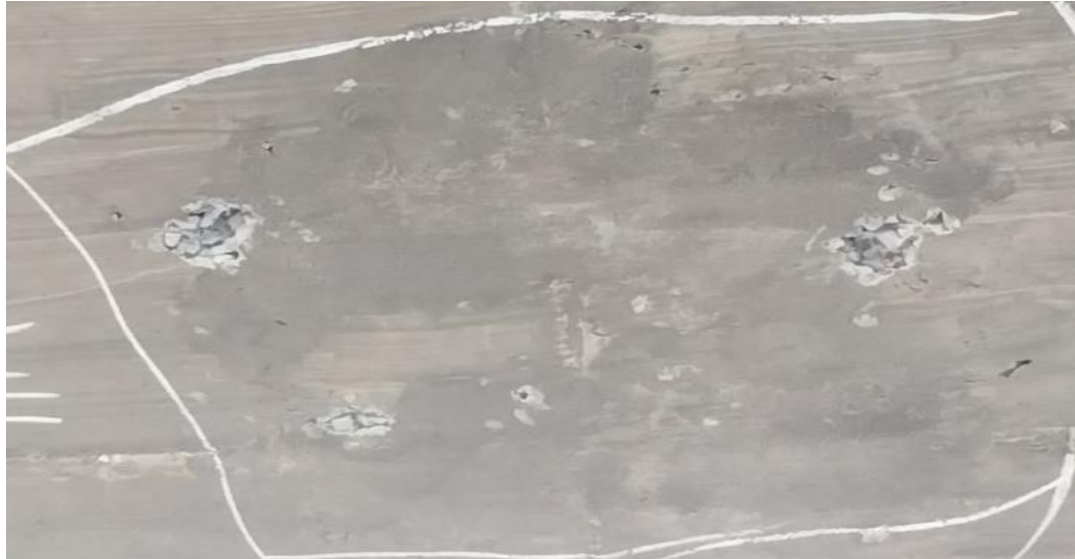
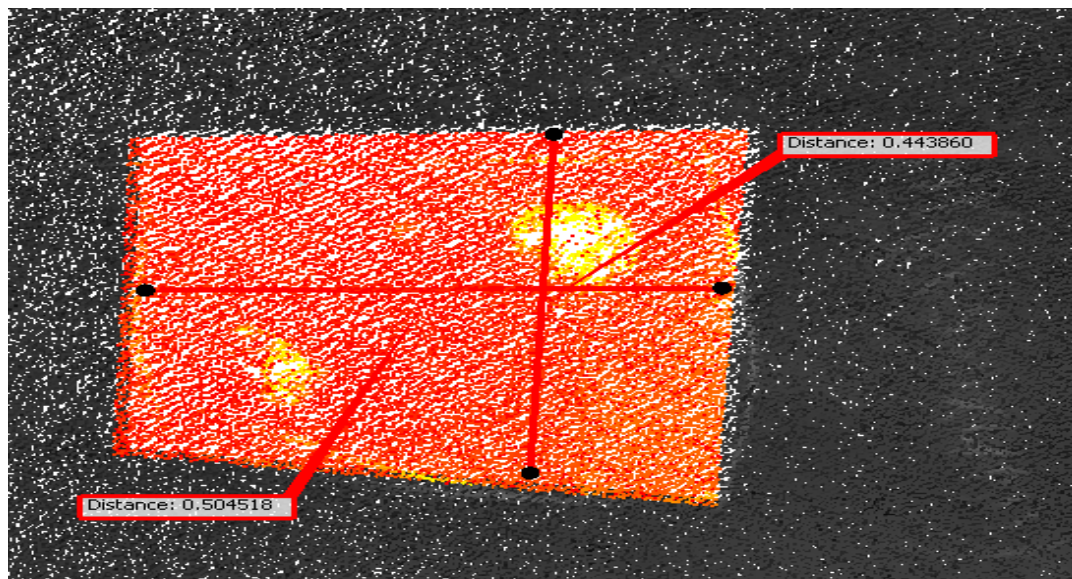
| Element Name | Observation | Location of Distress | Photo No. | Units | Distress Details | | | Area of Repair (Sq./RM T/m3) |
|---|---|---|---|---|---|---|---|---|
| Deck slab | Hollow pocket | - | 9 | M | 0.50 | 0.44 | 0.011 | 0.0024 |

**9. Hollow pocket-5 observed at bottom slab between A1–A2 span (RHS), measuring 0.50 m in length and 0.44 m in width. Depth ranges from 0.010 m (min) to 0.012 m (max), with an average depth of 0.011 m. The calculated volume of the distress is 0.0024 m<sup>3</sup>.**

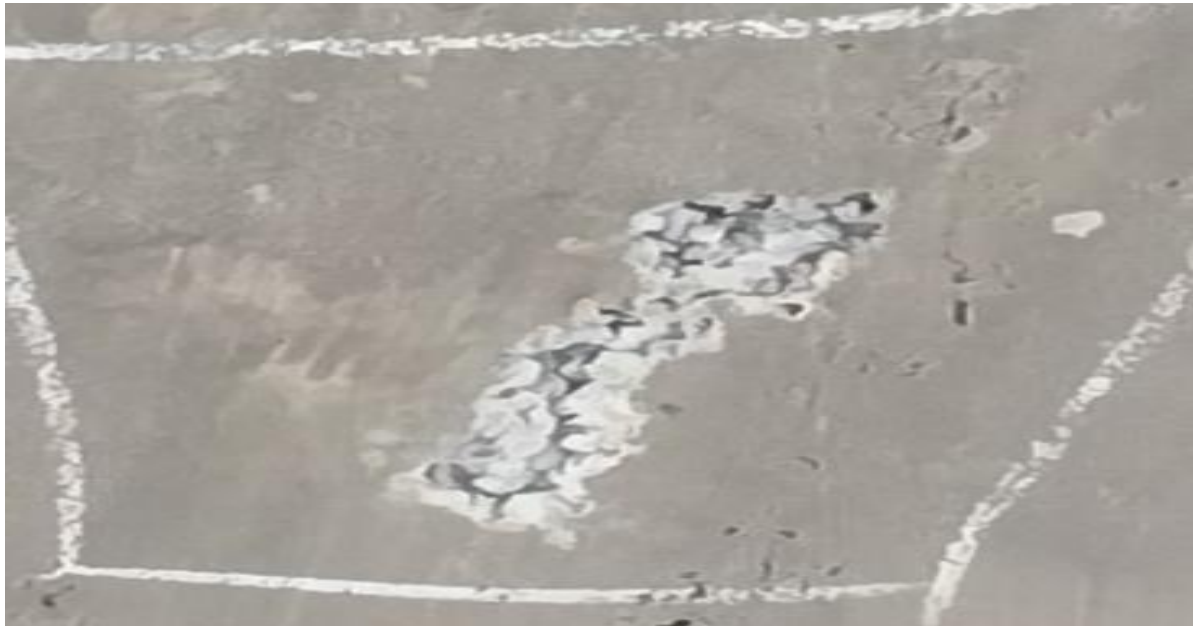
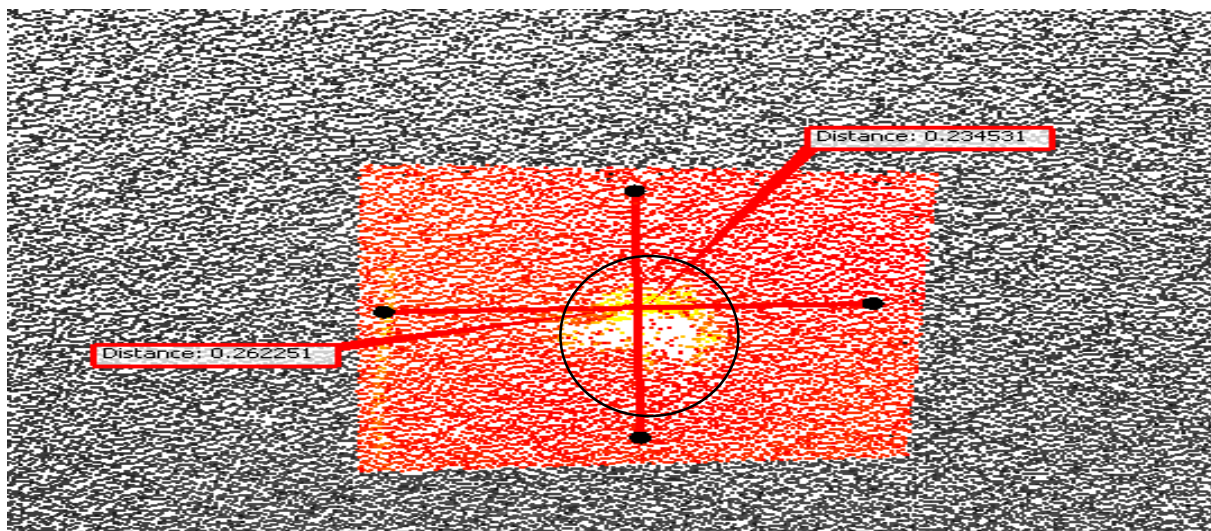
| Element Name | Observation | Location of Distress | Photo No. | Units | Distress Details | | | Area of Repair (Sq./RM T/m3) |
|---|---|---|---|---|---|---|---|---|
| Deck slab | Hollow pocket | - | 10 | M | 0.26 | 0.23 | 0.016 | 0.0009 |

**10. Hollow pocket-6 observed at bottom slab between A1–A2 span (RHS), measuring 0.26 m in length and 0.23 m in width. Depth ranges from 0.015 m (min) to 0.018 m (max), with an average depth of 0.016 m. The calculated volume of the distress is 0.010 m<sup>3</sup>.**

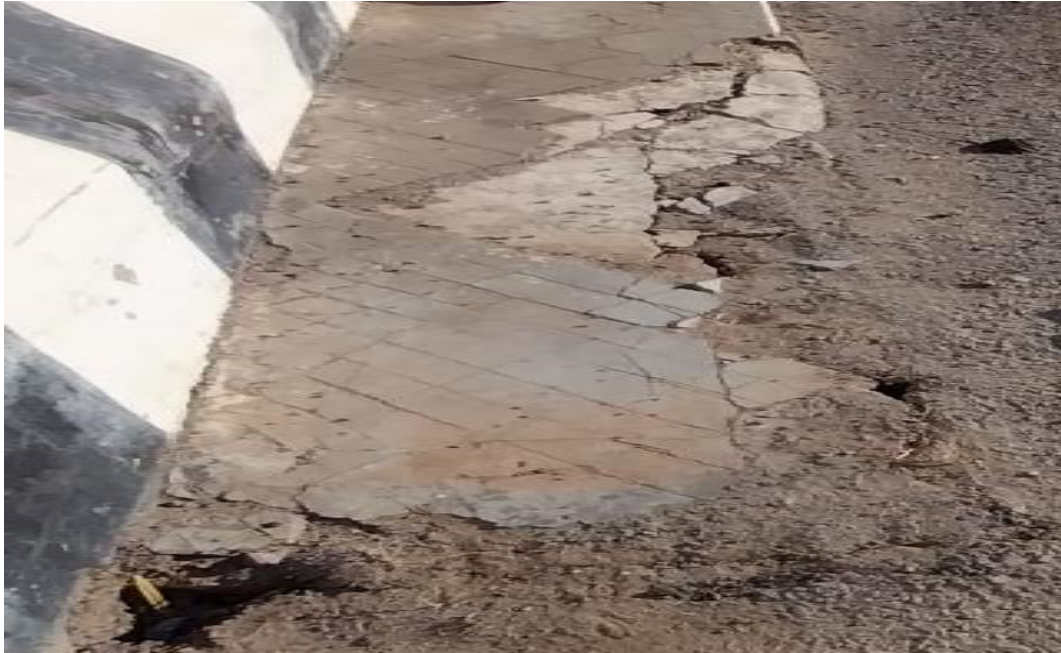
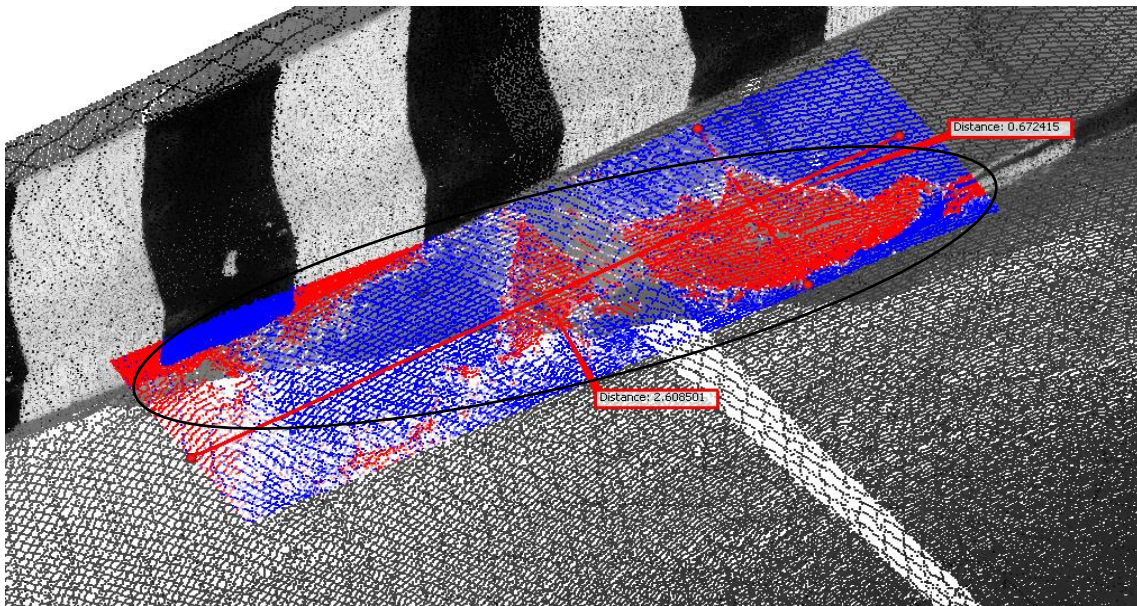
| Element Name | Observation | Location of Distress | Photo No. | Units | Distress Details | | | Area of Repair (Sq./RM T/m3) |
|---|---|---|---|---|---|---|---|---|
| Footpath | Damage | - | 11 | M | 2.60 | 0.67 | - | 1.742 |

**11. Footpath damage observed on RHS, measuring 2.60 m in length and 0.67 m in width, covering an area of 1.742 m<sup>2</sup>.**

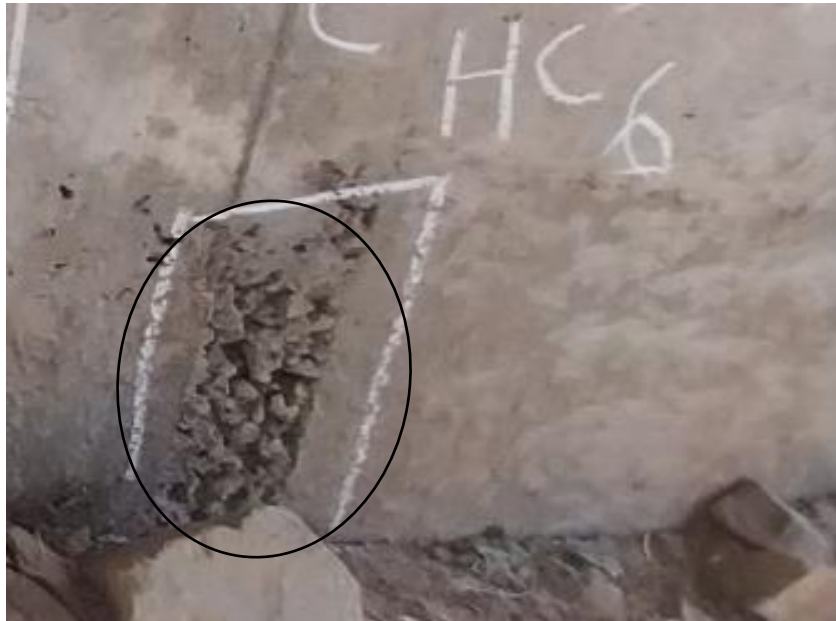
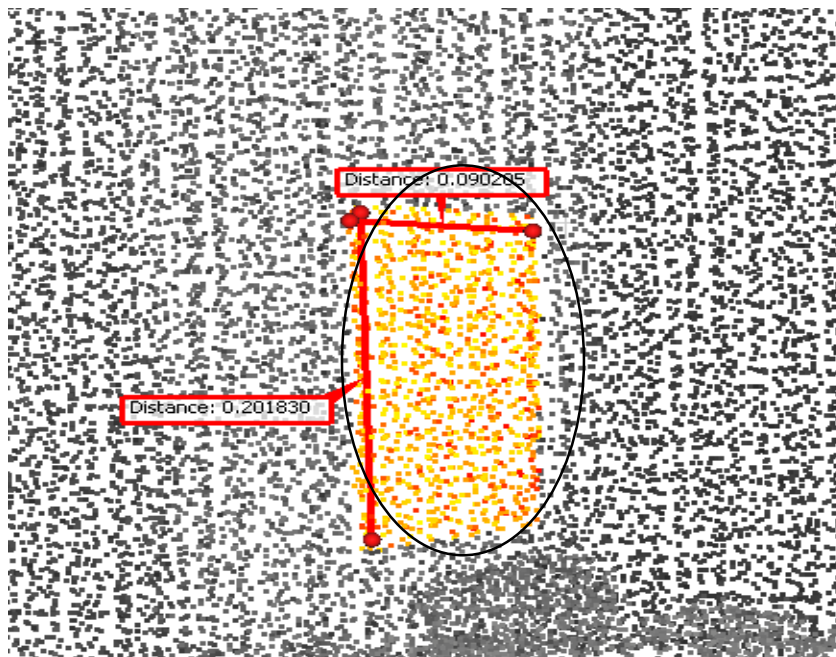
| Element Name | Observation | Location of Distress | Photo No. | Units | Distress Details | | | Area of Repair (Sq./RM T/m3) |
|---|---|---|---|---|---|---|---|---|
| Abutment 2 | Honeycombing | - | 12 | M | 0.20 | 0.09 | - | 0.018 |

**12.Honeycombing-2 observed at A2 (RHS), measuring 0.20 m in length and 0.09 m in width, with an affected area of 0.018 m<sup>2</sup>**

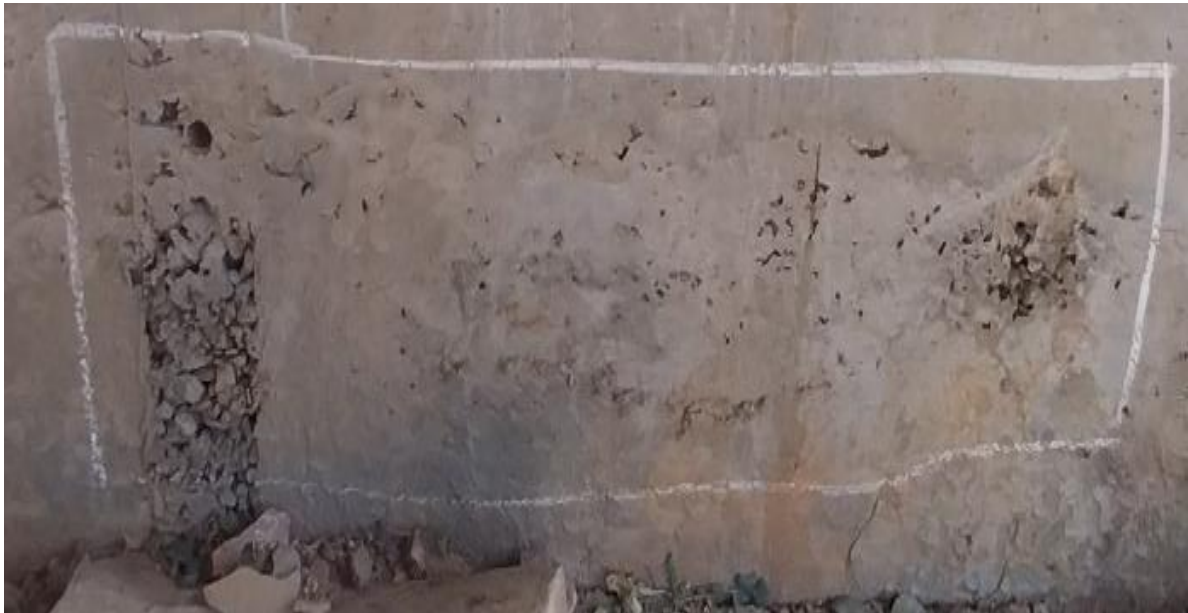
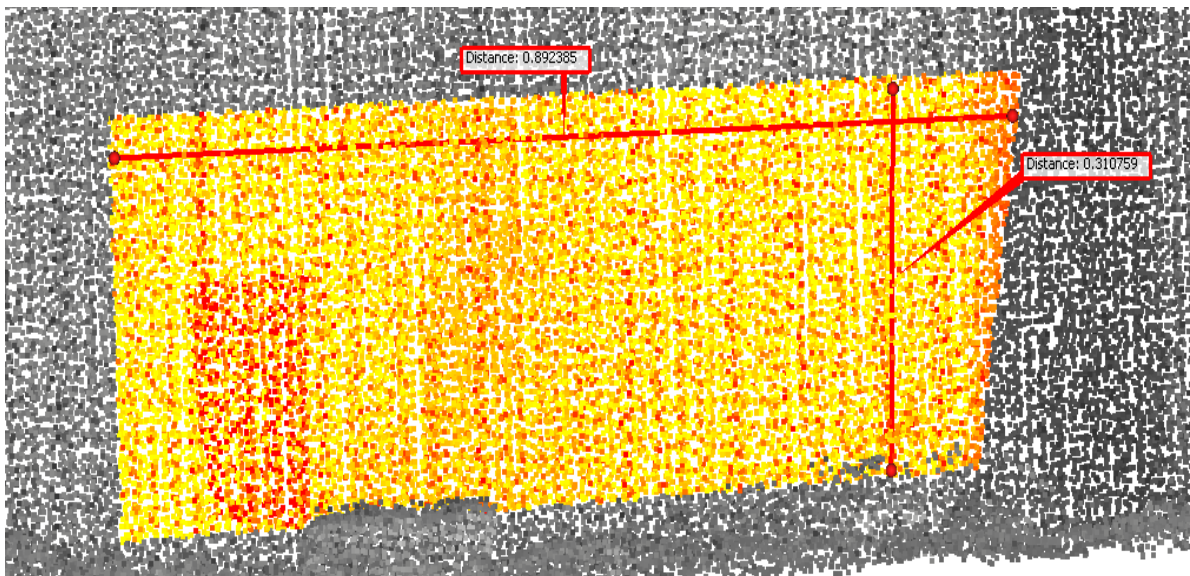
| Element Name | Observation | Location of Distress | Photo No. | Units | Distress Details | | | Area of Repair (Sq./RM T/m3) |
|---|---|---|---|---|---|---|---|---|
| Abutment 2 | Honeycombing | - | 13 | M | 0.89 | 0.31 | - | 0.275 |

**13.Honeycombing-3 observed at A2 (RHS), measuring 0.89 m in length and 0.31 m in width, with an affected area of 0.275 m<sup>2</sup>.**
