# **LIDAR Inspection Report of Box Culvert ch.970+050**

**Bridge Chainage:** 970+050

# **CH: 970+050 – BOX CULVERT**

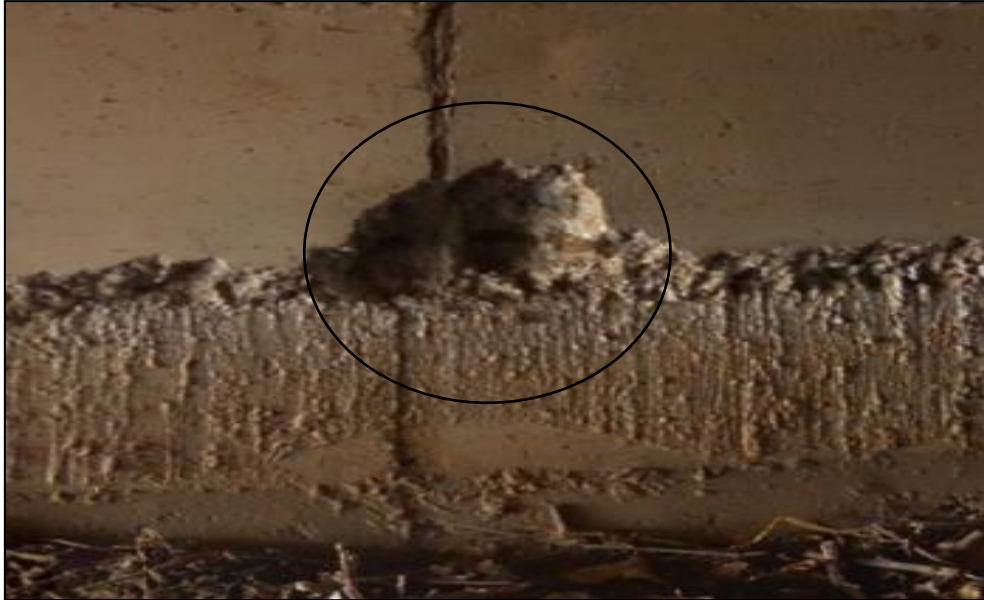
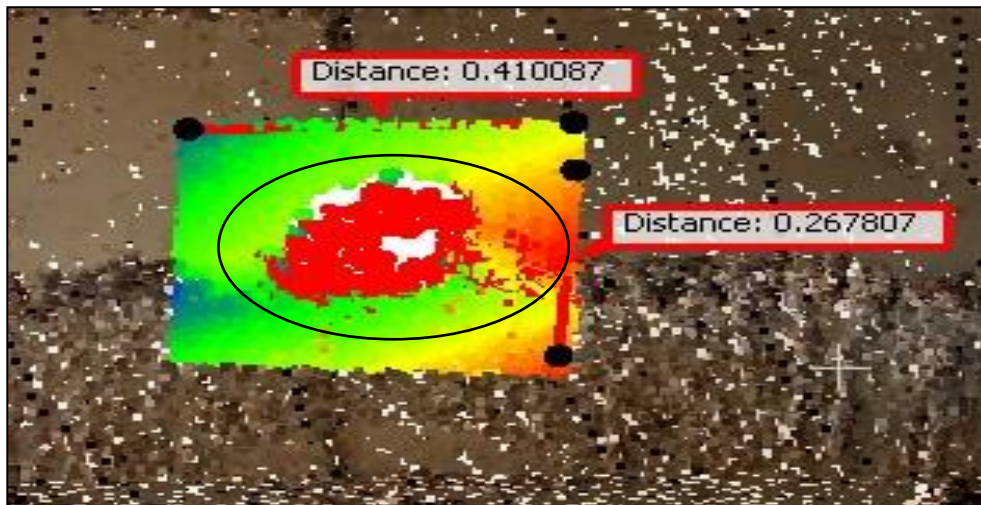
| Element Name | Observation | Location of Distress | Photo No. | Units | Distress Details | | | Area of Repair (Sq./RM T) |
|---|---|---|---|---|---|---|---|---|
| Abutment 1 | Damage | | 1 | CU | 0.410 | 0.267 | 0.014 | 0.1094 |

1. Damage observed on A1 (RHS), measuring 0.410 m in length and 0.267 m in width, covering an area of 0.1094 m<sup>2</sup>, with an average depth of 0.014 m.
