# **LIDAR Inspection Report of Slab Culvert ch.970+940**

**Bridge Chainage:** 970 + 940 (CKRP)

- **CKRP:** Chittorgarh to kota
- **State:** Rajasthan NH 27
- **Zone:** RJ-06

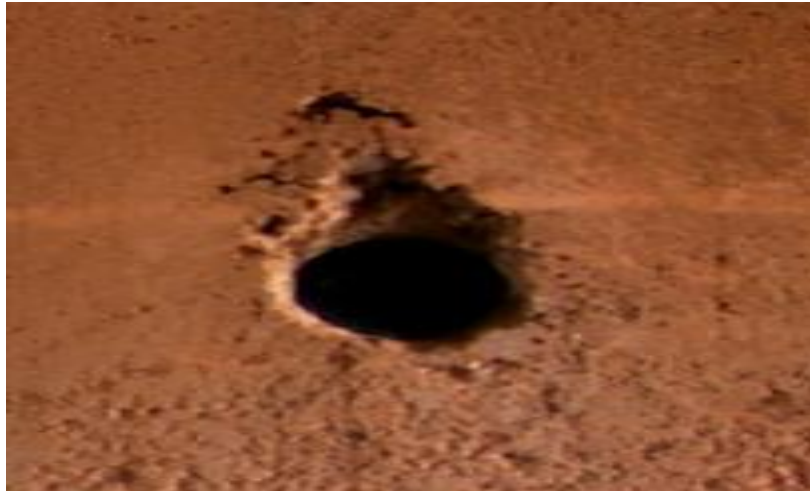
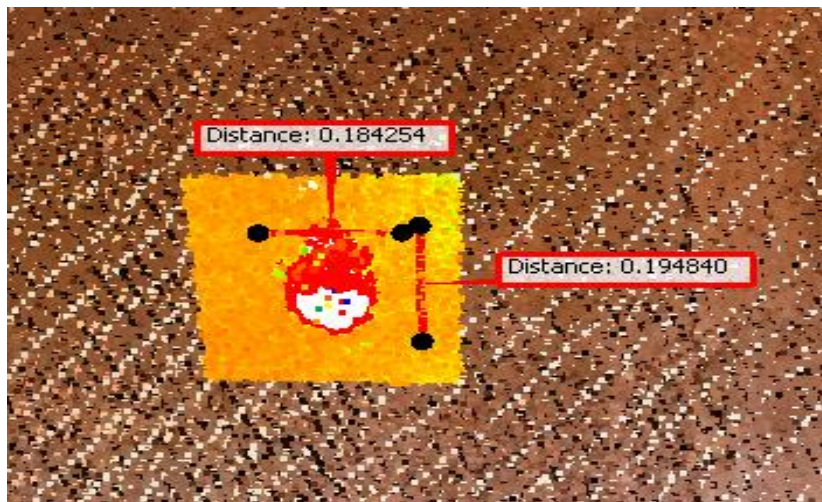
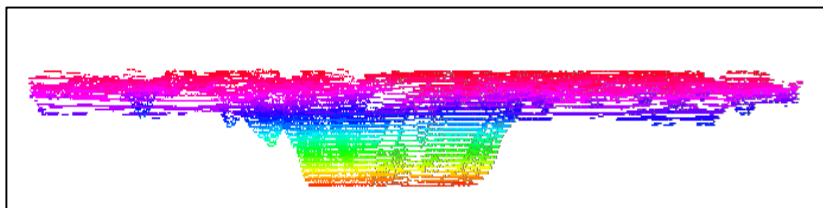
| Element Name | Observation | Location of Distress | Photo No. | Units | Distress Details | | | Area of Repair (Sq.m/ RMT/ m3) |
|---|---|---|---|---|---|---|---|---|
| Abutment 1 | Damage | | 1 | M | 0.19 | 0.18 | | 0.034 |

1. Weep hole damage observed on A1, measuring 0.19 m in length and 0.18 m in width, covering an area of 0.0342 m<sup>2</sup>.

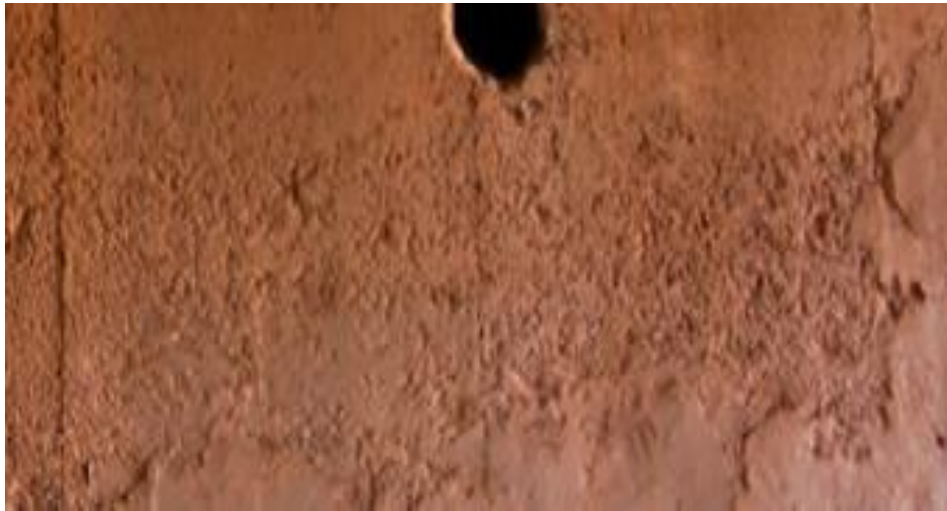
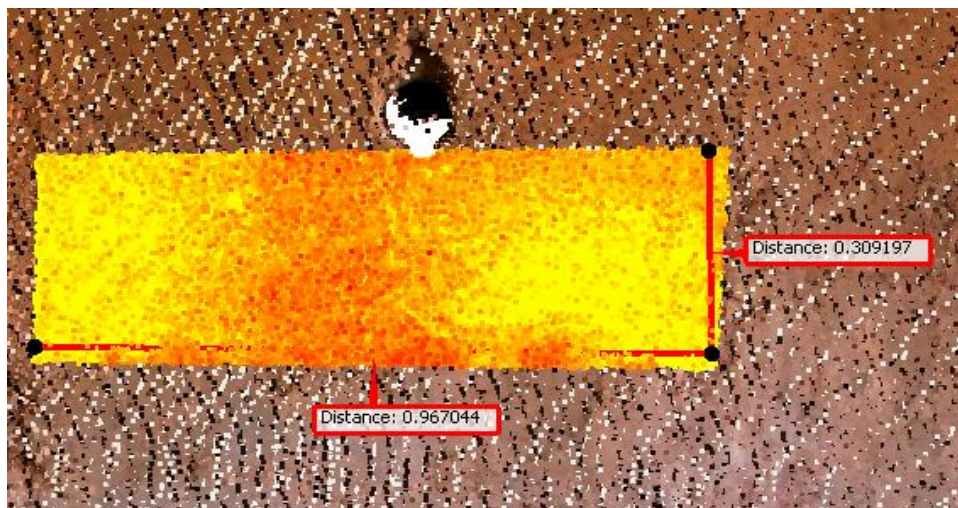
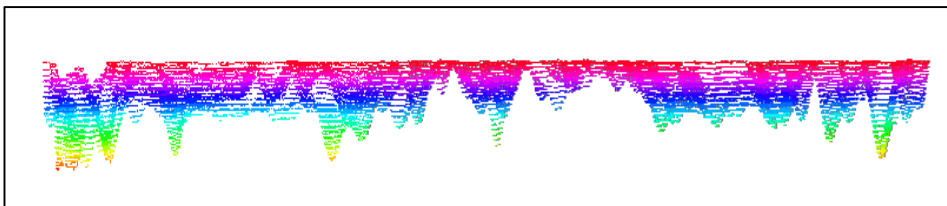
| Element Name | Observation | Location of Distress | Photo No. | Units | Distress Details | | | Area of Repair (Sq.m/ RMT/ m3) |
|---|---|---|---|---|---|---|---|---|
| Abutment 1 | Scaling | | 2 | M | 0.96 | 0.30 | | 0.288 |

- 2. Scaling observed on Abutment 1, measuring 0.96 m in length and 0.30 m in width, covering an area of 0.288 m<sup>2</sup>.**

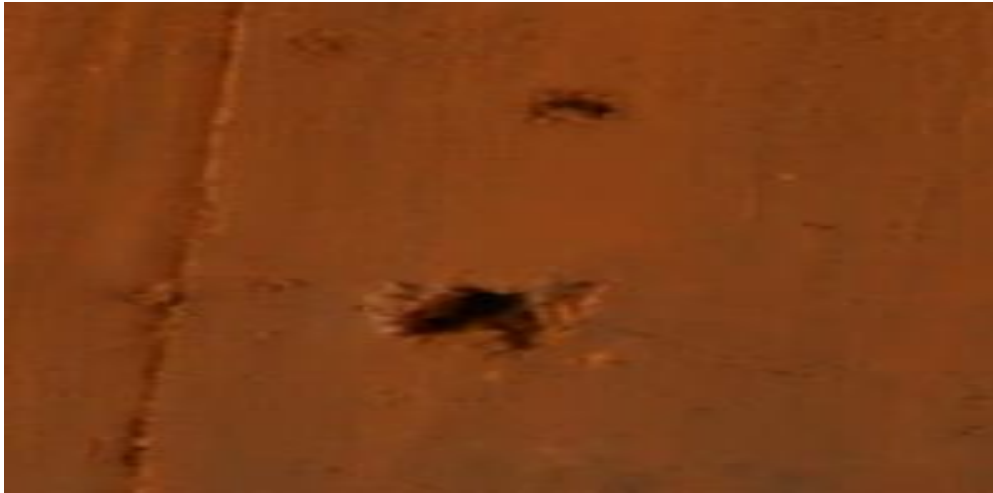
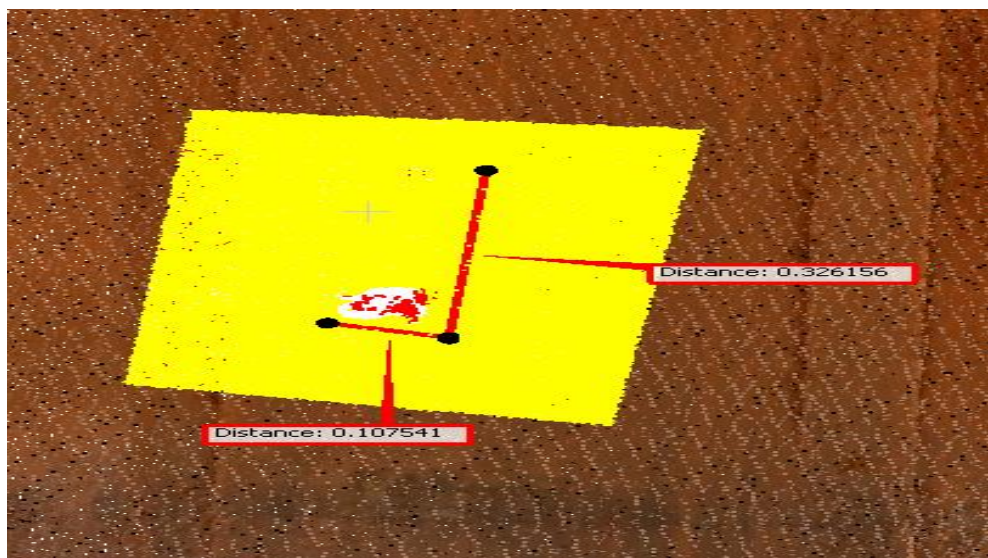
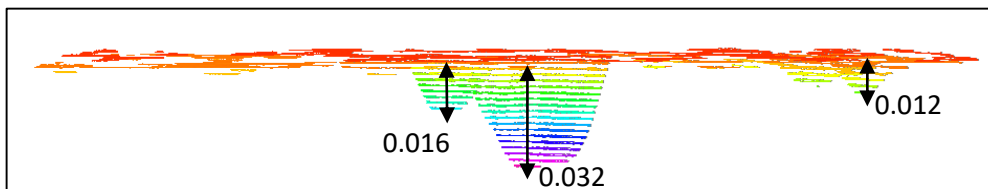
| Element Name | Observation | Location of Distress | Photo No. | Units | Distress Details | | | Area of Repair (Sq.m/ RMT/ m3) |
|---|---|---|---|---|---|---|---|---|
| Abutment 2 | Hollow Section | | 3 | M | 0.32 | 0.10 | 0.016 | 0.0005 |

**3. Hollow section observed on Abutment 2 , measuring 0.32 m in length and 0.10 m in width. Depth ranges from 0.012 m (min) to 0.032 m (max), with an average depth of 0.016 m. The calculated volume of the distress is 0.0005 m<sup>3</sup>.**
