# **LIDAR Inspection Report of Slab Culvert ch.971+520**

**Bridge Chainage:** 971 + 520 (CKRP)

- **CKRP:** Chittorgarh to kota
- **State:** Rajasthan NH 27
- **Zone:** RJ-06

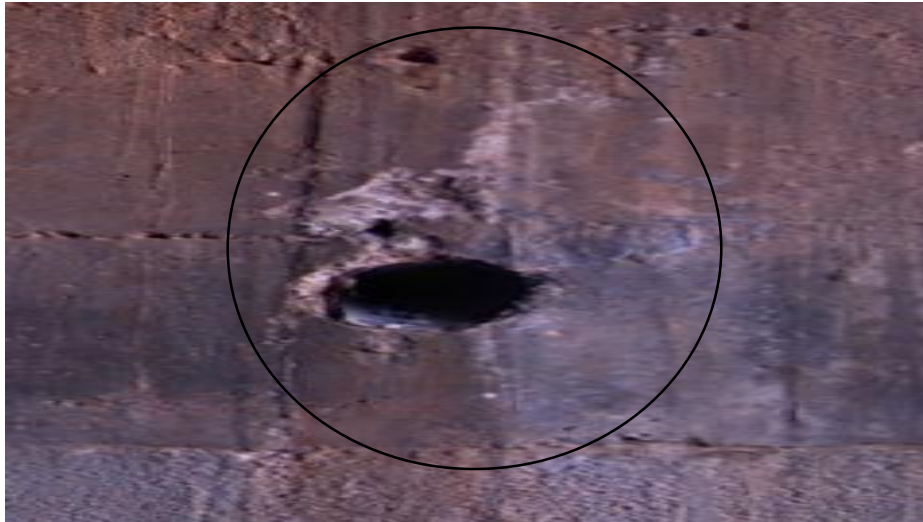
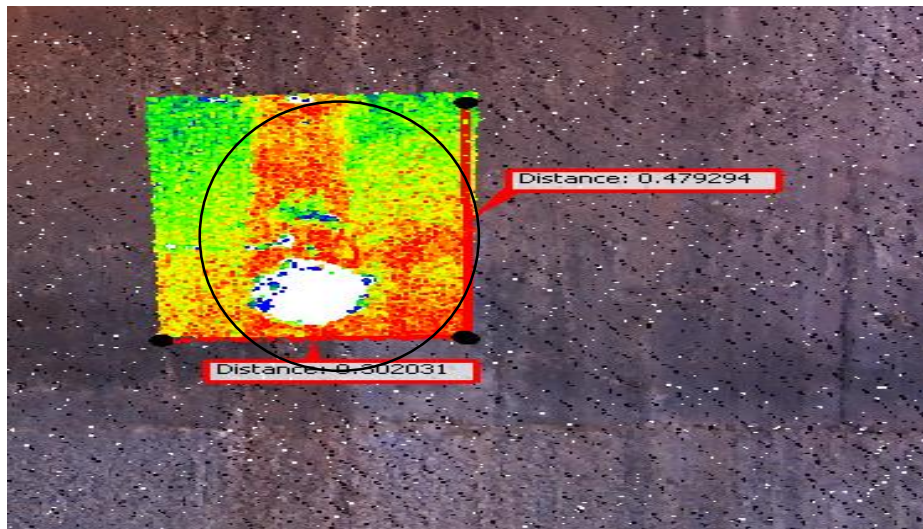
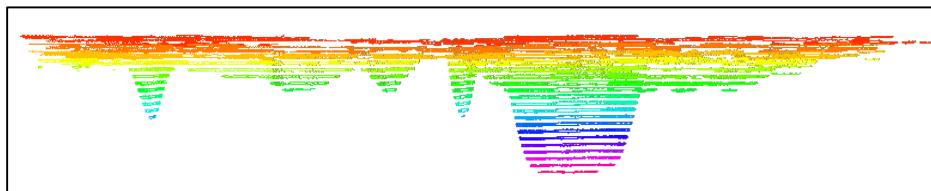
| Element Name | Observation | Location of Distress | Photo No. | Units | Distress Details | | | Area of Repair<br>(Sq.m/R<br>MT/m3) |
|---|---|---|---|---|---|---|---|---|
| Abutment Wall | Damage | | 1 | | 0.47 | 0.30 | | 0.12 |

1. Weep hole damage observed on Abutment wall, measuring 0.47 m in length and 0.30 m in width, covering an area of 0.12 m<sup>2</sup>

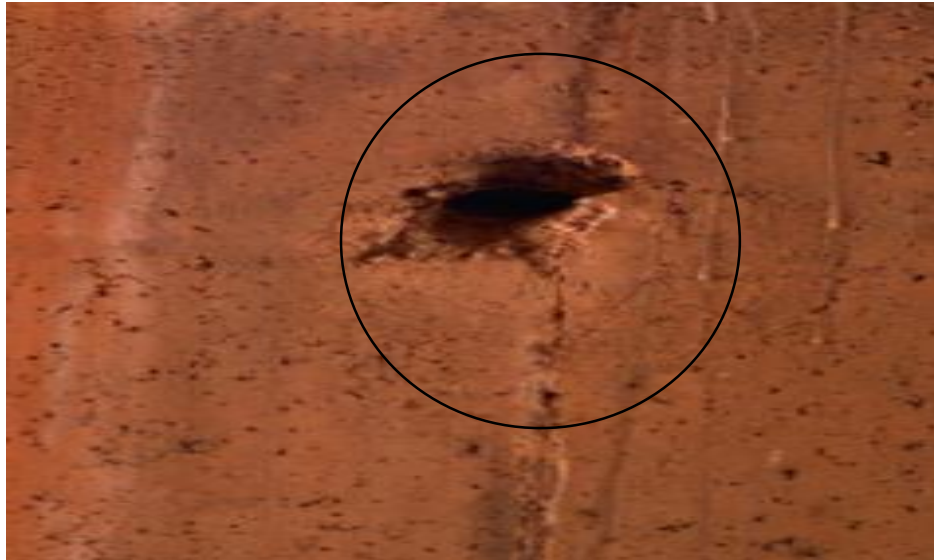
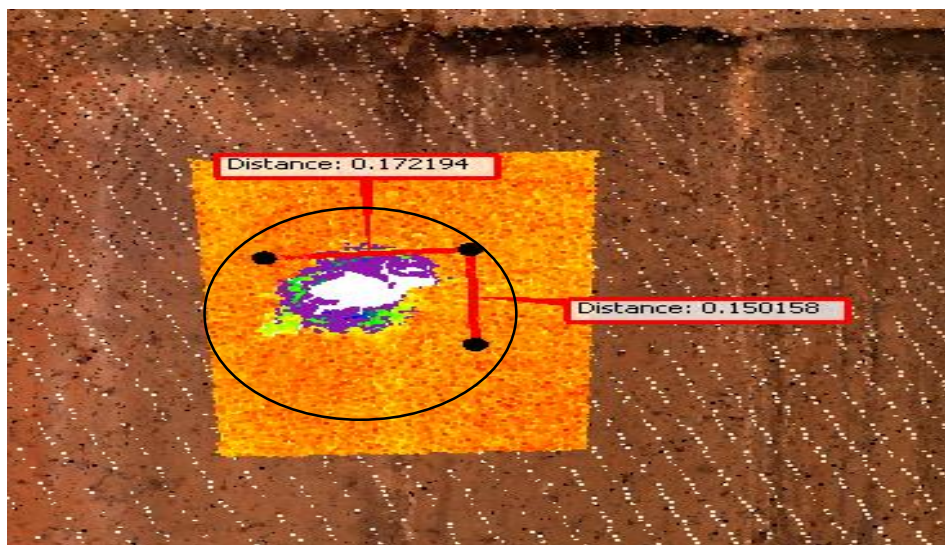
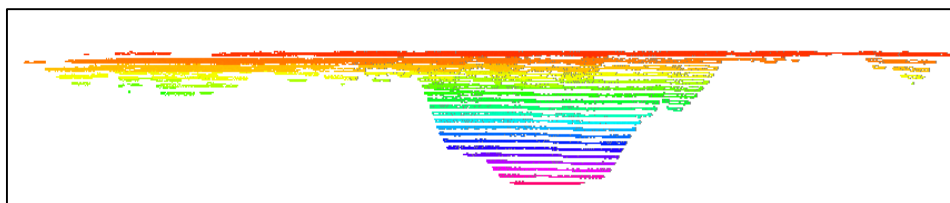
| Element Name | Observation | Location of Distress | Photo No. | Units | Distress Details | | | Area of Repair<br>(Sq.m/R<br>MT/m3) |
|---|---|---|---|---|---|---|---|---|
| Abutment Wall | Damage | | 2 | | 0.17 | 0.15 | | 0.02 |

- 2. Weep hole damage observed on Abutment wall, measuring 0.17 m in length and 0.15 m in width, covering an area of 0.0255 m<sup>2</sup>**
