# **LIDAR Inspection Report of Slab Culvert ch.971+830**

**Bridge Chainage:** 971 + 830 (CKRP)

**Latitude/Longitude:** 25.127318, 75.087288

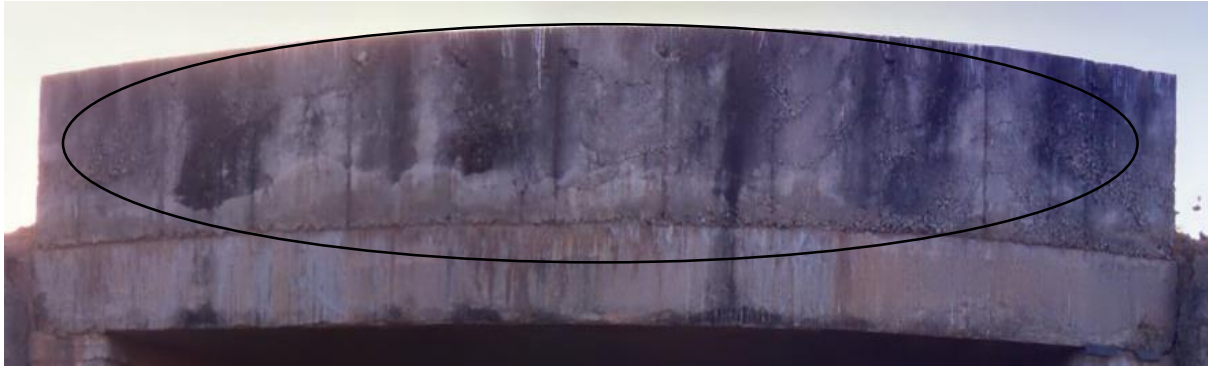
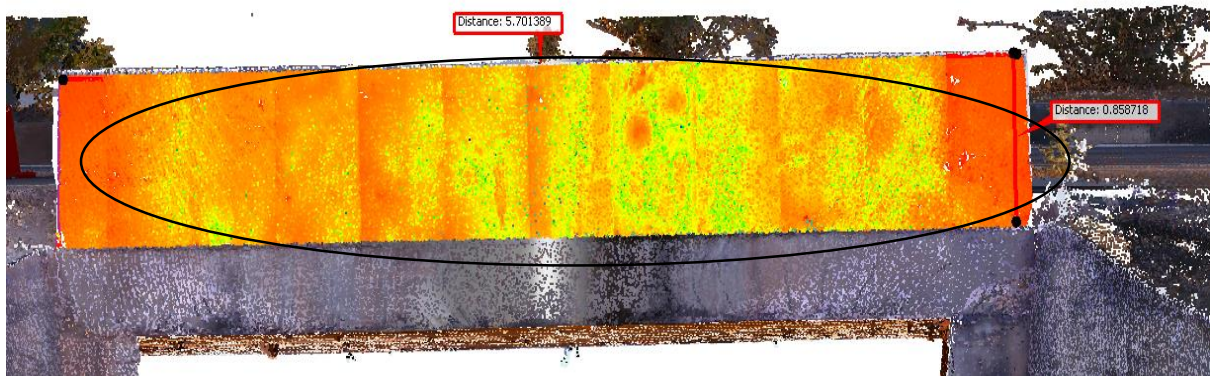
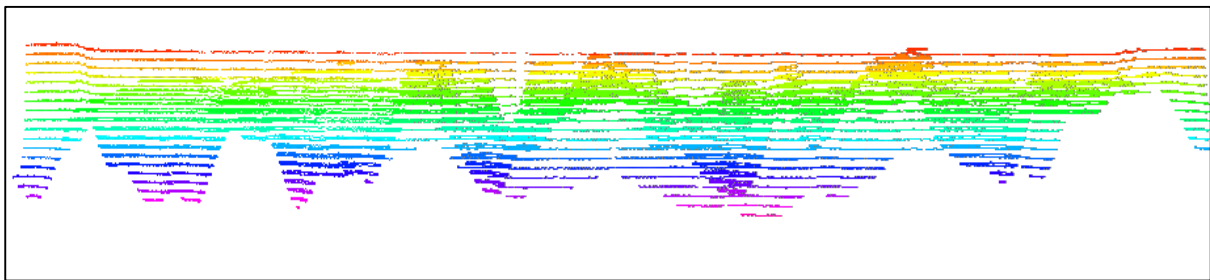
| Element Name | Observation | Location of Distress | Photo No. | Units | Distress Details | | | Area of Repair (Sq.m/R MT/m3) |
|---|---|---|---|---|---|---|---|---|
| Parapet Wall | Scaling | | 1 | | 5.70 | 0.85 | | 4.845 |

1. Scaling observed on Parapet wall, measuring 5.70 m in length and 0.85 m in width, covering an area of 4.845 m<sup>2</sup>.
