# **LIDAR Inspection Report of PUP ch.972 + 320**

**Bridge Chainage:** 972 + 320 (CKRP)

- **CKRP:** Chittorgarh to kota
- **State:** Rajasthan NH 27
- **Zone:** RJ-06

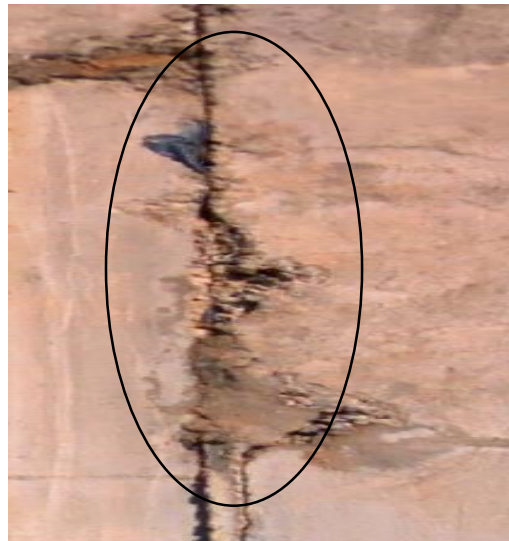
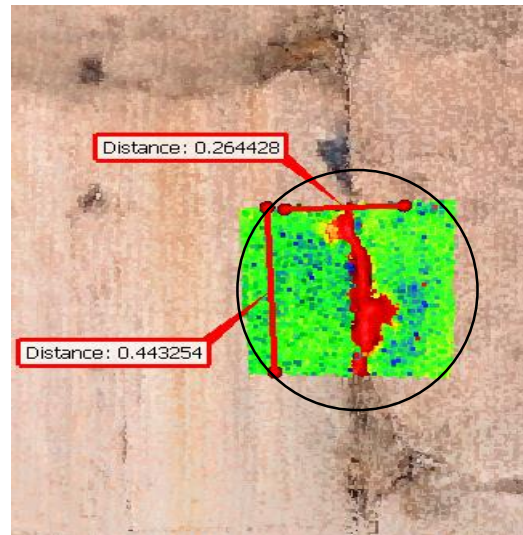
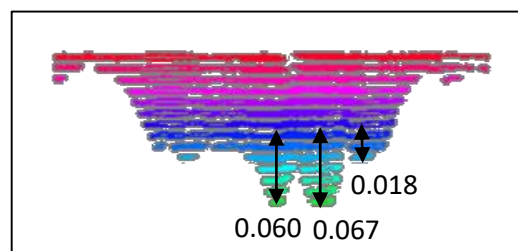
| Element Name | Observation | Location of Distress | Photo No. | Units | Distress Details | | | Area of Repair (Sq.m/ RMT/ m3) |
|---|---|---|---|---|---|---|---|---|
| Wing Wall | Damage | | 1 | M | 0.44 | 0.26 | 0.060 | 0.0068 |

1. Wing wall damage observed on LHS Abutment 2 , measuring 0.44 m in length and 0.26 m in width, Depth ranges from 0.018 m (min) to 0.067 m (max), with an average depth of 0.060 m. The calculated volume of the distress is 0.00686 m<sup>3</sup>.

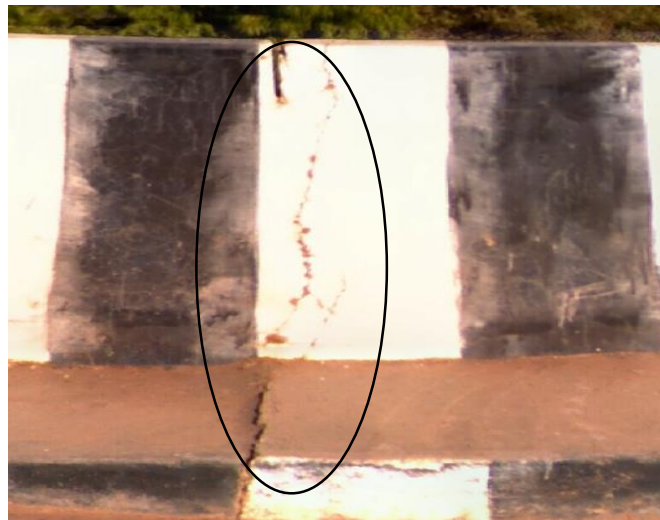
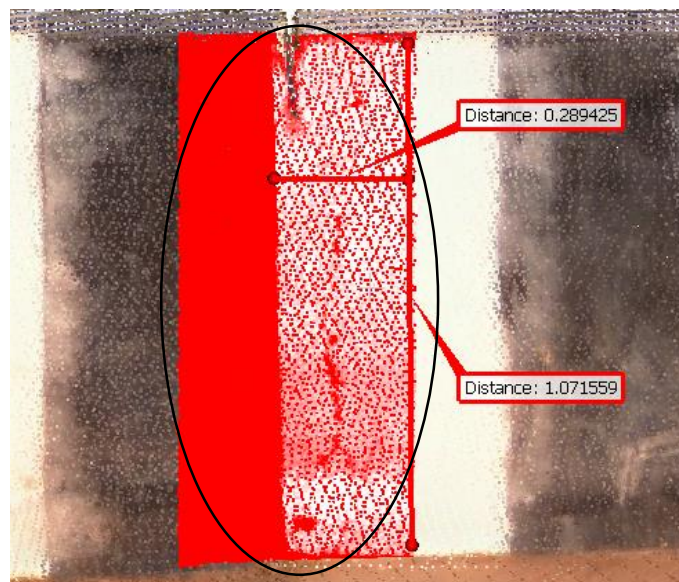
| Element Name | Observation | Location of Distress | Photo No. | Units | Distress Details | | | Area of Repair (Sq.m/ RMT/ m3) |
|---|---|---|---|---|---|---|---|---|
| Crash Barrier | Steel Exposed | | 2 | M | 1.07 | 0.28 | | 0.2996 |

2. **Steel Exposed and Crack observed on LHS Abutment 1 , measuring 1.07 m in length and 0.28 m in width, covering an area of 0.2996 m<sup>2</sup>.**
