# LIDAR Inspection Report of **Box Culvert** ch.972+580

**Bridge Chainage:** 972+580 (CKRP)

- **CKRP:** Chittorgarh to kota
- **State:** Rajasthan NH 27
- **Zone:** RJ-06

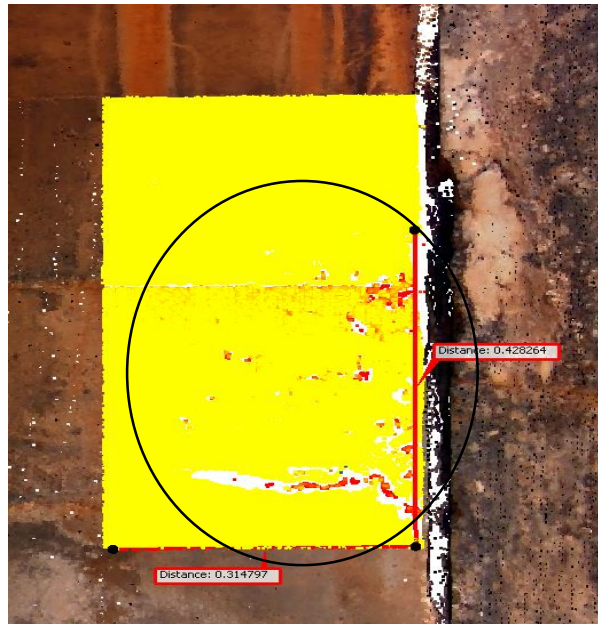
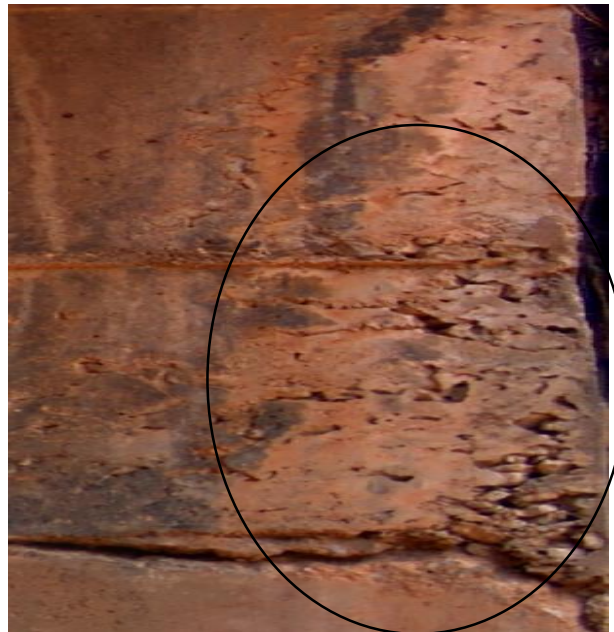
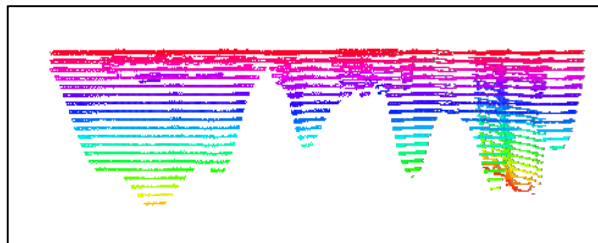
| Element Name | Observation | Location of Distress | Photo No. | Units | Distress Details | | | Area of Repair<br>(Sq.m/R<br>MT/m3) |
|---|---|---|---|---|---|---|---|---|
| Abutment | Honeycombing | - | 1 | M | 0.42 | 0.31 | - | 0.1302 |

**1.Honeycombing observed on abutment wall, measuring 0.42 m in length and 0.31 m in width, covering an area of 0.1302 m<sup>2</sup>.**

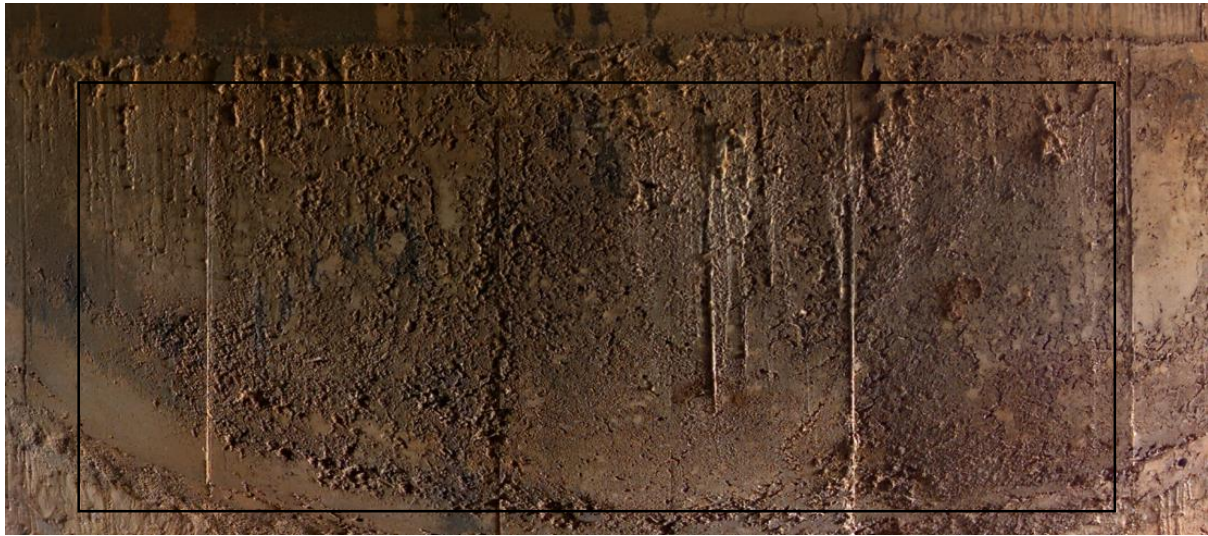
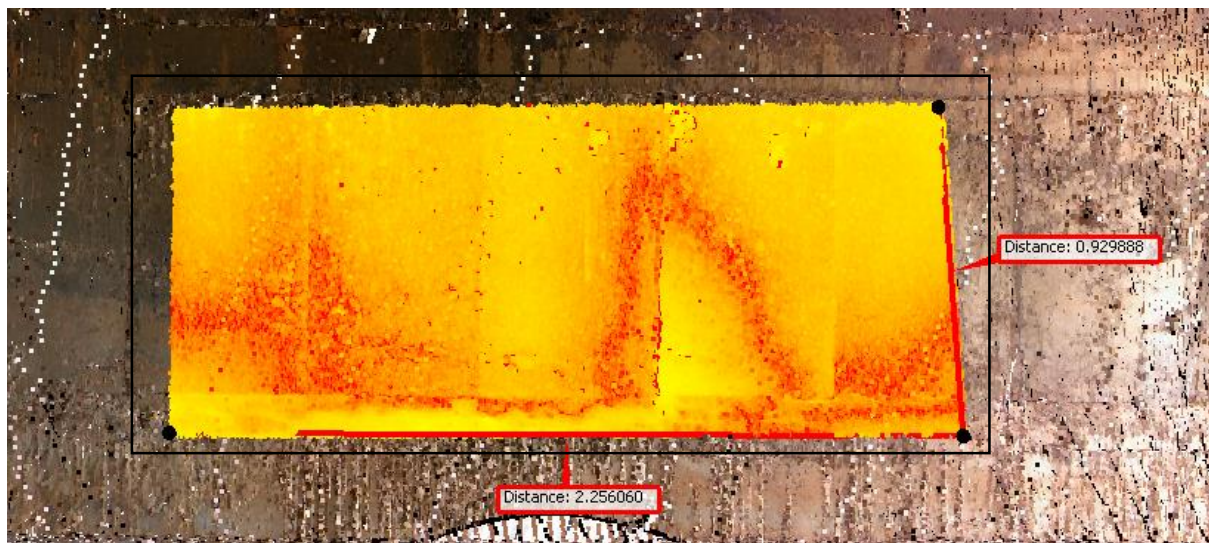
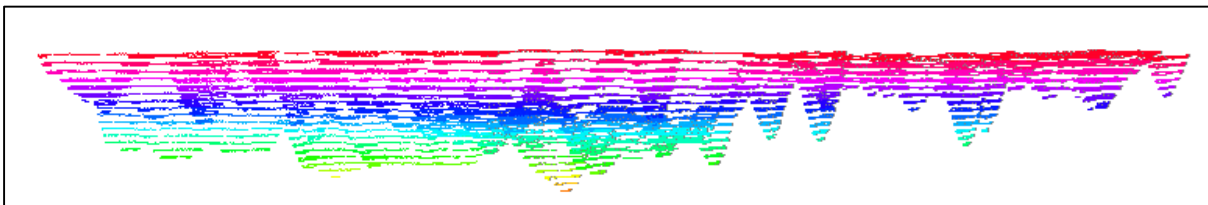
| Element Name | Observation | Location of Distress | Photo No. | Units | Distress Details | | | Area of Repair<br>(Sq.m/R<br>MT/m3) |
|---|---|---|---|---|---|---|---|---|
| Abutment | scaling | - | 2 | M | 2.25 | 0.92 | - | 2.07 |

**2. Scaling observed on abutment, measuring 2.25 m in length and 0.92 m in width, covering an area of 2.07 m<sup>2</sup>.**
