# LIDAR Inspection Report of **Box Culvert** ch.972+770

**Bridge Chainage:** 972 + 770 (CKRP)

- **CKRP:** Chittorgarh to kota
- **State:** Rajasthan NH 27
- **Zone:** RJ-06

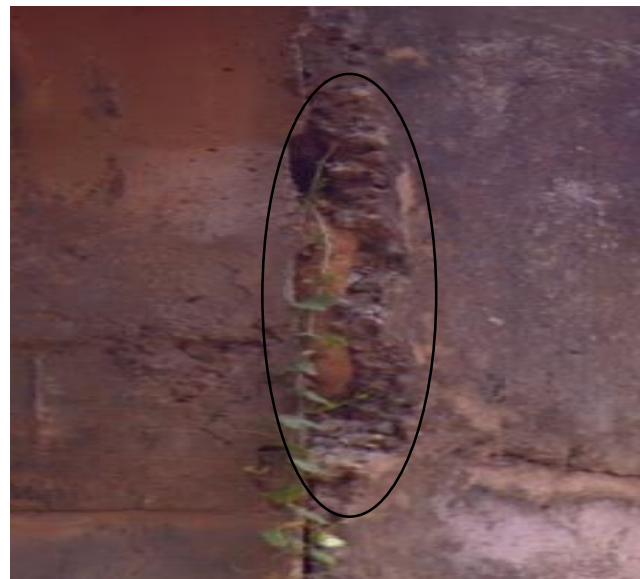
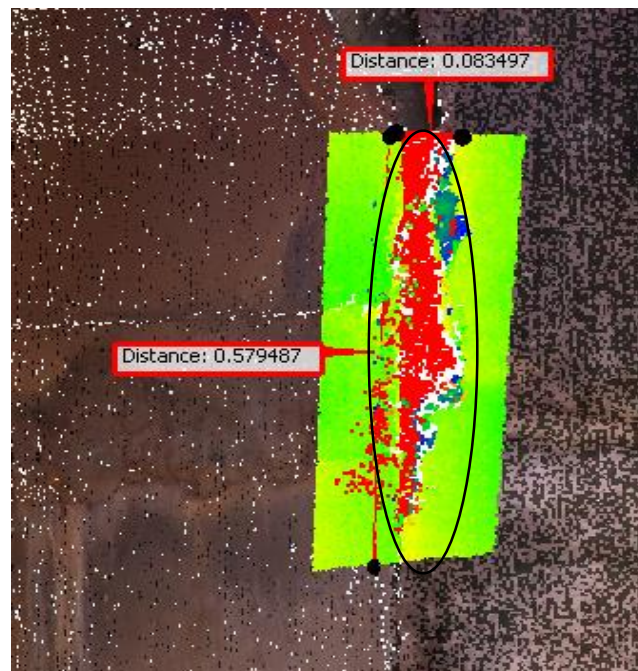
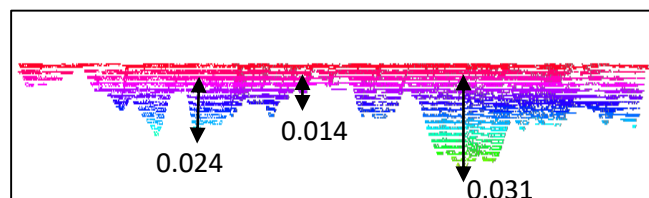
| Element Name | Observation | Location of Distress | Photo No. | Units | Distress Details | | | Area of Repair<br>(Sq.m/R<br>MT/m3) |
|---|---|---|---|---|---|---|---|---|
| Abutment corner | Damage | - | 1 | M | 0.57 | 0.08 | 0.024 | 0.0010 |

1. Damage observed on abutment corner, measuring 0.57 m in length and 0.08 m in width, Depth ranges from 0.014 m (min) to 0.031 m (max), with an average depth of 0.024 m. The calculated volume of the distress is 0.0010 m<sup>3</sup>
