# **LIDAR Inspection Report of Box Culvert ch.972+820**

**Bridge Chainage:** 972+820

- **Bridge No:** -
- **Chainage:** 972+820
- **Structure type:** Box Culvert

- **CKRP:** Chittorgarh to kota
- **State:** Rajasthan NH 27
- **Zone:** RJ-20

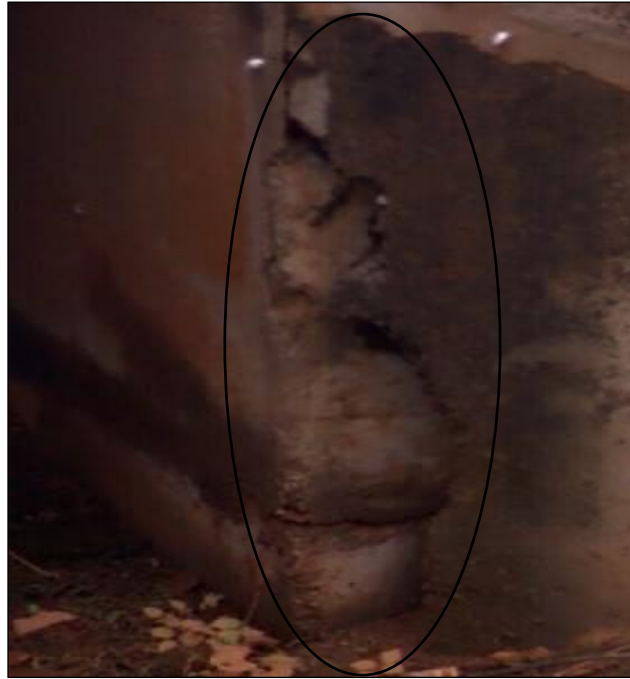
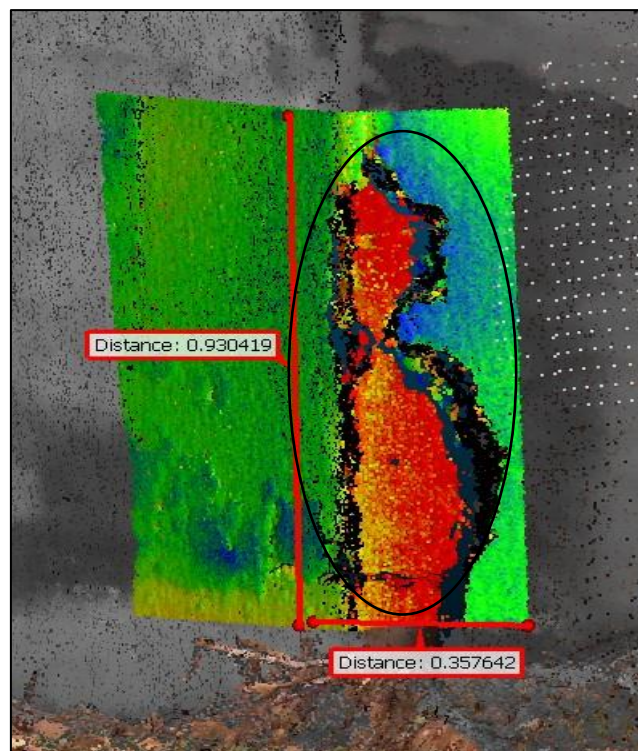
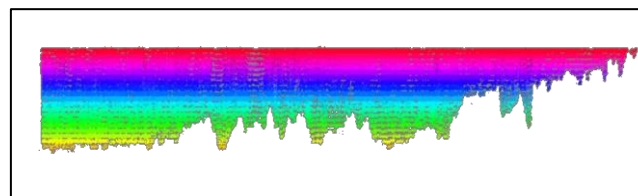
| Element Name | Observation | Location of Distress | Photo No. | Units | Distress Details | | | Area of Repair (Sq.m/R MT/m3) |
|---|---|---|---|---|---|---|---|---|
| Return Wall | Damage | - | 1 | Sq m | 0.93 | 0.35 | - | 0.32 |

**1.Damage observed on return wall, Abutment 2 RHS side, measuring 0.93 m in length and 0.35 m in width, covering an area of 0.32 m<sup>2</sup>.**
