# **LIDAR Inspection Report of Box Culvert ch.973+070**

**Bridge Chainage:** 973+070

# **CH: 973+070 BOX CULVERT**

**DISTRESS PHOTOS**

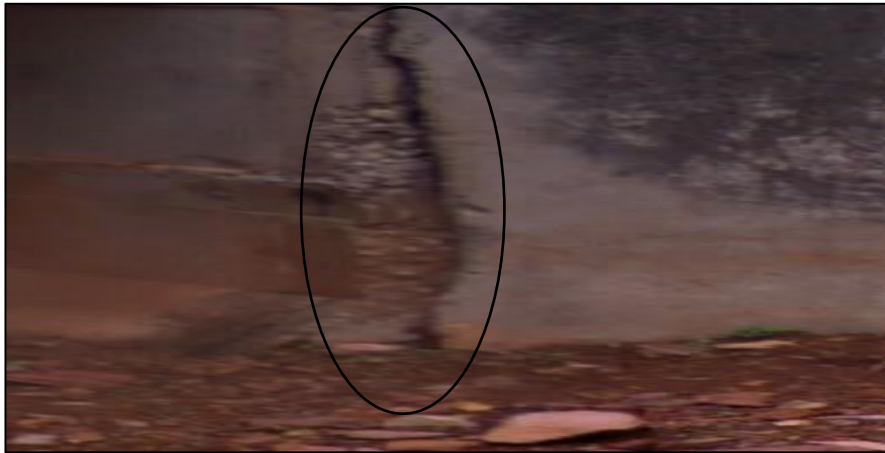
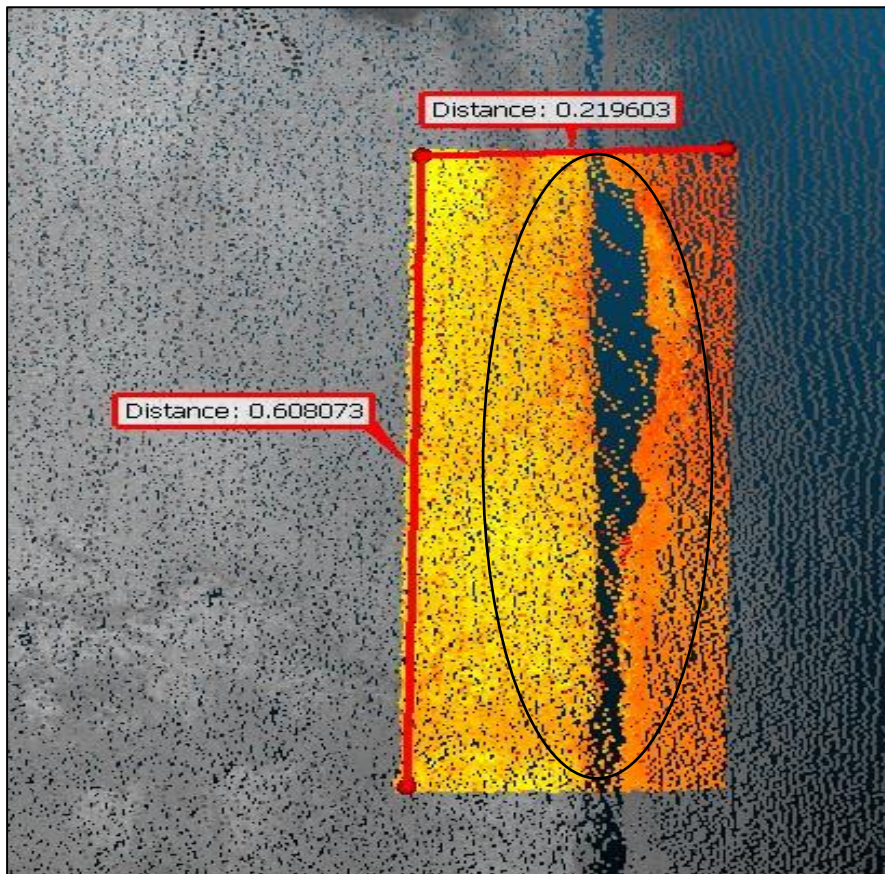
| Element Name | Observation | Location of Distress | Photo No. | Units | Distress Details | | | Area of Repair (Sq.m/R MT/m3) |
|---|---|---|---|---|---|---|---|---|
| Return Wall | Damage | - | 1 | Sq m | 0.60 | 0.21 | - | 0.126 |

**1.Return wall corner damage observed on Abutment 2 RHS side, measuring 0.60 m in length and 0.21 m in width, covering an area of 0.126 m<sup>2</sup>.**

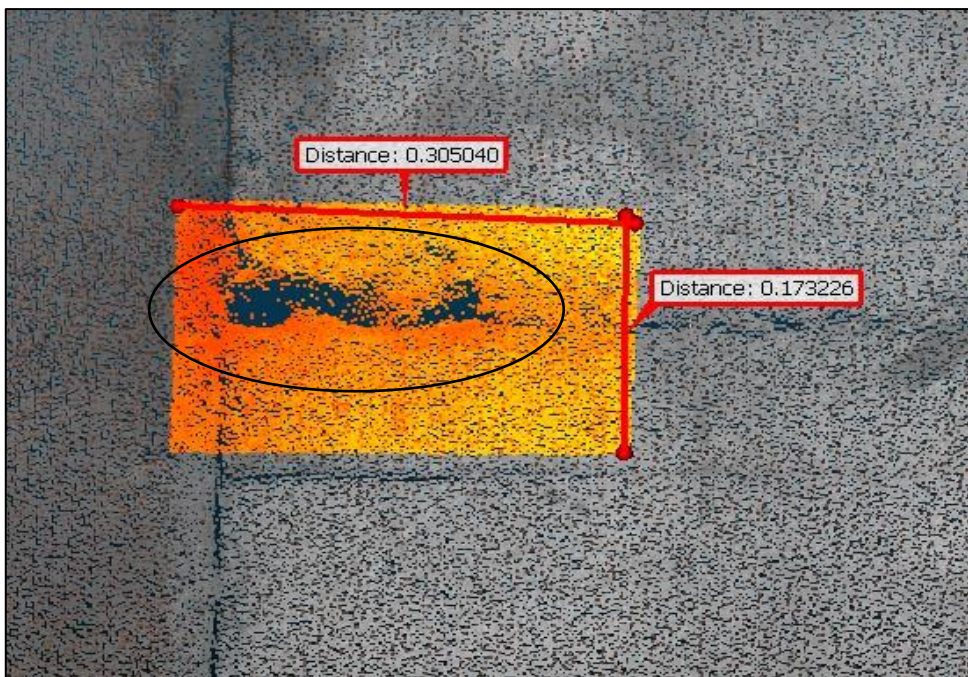
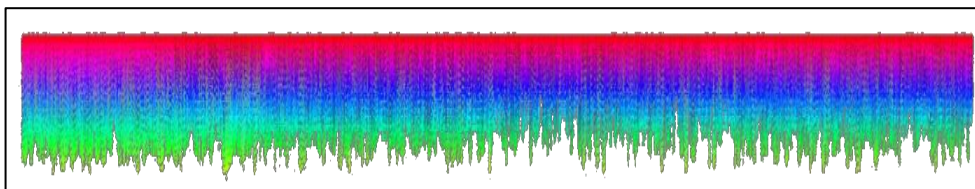
| Element Name | Observation | Location of Distress | Photo No. | Units | Distress Details | | | Area of Repair (Sq.m/R MT/m3) |
|---|---|---|---|---|---|---|---|---|
| Abutment 2 | Damage | - | 2 | Sq m | 0.30 | 0.17 | - | 0.051 |

**2.Damage observed on Abutment 2 LHS side, measuring 0.30 m in length and 0.17 m in width, covering an area of 0.051 m<sup>2</sup>.**

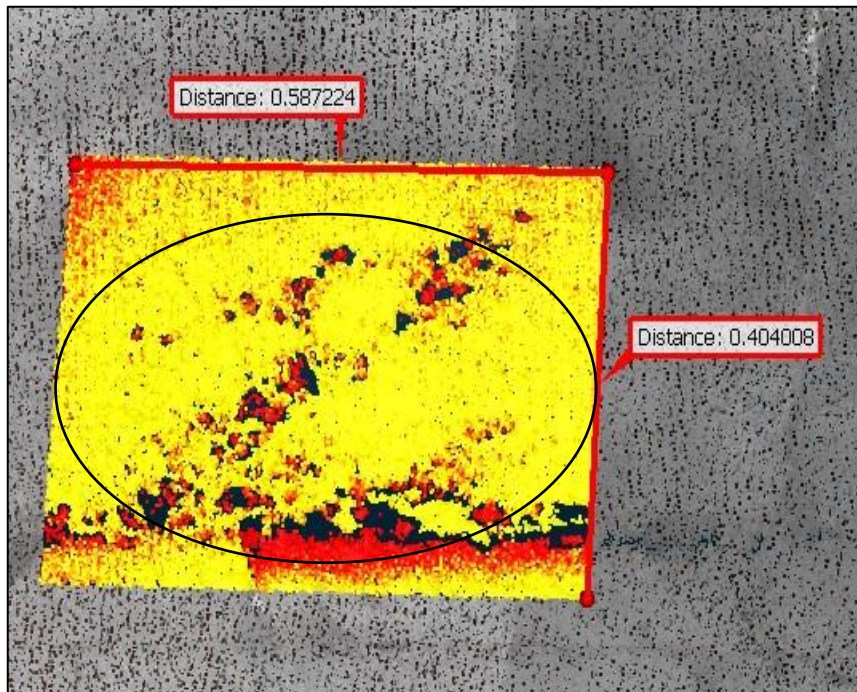
| Element Name | Observation | Location of Distress | Photo No. | Units | Distress Details | | | Area of Repair (Sq.m/R MT/m3) |
|---|---|---|---|---|---|---|---|---|
| Abutment 2 | Honeycombing | - | 3 | Sq m | 0.58 | 0.40 | - | 0.23 |

**3. Honeycombing observed on Abutment 2 LHS side, measuring 0.58 m in length and 0.40 m in width, covering an area of 0.23 m<sup>2</sup>.**

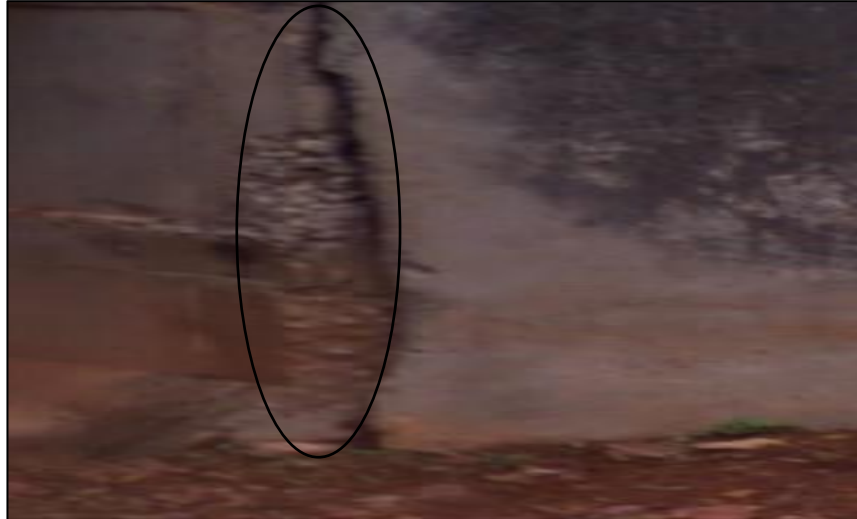
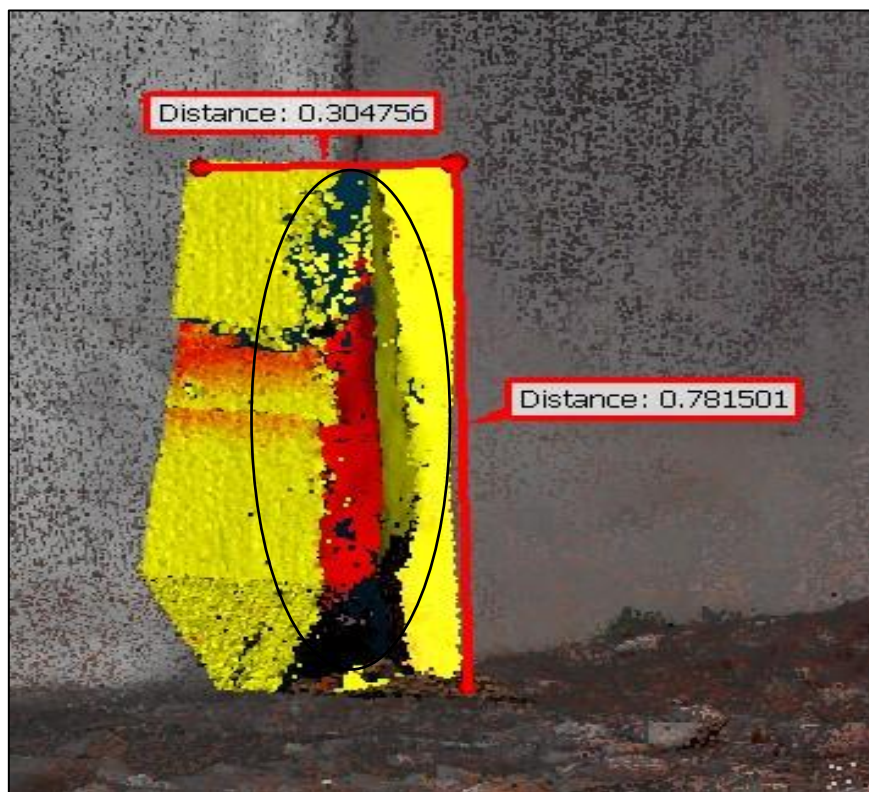
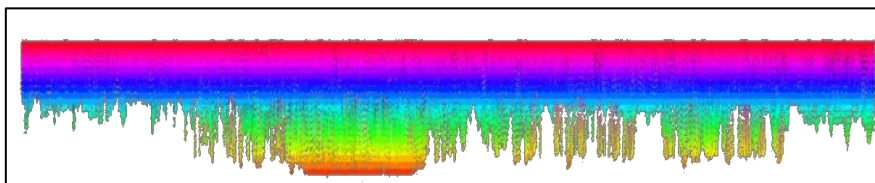
| Element Name | Observation | Location of Distress | Photo No. | Units | Distress Details | | | Area of Repair (Sq.m/R MT/m3) |
|---|---|---|---|---|---|---|---|---|
| Abutment 1 | Damage | - | 4 | Sq m | 0.78 | 0.30 | - | 0.23 |

**4.Damage observed on Abutment 1 corner LHS side, measuring 0.78 m in length and 0.30 m in width, covering an area of 0.23**
