# LIDAR Inspection Report of **Box Culvert** ch.973+600

**Bridge No:** Box Culvert

**Bridge Chainage:** 949+940 (CKRP)

- **Bridge No:** -
- **Chainage:** 973+600
- **Structure type:** Box Culvert

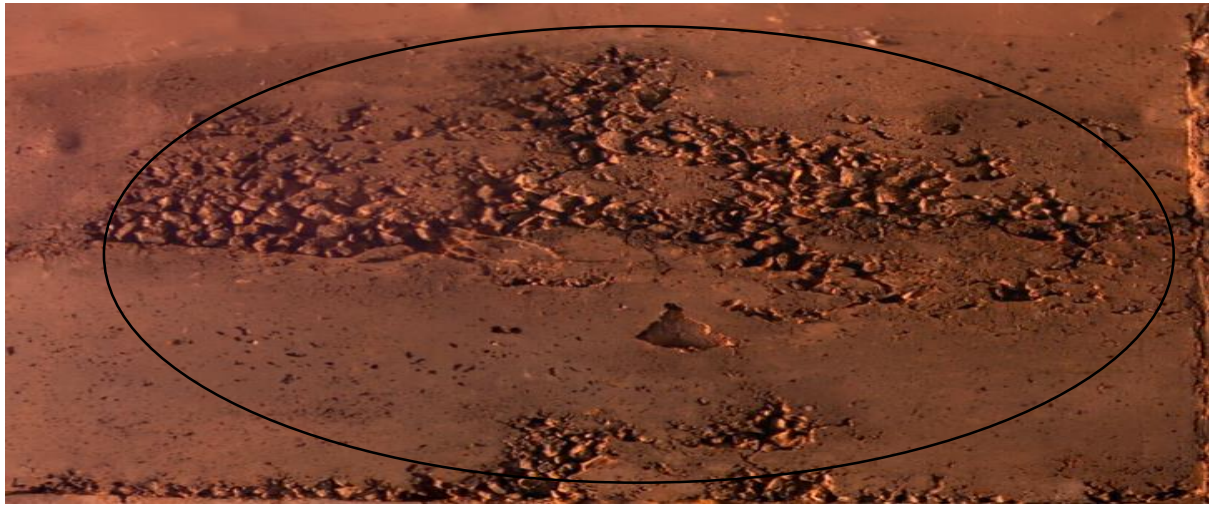
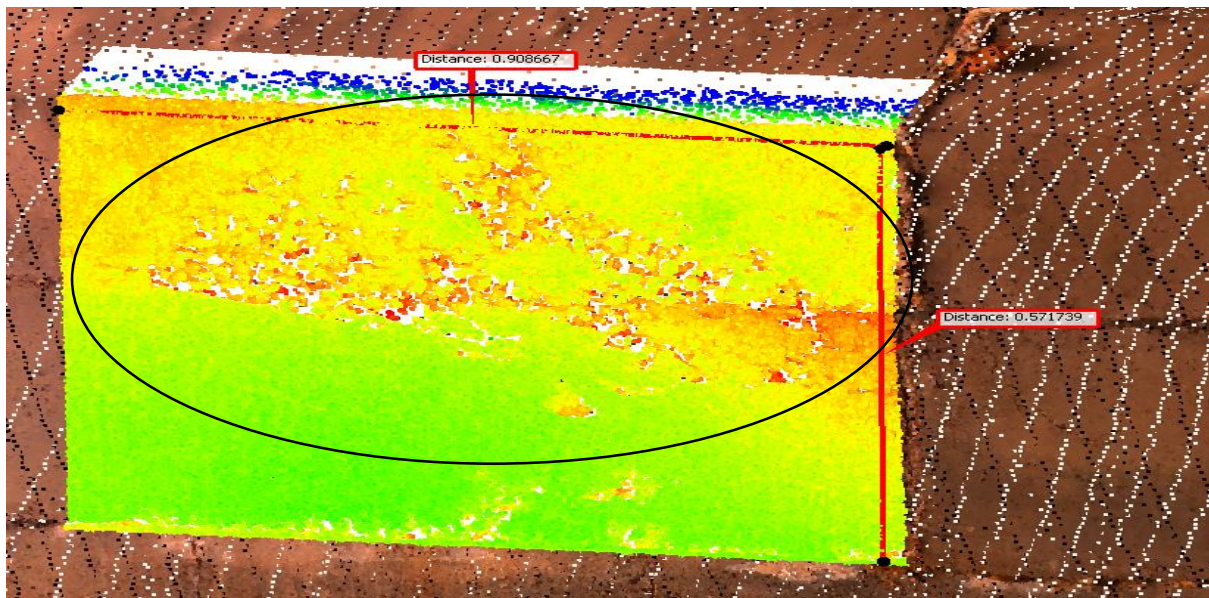
| Element Name | Observation | Location of Distress | Photo No. | Units | Distress Details | | | Area of Repair (Sq.m/R MT/m3) |
|---|---|---|---|---|---|---|---|---|
| Abutment wall | Honeycombing | - | 1 | M | 0.90 | 0.57 | - | 0.513 |

**1. Honeycombing observed on A2 1, measuring 0.90 m in length and 0.57 m in width, covering an area of 0.513 m<sup>2</sup>.**

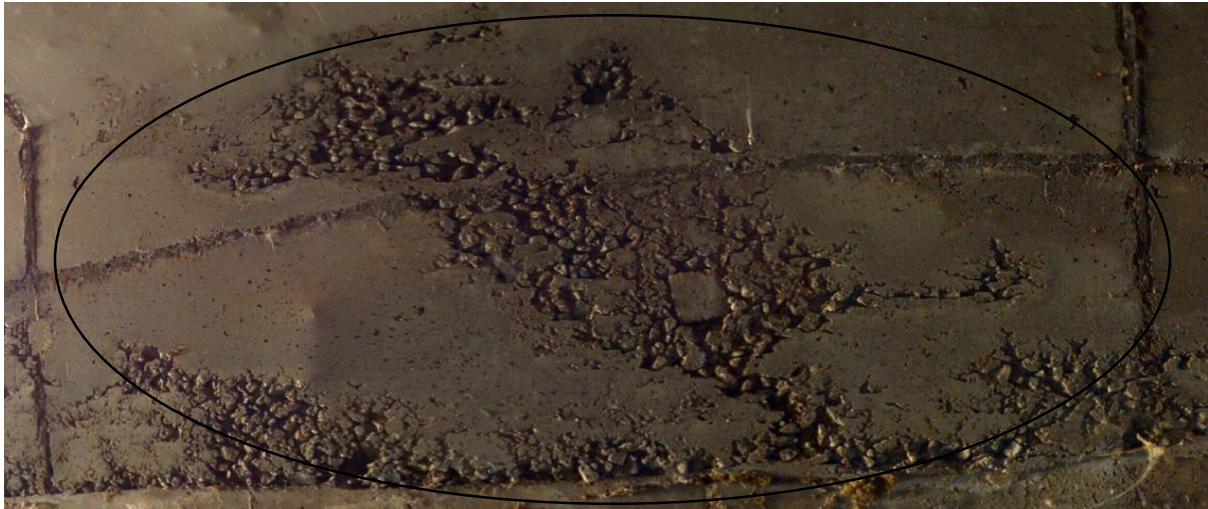
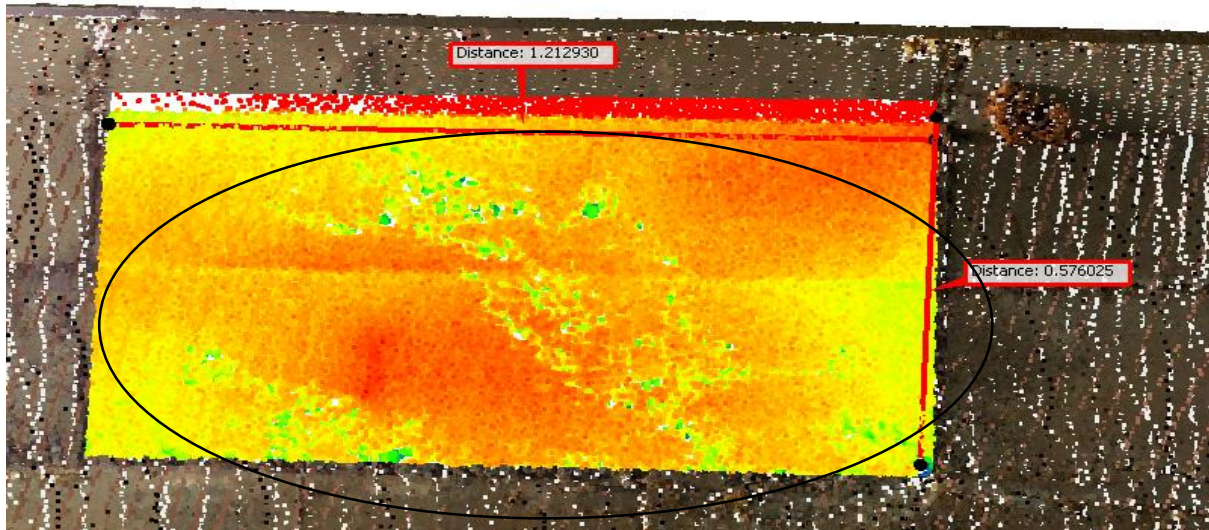
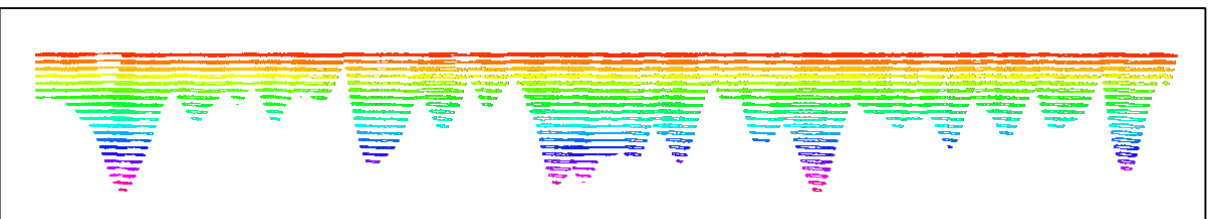
| Element Name | Observation | Location of Distress | Photo No. | Units | Distress Details | | | Area of Repair (Sq.m/R MT/m3) |
|---|---|---|---|---|---|---|---|---|
| Abutment wall | Honeycombing | - | 2 | M | 1.21 | 0.57 | - | 0.6897 |

**2. Honeycombing observed on A2 2, measuring 1.21 m in length and 0.57 m in width, covering an area of 0.6897 m<sup>2</sup>.**
