# **LIDAR Inspection Report of Box Culvert ch.974+020**

**Bridge Chainage:** Ch. 974+020

- **Bridge No:** -
- **Chainage:** Ch.974+020
- **Structure type:** Box Culvert

- **CKRP:** Chittorgarh to kota
- **State:** Rajasthan NH 27
- **Zone:** RJ-20

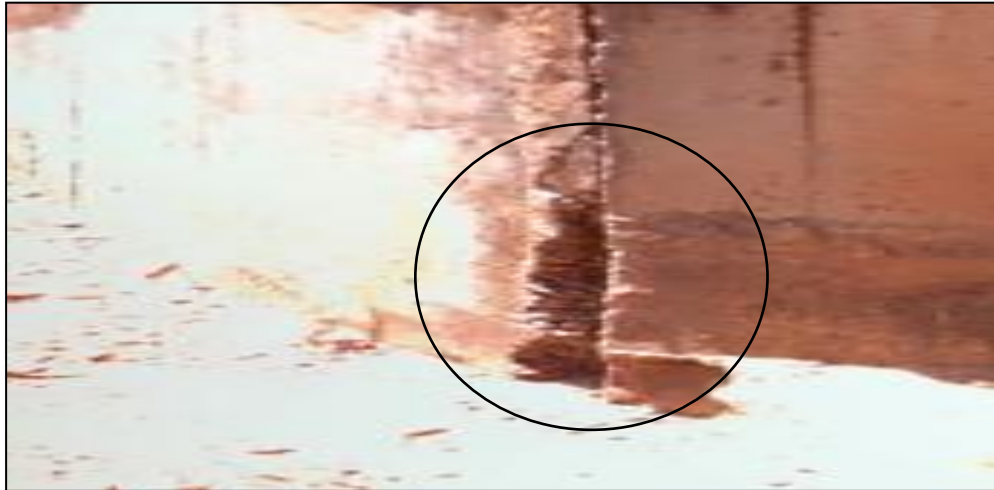
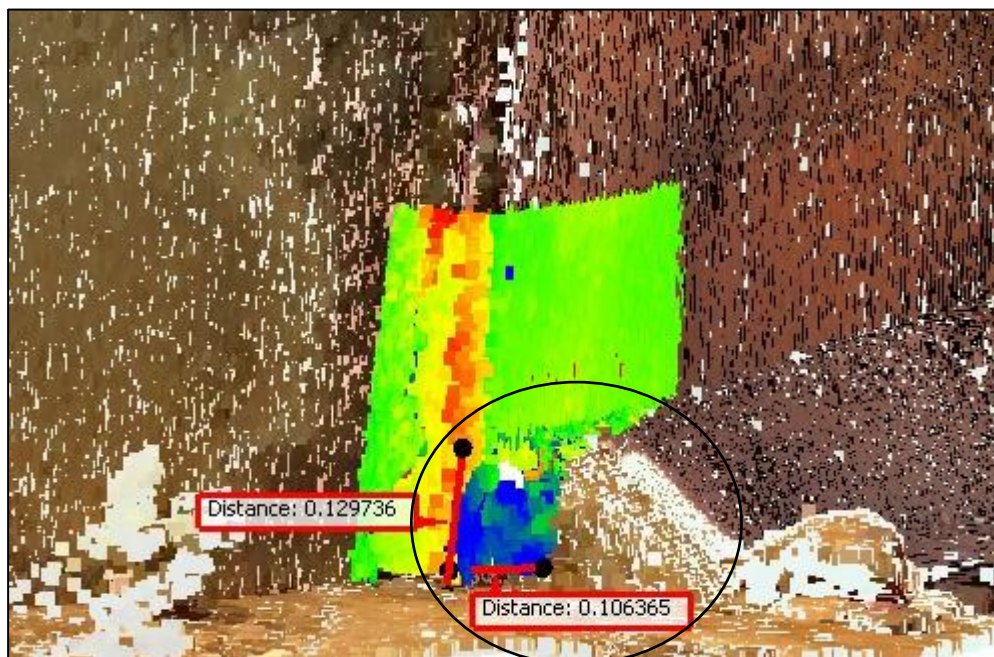
| Element Name | Observation | Location of Distress | Photo No. | Units | Distress Details | | | Area of Repair (Sq.m/R MT/m3) |
|---|---|---|---|---|---|---|---|---|
| Wing Wall | Damage | | 1 | Cu m | 0.1297 | 0.1063 | 0.017 | 0.000234 |

1. Wing Wall Damage observed on A2 (LHS), measuring 0.1297 m in length and 0.1063 m in width, covering an area of 0.000234 m<sup>2</sup>, with an average depth of 0.017 m.

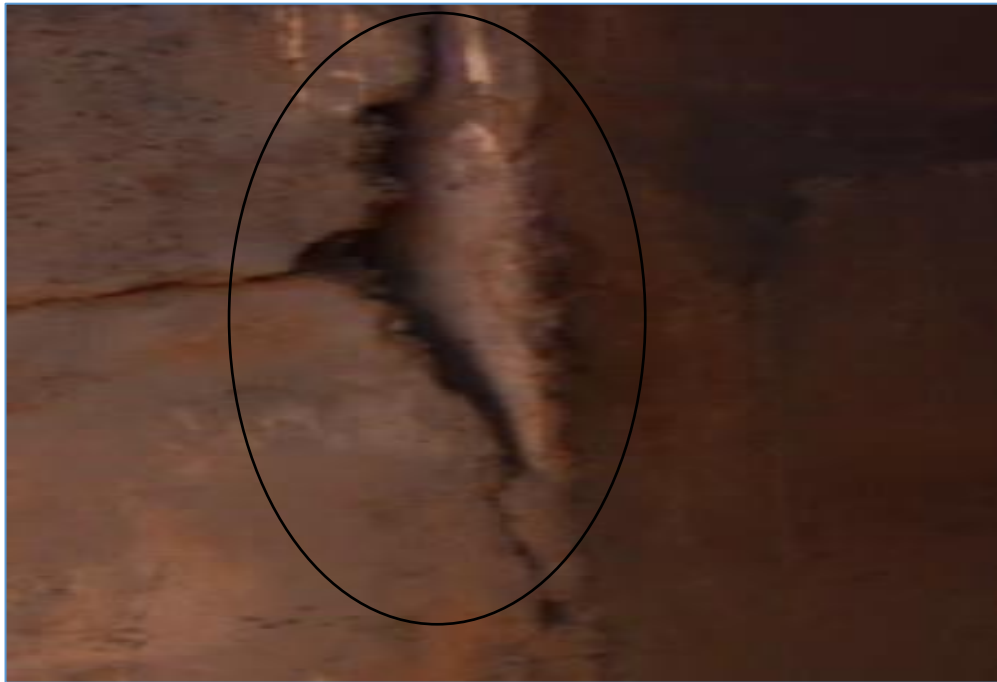
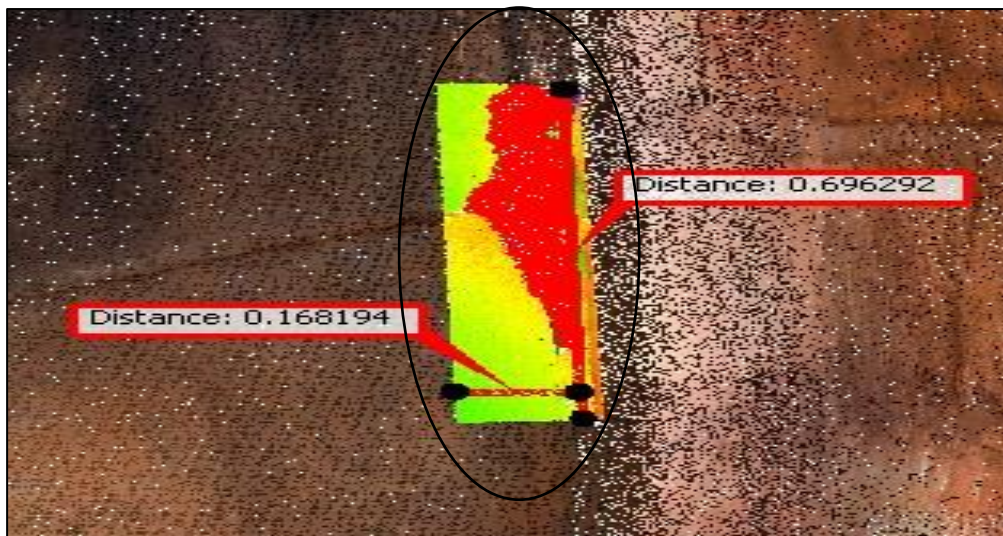
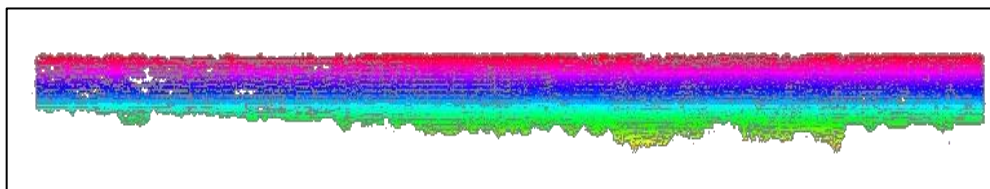
| Element Name | Observation | Location of Distress | Photo No. | Units | Distress Details | | | Area of Repair (Sq.m/RMT/ m3) |
|---|---|---|---|---|---|---|---|---|
| Wing Wall | Damage | | 2 | Sq m | 0.6962 | 0.1681 | | 0.11703 |

2. Wing Wall Damage observed on A1 (RHS), measuring 0.6962 m in length and 0.1681 m in width, covering an area of 0.11703 m<sup>2</sup>.
