# **LIDAR Inspection Report of Slab Culvert ch.974+480**

**Bridge Chainage:** 974+480 (CKRP)

- **Bridge No:** -
- **Chainage:** 974+480
- **Structure type:** Box Culvert

- **CKRP:** Chittorgarh to kota
- **State:** Rajasthan NH 27
- **Zone:** RJ-06

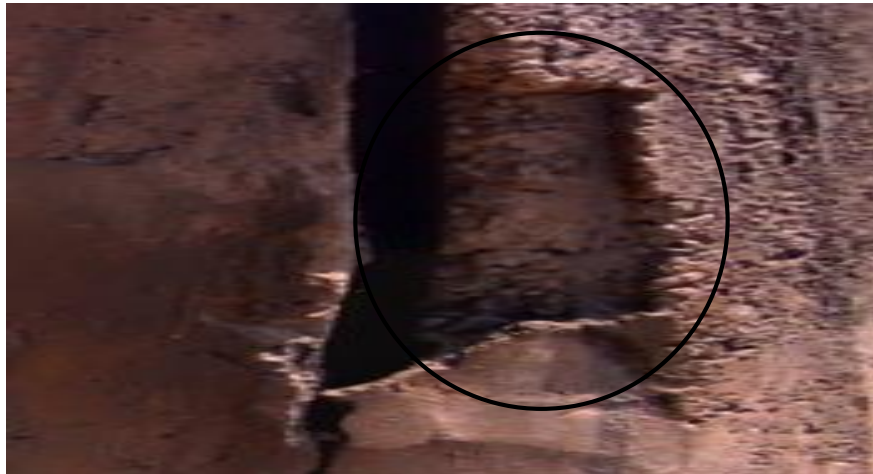
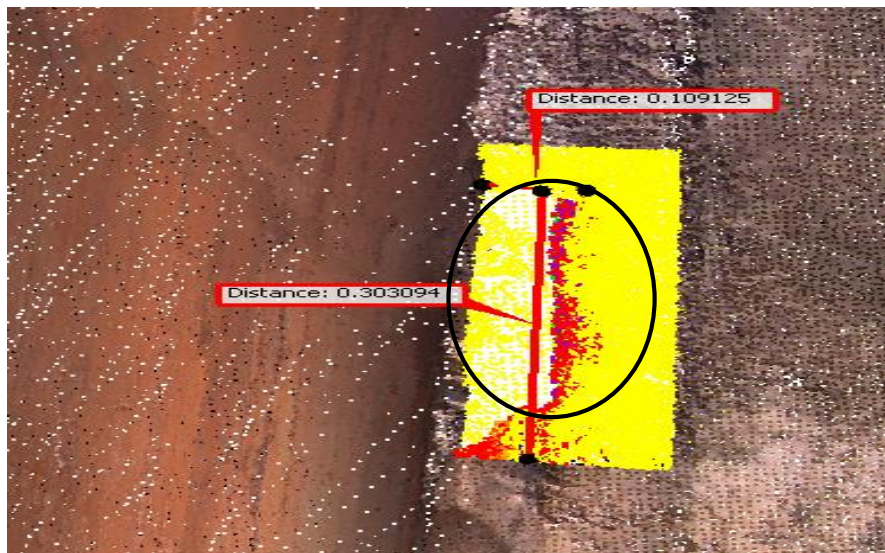
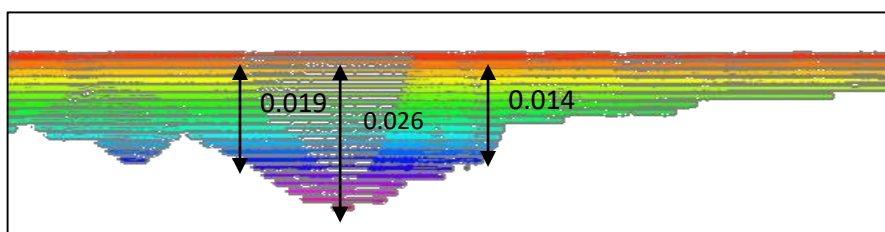
| Element Name | Observation | Location of Distress | Photo No. | Units | Distress Details | | | Area of Repair (Sq.m/ RMT/ m3) |
|---|---|---|---|---|---|---|---|---|
| Abutment 2 wing wall | Damage | | 1 | | 0.30 | 0.10 | 0.019 | 0.0005 |

**1. Damage observed on RHS A2 Wing Wall, measuring 0.30 m in length and 0.10 m in width. Depth ranges from 0.014 m (min) to 0.026 m (max), with an average depth of 0.019 m. The calculated volume of the distress is 0.0005 m<sup>3</sup>.**

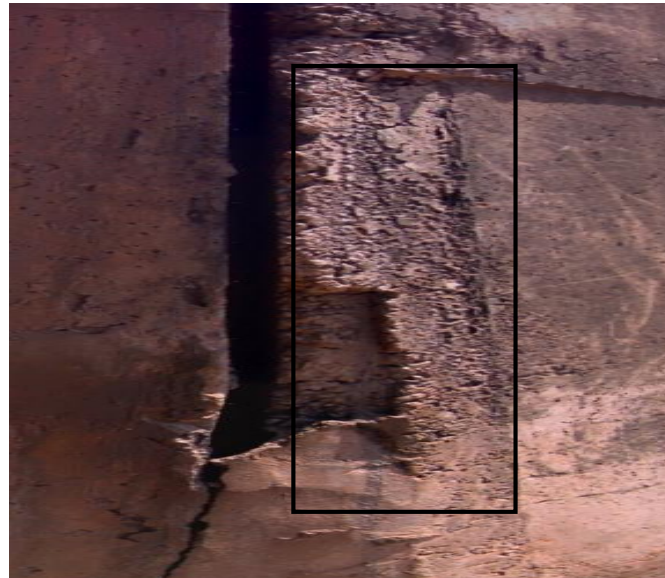
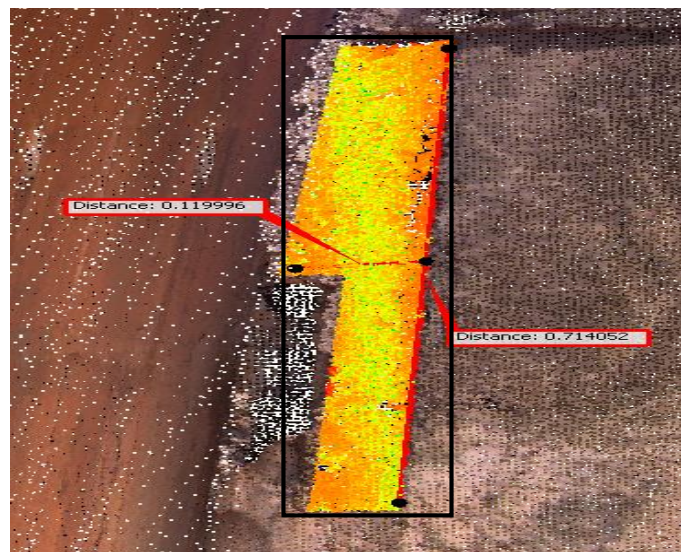
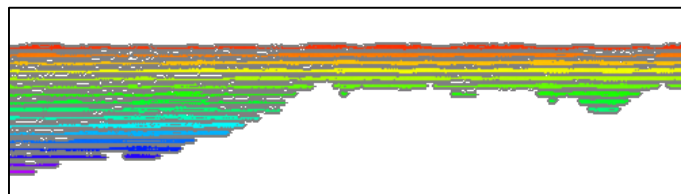
| Element Name | Observation | Location of Distress | Photo No. | Units | Distress Details | | | Area of Repair (Sq.m/ RMT/ m3) |
|---|---|---|---|---|---|---|---|---|
| Abutment 2 wing wall | Honeycombing | | 2 | | 0.71 | 0.11 | | 0.07 |

1. Honeycombing observed on RHS A2 Wing Wall, measuring 0.71 m in length and 0.11 m in width, covering an area of 0.07 m<sup>2</sup>.

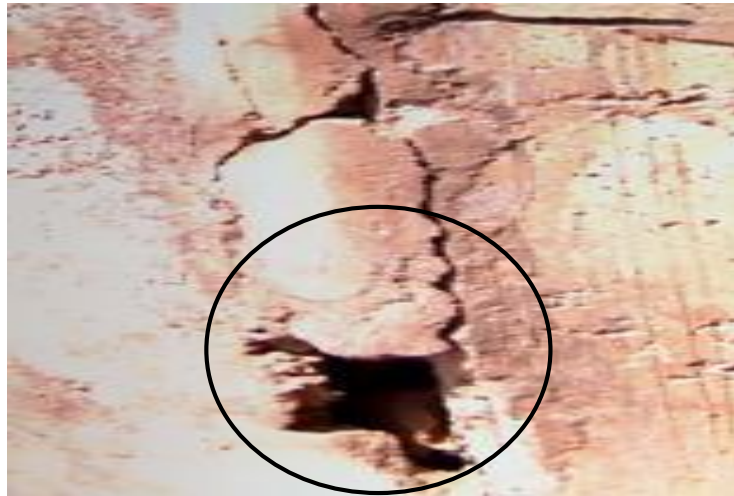
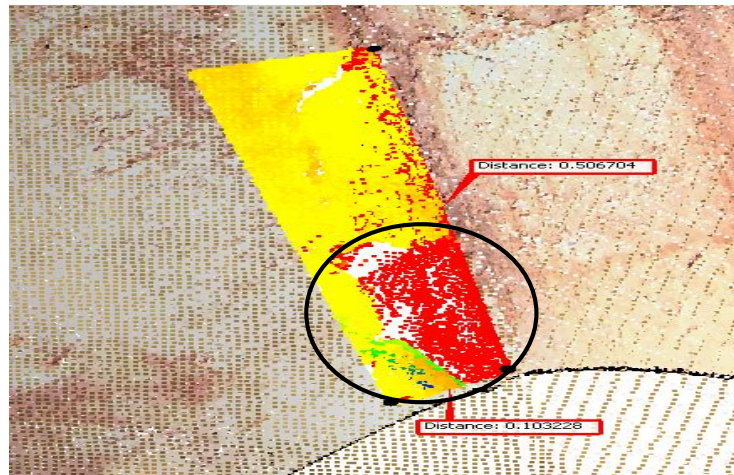
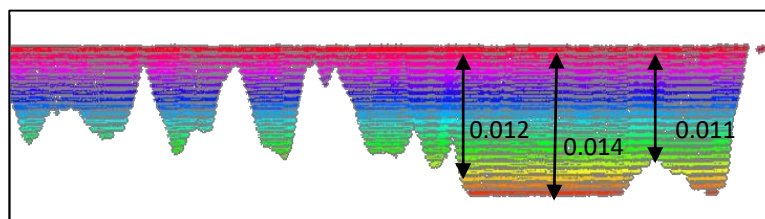
| Element Name | Observation | Location of Distress | Photo No. | Units | Distress Details | | | Area of Repair (Sq.m/ RMT/ m3) |
|---|---|---|---|---|---|---|---|---|
| Abutment 1 wing wall | Damage | | 3 | | 0.50 | 0.10 | 0.012 | 0.0006 |

**2. Damage observed on A1 Wing Wall, measuring 0.50 m in length and 0.10 m in width. Depth ranges from 0.011 m (min) to 0.014 m (max), with an average depth of 0.012 m. The calculated volume of the distress is 0.006 m<sup>3</sup>.**

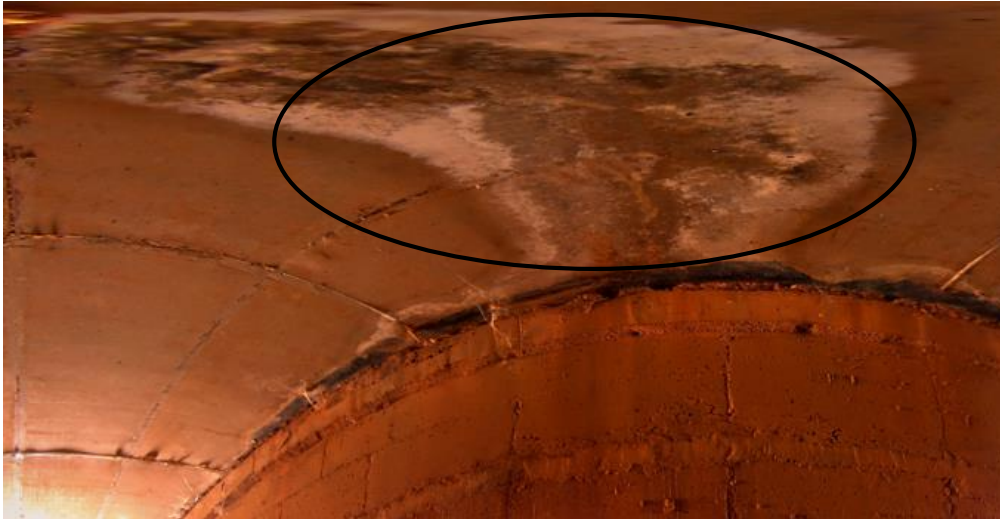
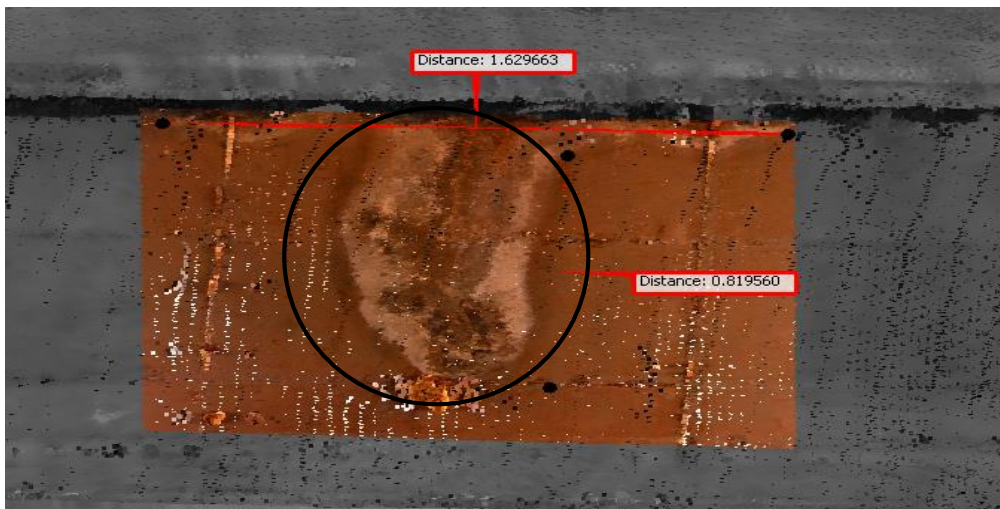
| Element Name | Observation | Location of Distress | Photo No. | Units | Distress Details | | | Area of Repair (Sq.m/ RMT/ m3) |
|---|---|---|---|---|---|---|---|---|
| Slab Bottom | Efflorescence | | 4 | | 1.63 | 0.81 | | 1.32 |

- 2. Efflorescence observed on Slab Bottom, measuring 1.63 m in length and 0.81 m in width, covering an area of 1.32 m<sup>2</sup>**
