# **LIDAR Inspection Report of Slab Culvert ch.974+625**

**Bridge Chainage:** 974+625

- **Bridge No:** -
- **Chainage:** 974+625
- **Structure type:** Slab Culvert

- **CKRP:** Chittorgarh to kota
- **State:** Rajasthan NH 27
- **Zone:** RJ-20

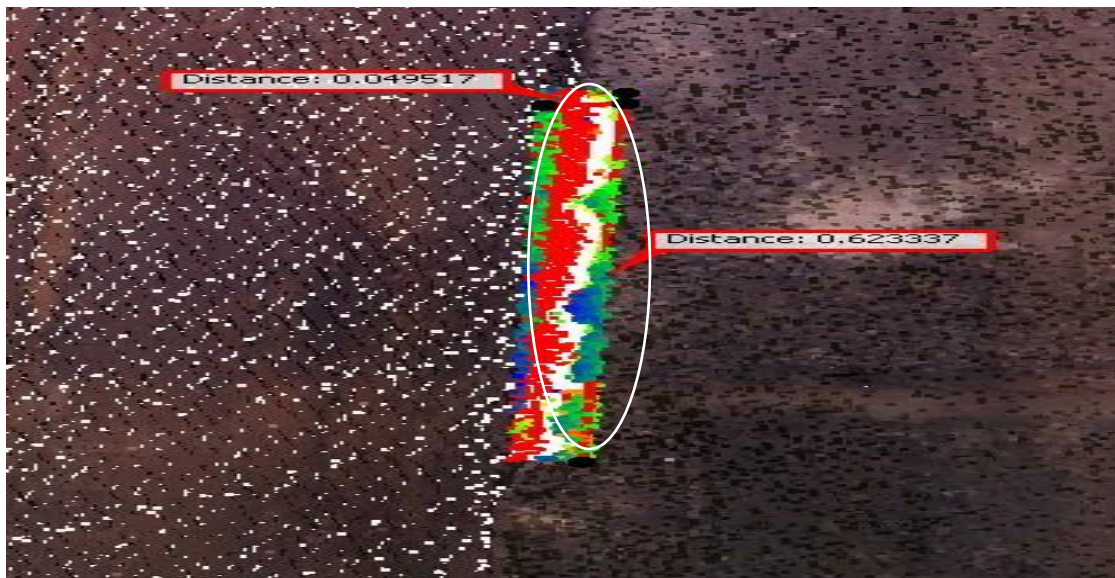
| Element Name | Observation | Location of Distress | Photo No. | Units | Distress Details | | | Area of Repair (Sq.m/R MT/m3) |
|---|---|---|---|---|---|---|---|---|
| Wing Wall | Damage | - | 1 | Sq m | 0.6233 | 0.0495 | | 0.0308 |

- 1. Wing Wall Damage-1 observed on A1 (RHS), measuring 0.6233 m in length and 0.0495 m in width, covering an area of 0.0308 m<sup>2</sup>.**

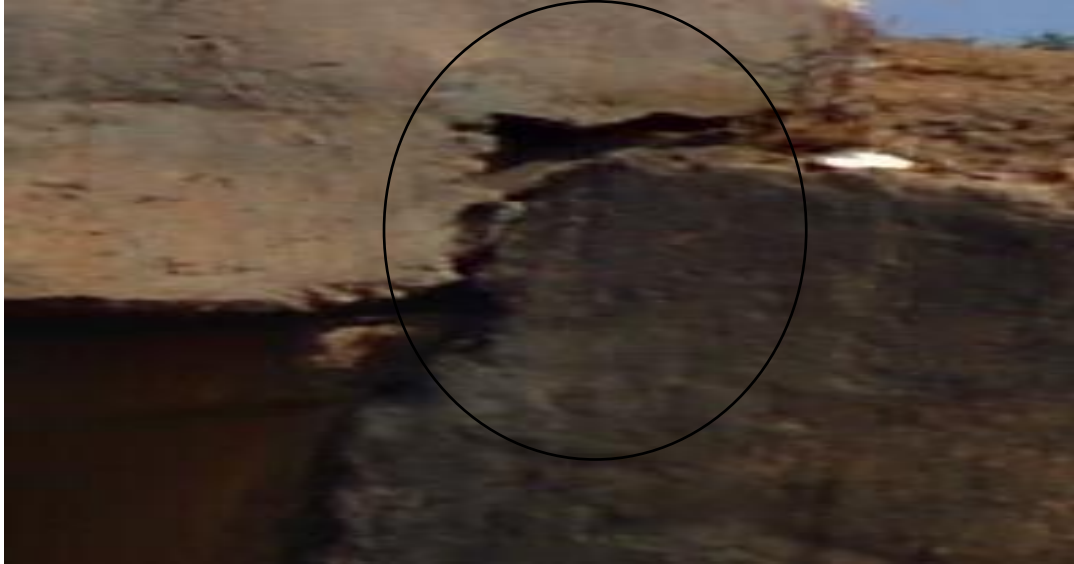
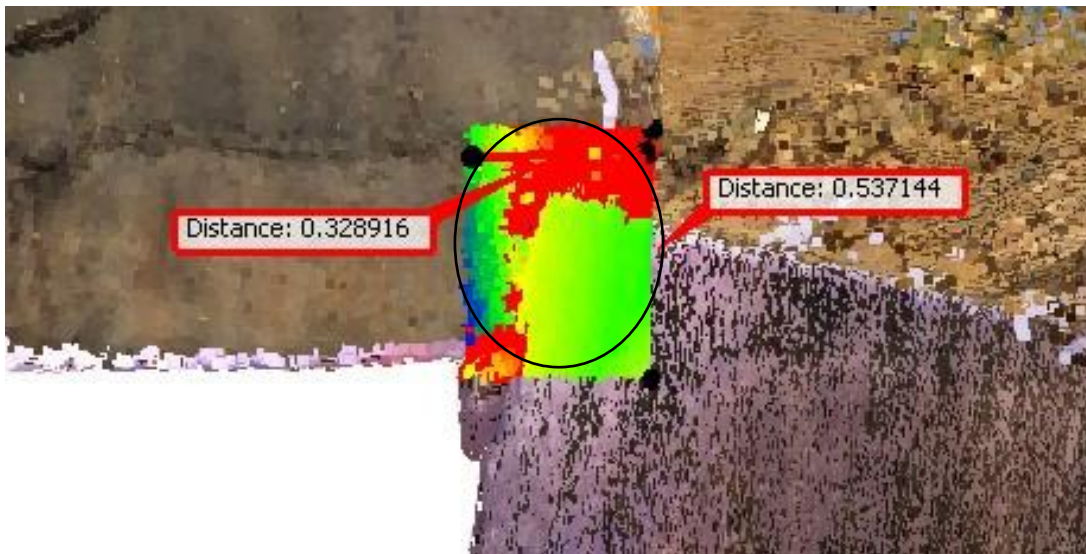
| Element Name | Observation | Location of Distress | Photo No. | Units | Distress Details | | | Area of Repair (Sq.m/R MT/m3) |
|---|---|---|---|---|---|---|---|---|
| Wing Wall | Damage | - | 2 | Sq m | 0.5371 | 0.3289 | | 0.1766 |

**2. Wing Wall Damage-2 observed on A1 (RHS), measuring 0.5371 m in length and 0.3289 m in width, covering an area of 0.1766 m<sup>2</sup>.**
