# **LIDAR Inspection Report of MNB ch.974+880**

**Bridge No:** MNB – 974/5

**Bridge Chainage:** 974+880 (CKRP)

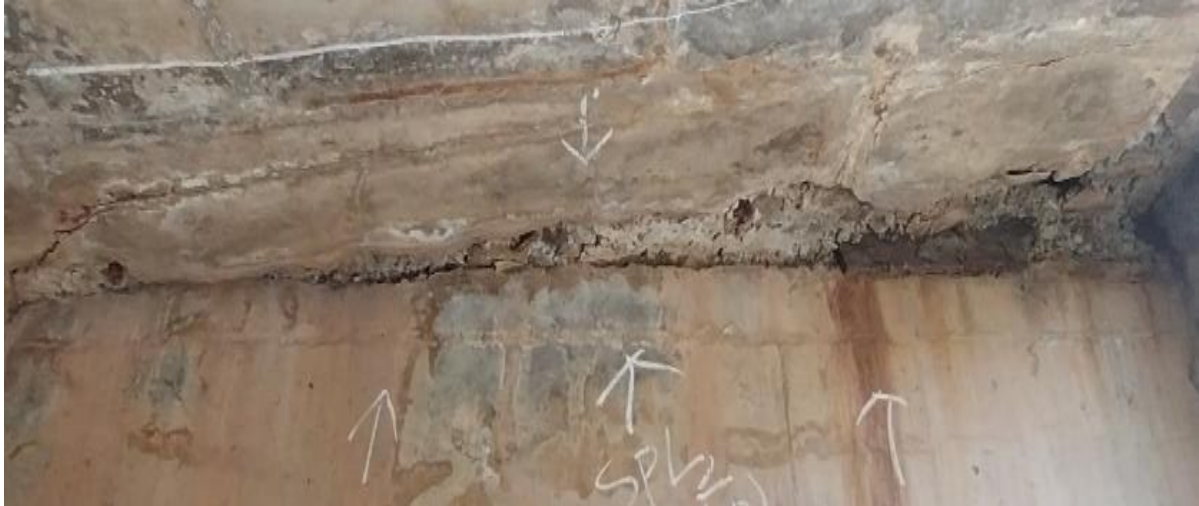
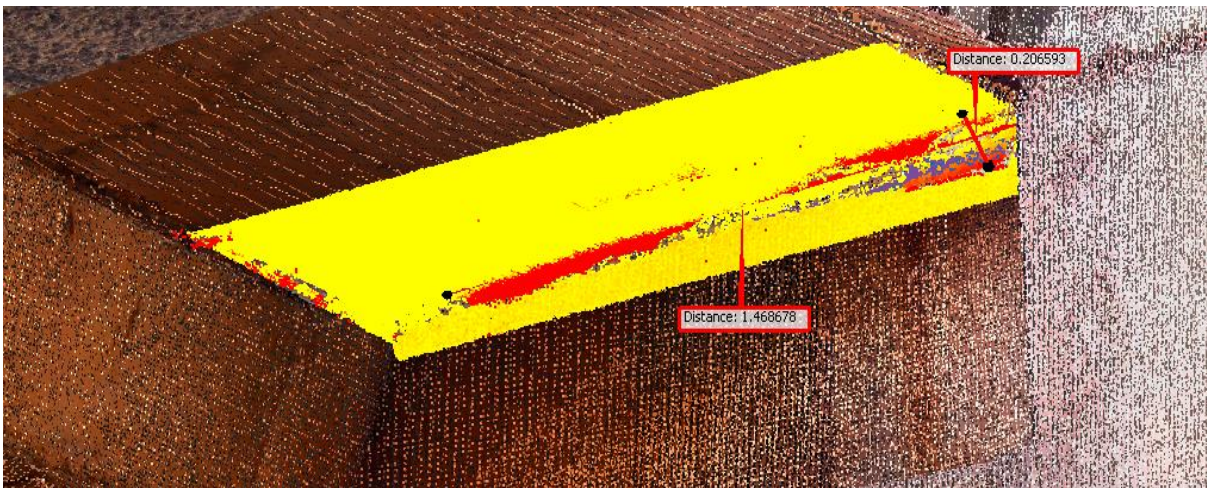
| Element Name | Observation | Location of Distress | Photo No. | Units | Distress Details | | | Area of Repair (Sq.m/R MT/m3) |
|---|---|---|---|---|---|---|---|---|
| Abutment 2 | Scaling | - | 1 | M | 1.46 | 0.20 | 0.037 | 0.010 |

**1. Damage observed on the Left Hand Side (LHS), measuring 1.46 m in length and 0.20 m in width. Depth ranges from 0.028 m (min) to 0.042 m (max), with an average depth of 0.037 m. The calculated volume of the distress is 0.010 m<sup>3</sup>.**

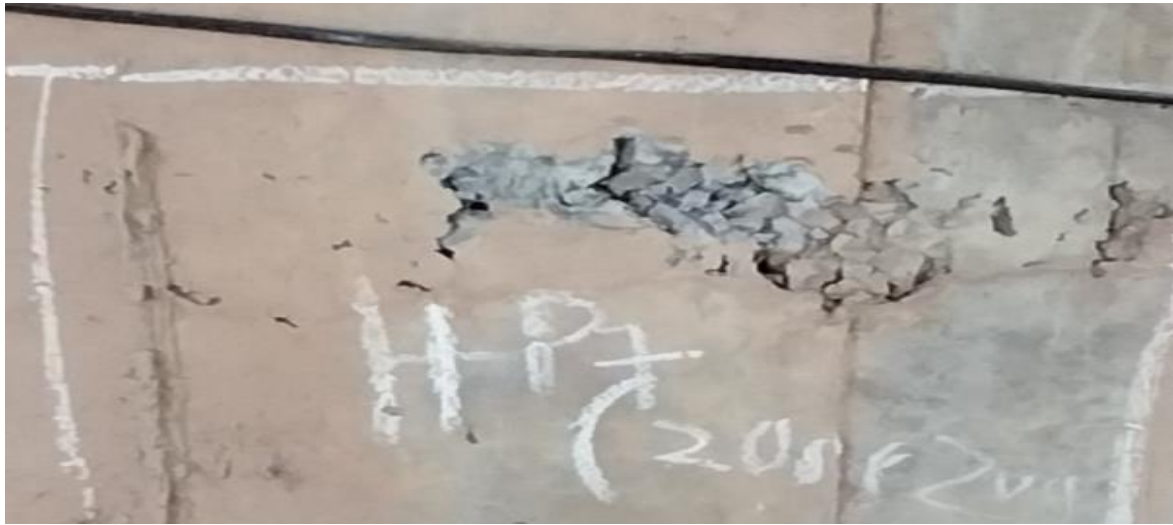
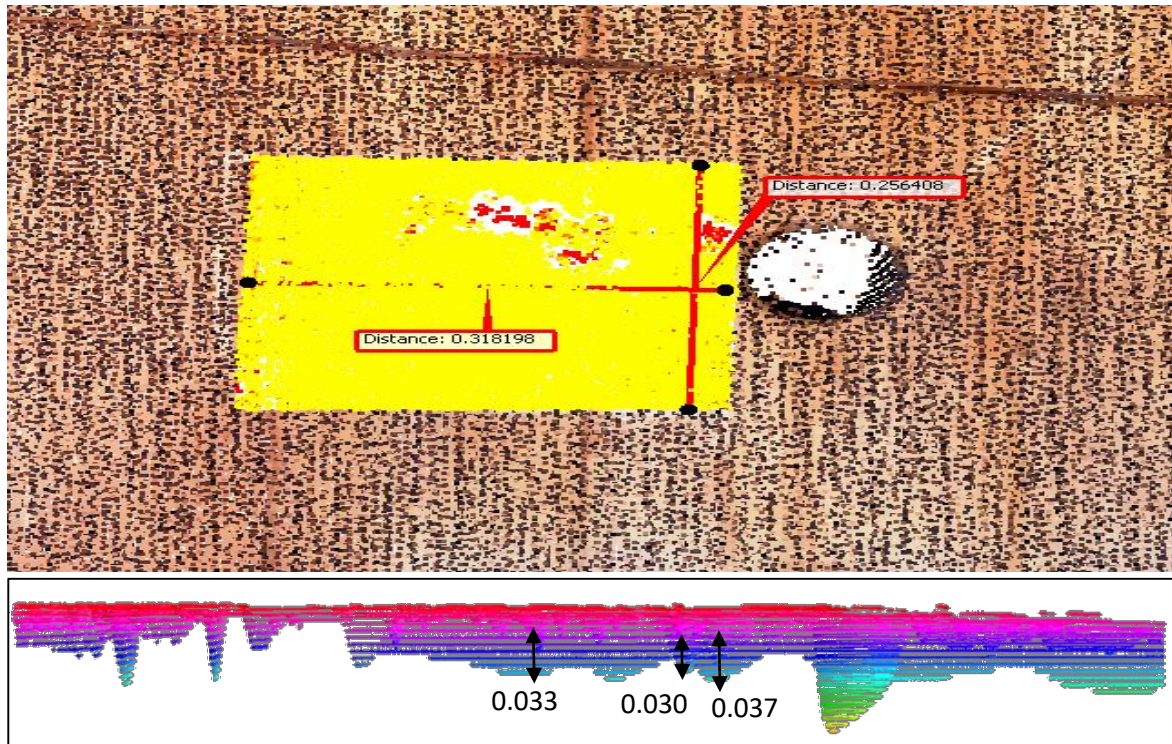
| Element Name | Observation | Location of Distress | Photo No. | Units | Distress Details | | | Area of Repair (Sq.m/R MT/m3) |
|---|---|---|---|---|---|---|---|---|
| Abutment 1 | Hollow Pocket | | 2 | M | 0.32 | 0.25 | 0.033 | 0.002 |

**2. Hollow pocket observed on the Left Hand Side (LHS) of A1 at HP 7, measuring 0.32 m in length and 0.25 m in width. Depth ranges from 0.030 m (min) to 0.037 m (max), with an average depth of 0.033 m. The calculated volume of the distress is 0.026 m<sup>3</sup>.**

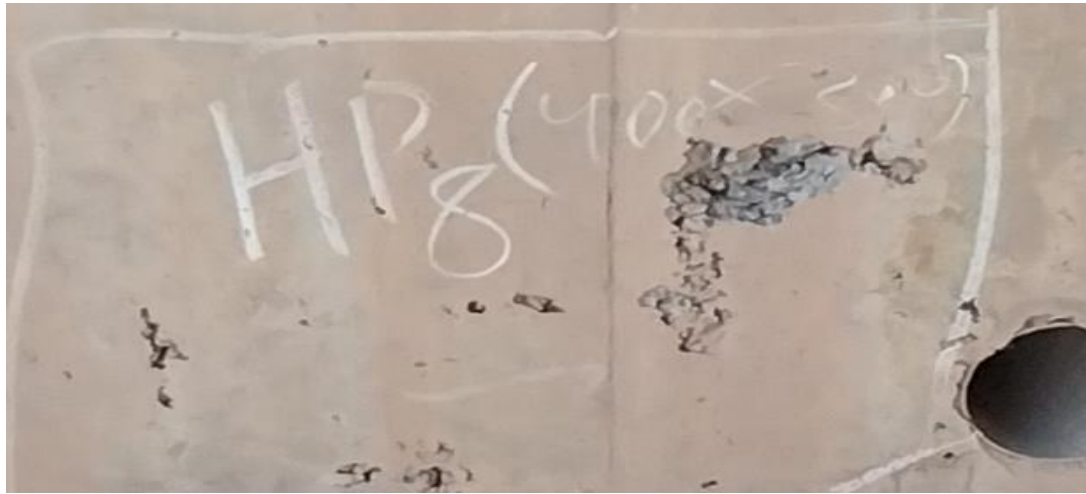
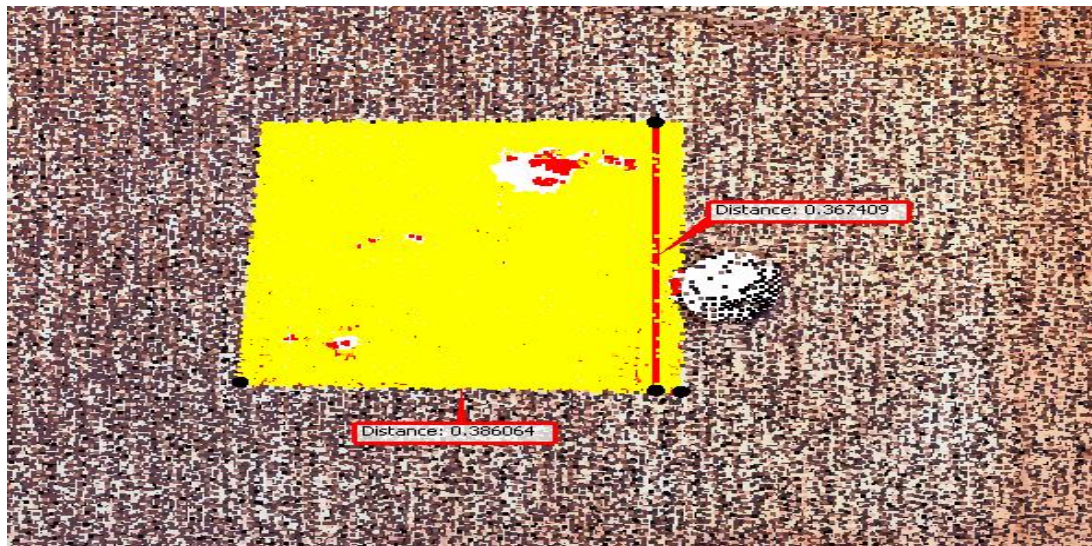
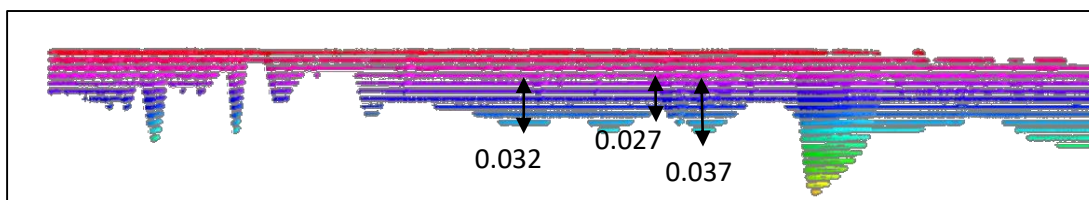
| Element Name | Observation | Location of Distress | Photo No. | Units | Distress Details | | | Area of Repair (Sq.m/R MT/m3) |
|---|---|---|---|---|---|---|---|---|
| Abutment 1 | Hollow Pocket | | 3 | M | 0.38 | 0.36 | 0.032 | 0.004 |

**3. Hollow pocket observed on the Left Hand Side (LHS) of A1 at HP, measuring 0.38 m in length and 0.36 m in width. Depth ranges from 0.027 m (min) to 0.037 m (max), with an average depth of 0.032 m. The calculated volume of the distress is 0.0043 m<sup>3</sup>.**

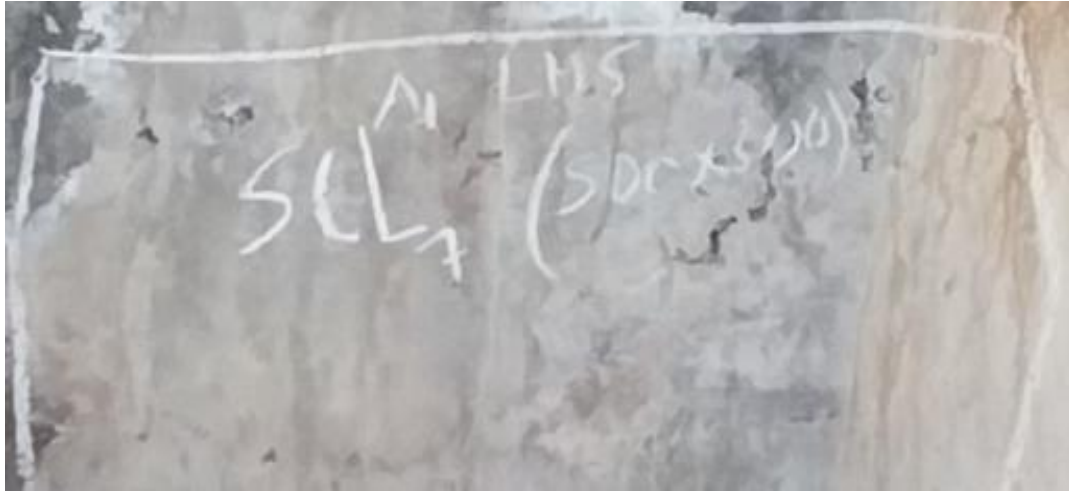
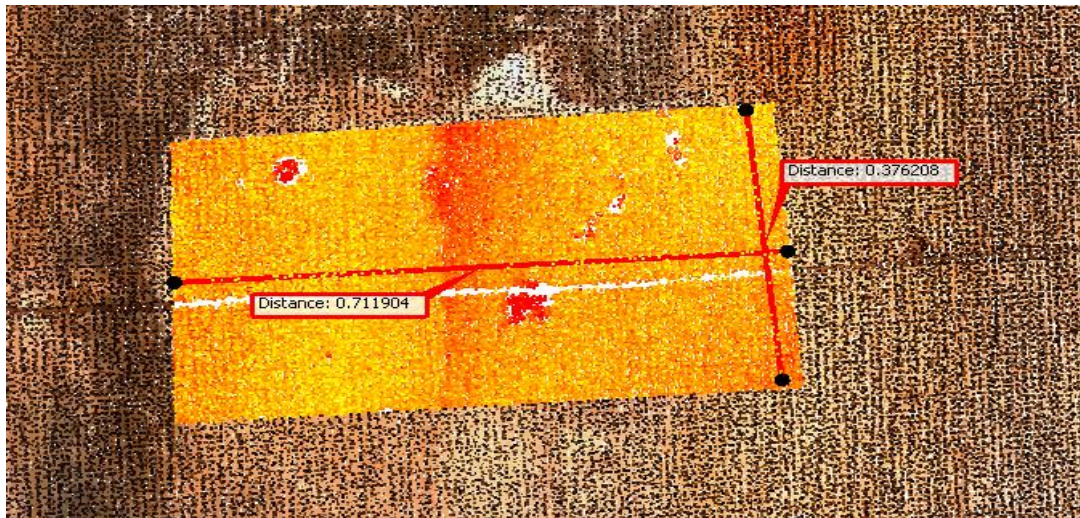
| Element Name | Observation | Location of Distress | Photo No. | Units | Distress Details | | | Area of Repair (Sq.m/R MT/m3) |
|---|---|---|---|---|---|---|---|---|
| Abutment 1 | Scaling | | 4 | M | 0.71 | 0.37 | | 0.262 |

**4. Scaling observed on LHS A1 SCL 7, measuring 0.71 m in length and 0.37 m in width, covering an area of 0.2627 m<sup>2</sup>.**

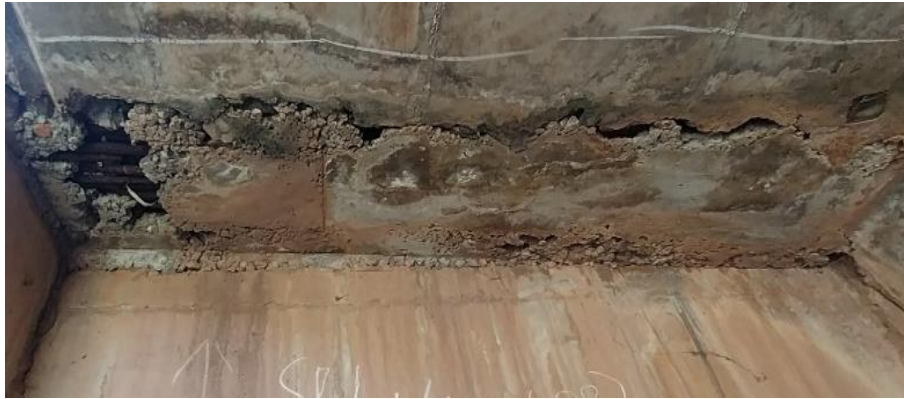
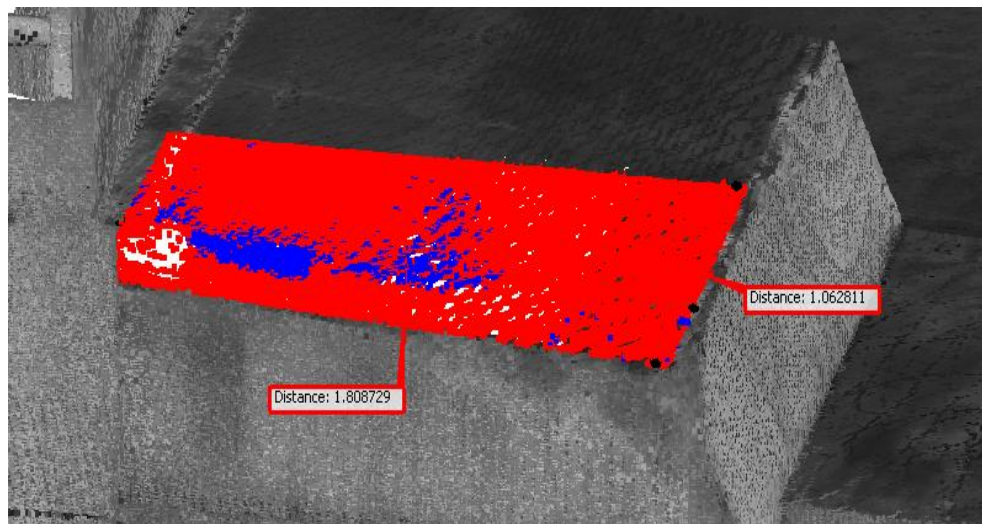
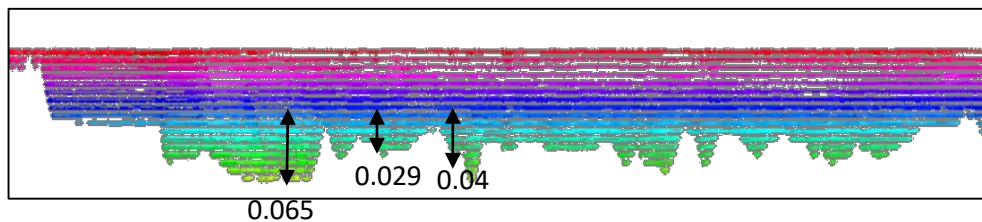
| Element Name | Observation | Location of Distress | Photo No. | Units | Distress Details | | | Area of Repair (Sq.m/R MT/m3) |
|---|---|---|---|---|---|---|---|---|
| Abutment 1 | Spalling | | 5 | M | 1.80 | 1.06 | 0.04 | 0.010 |

**5. Spalling observed on LHS A1 SPL 4, measuring 1.80 m in length and 1.06 m in width. Depth ranges from 0.029 m (min) to 0.065 m (max), with an average depth of 0.04 m. The calculated volume of the distress is 0.0105 m<sup>3</sup>.**

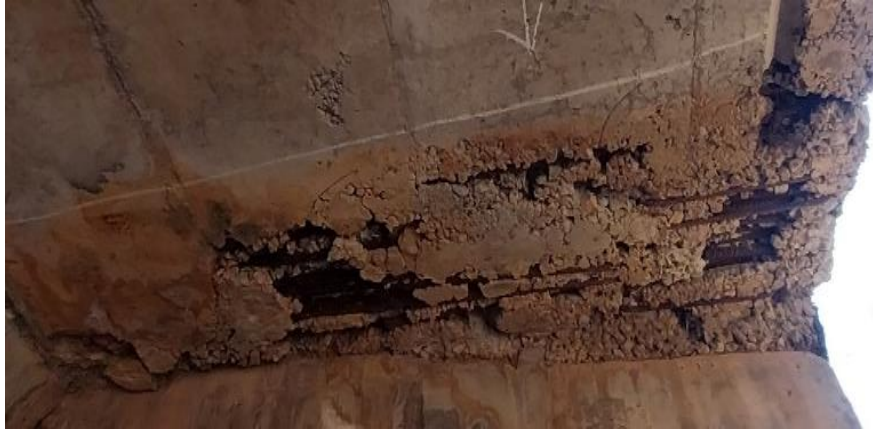
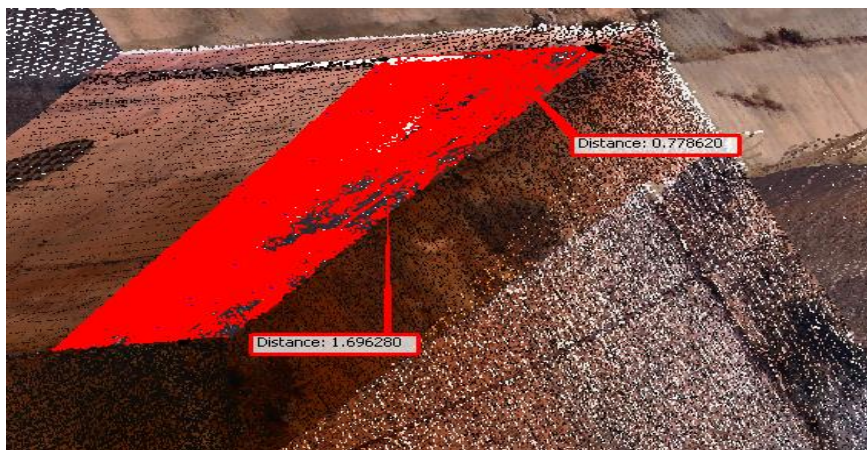
| Element Name | Observation | Location of Distress | Photo No. | Units | Distress Details | | | Area of Repair (Sq.m/R MT/m3) |
|---|---|---|---|---|---|---|---|---|
| Abutment 1 | Spalling | | 6 | M | 1.69 | 0.77 | 0.034 | 0.044 |

**6. Spalling with honeycombing and surface erosion observed on LHS A1 SPL 3, measuring 1.69 m in length and 0.77 m in width. Depth ranges from 0.026 m (min) to 0.072 m (max), with an average depth of 0.034 m. The calculated volume of the distress is 0.0442 m<sup>3</sup>.**

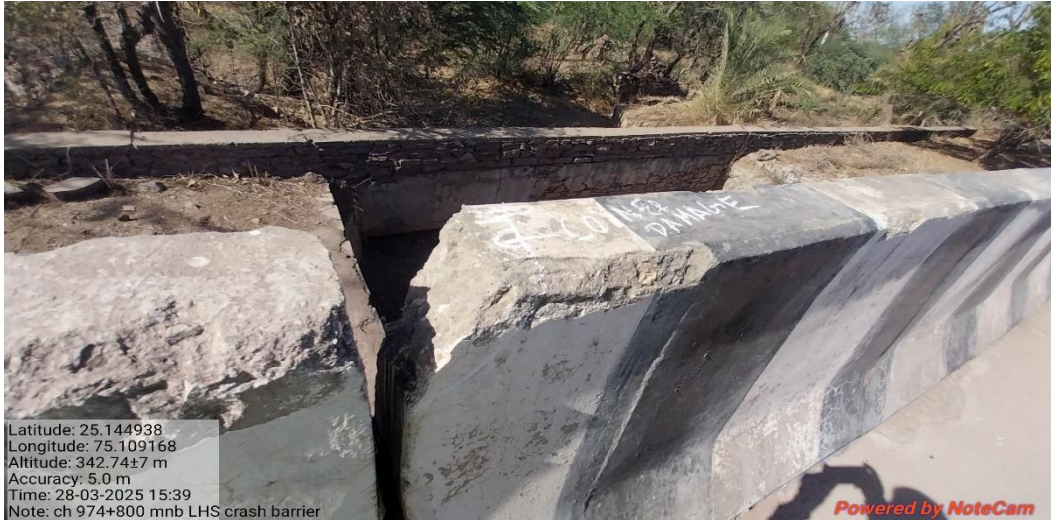
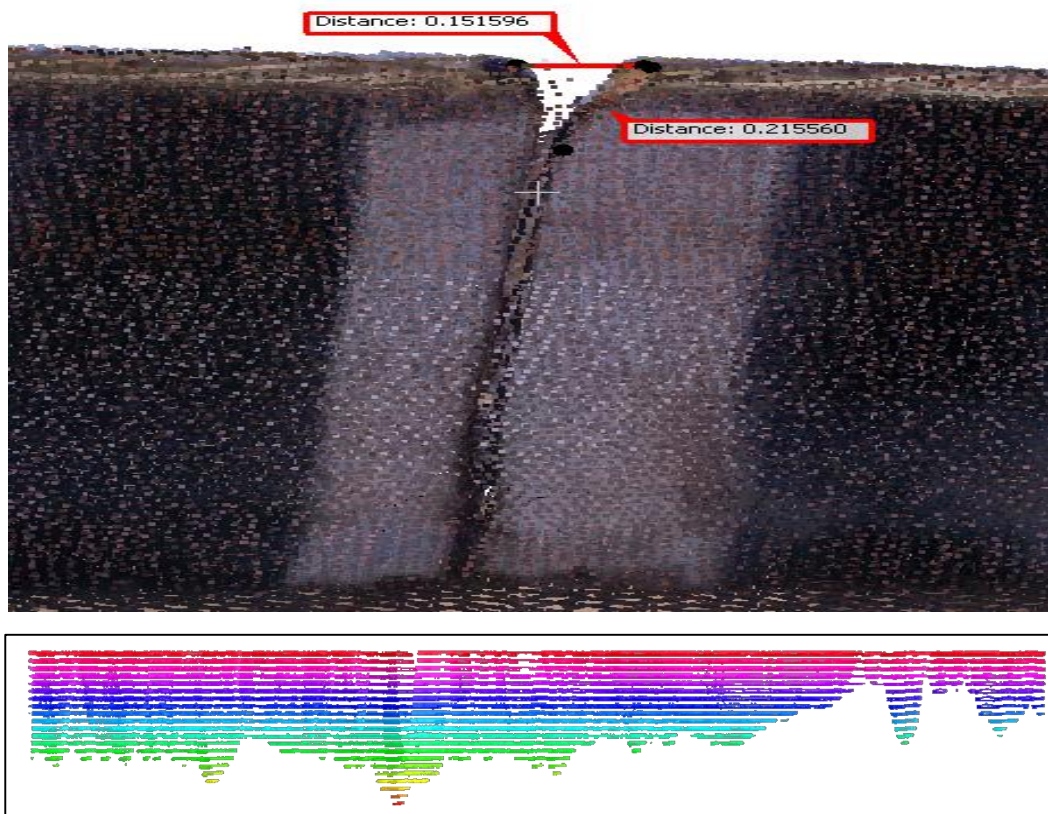
| Element Name | Observation | Location of Distress | Photo No. | Units | Distress Details | | | Area of Repair (Sq.m/R MT/m3) |
|---|---|---|---|---|---|---|---|---|
| Crash Barrier | Damage | | 7 | M | 0.21 | 0.15 | | 0.031 |

**7. Crash barrier damage observed on LHS, measuring 0.21 m in length and 0.15 m in width, covering an area of 0.0315 m<sup>2</sup>.**

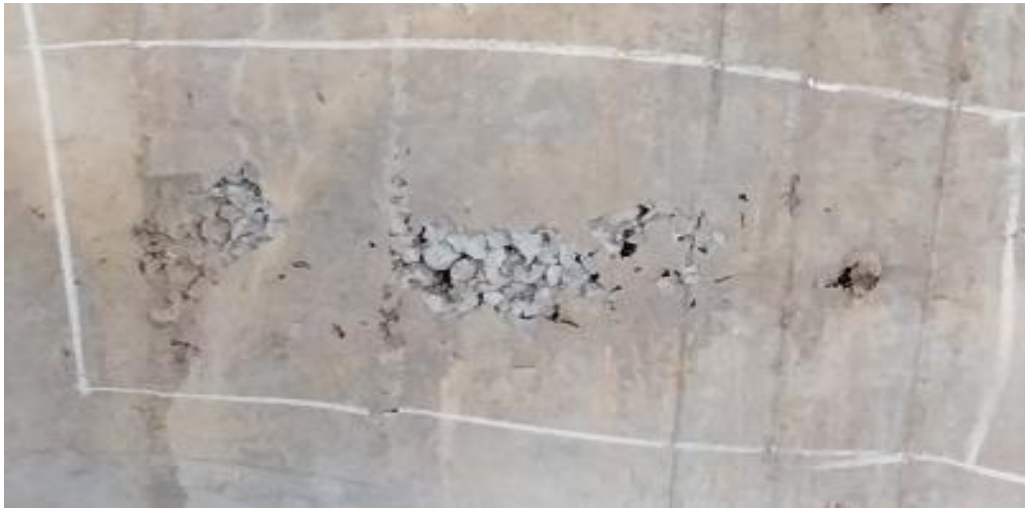
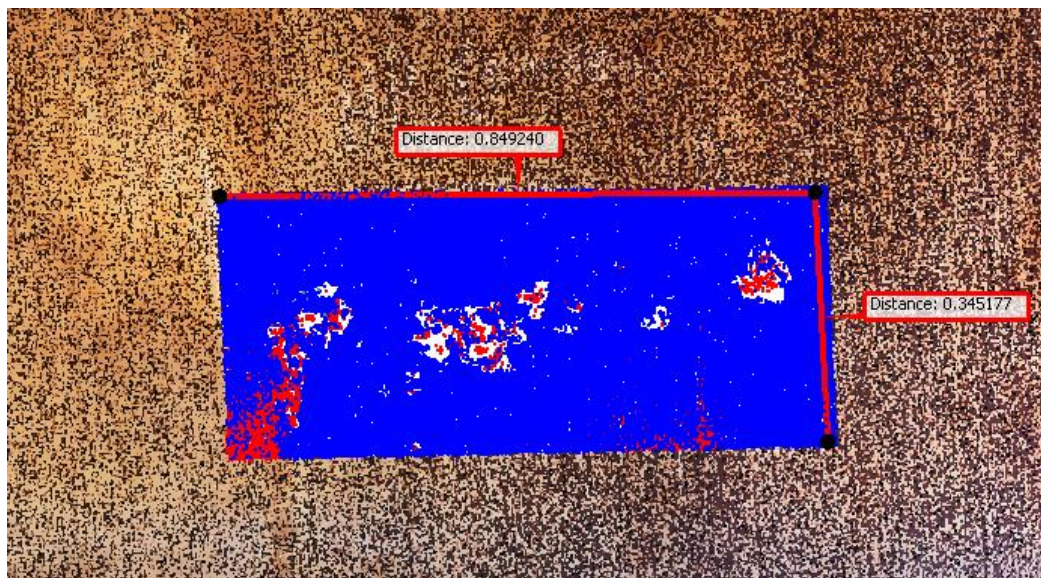
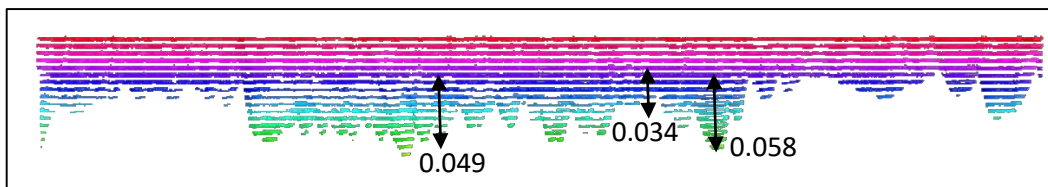
| Element Name | Observation | Location of Distress | Photo No. | Units | Distress Details | | | Area of Repair (Sq./RM Tm3) |
|---|---|---|---|---|---|---|---|---|
| Abutment 1 | Hollow Pocket | | 8 | M | 0.84 | 0.34 | 0.049 | 0.0139 |

**8. Hollow pocket observed on the Right Hand Side (RHS) of A1, measuring 0.84 m in length and 0.34 m in width. Depth ranges from 0.034 m (min) to 0.058 m (max), with an average depth of 0.049 m. The calculated volume of the distress is 0.0139 m<sup>3</sup>.**

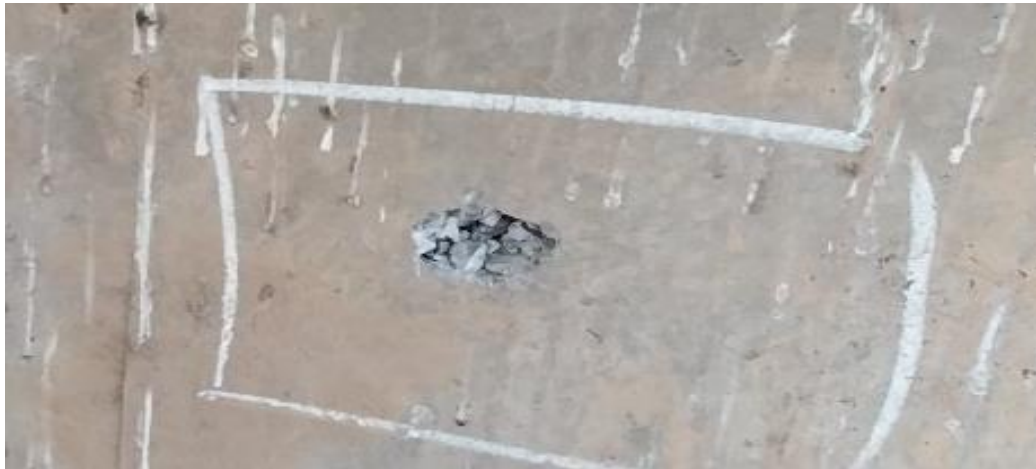
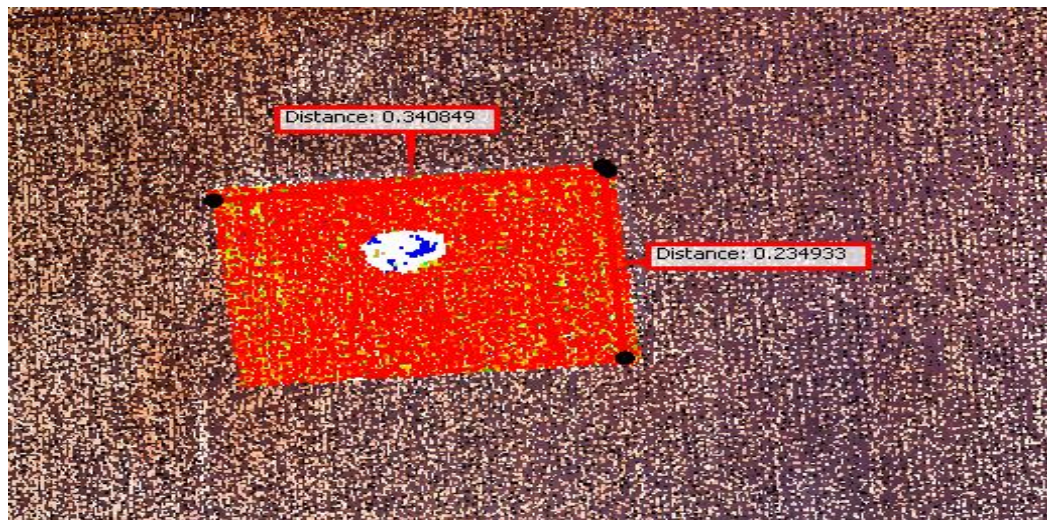
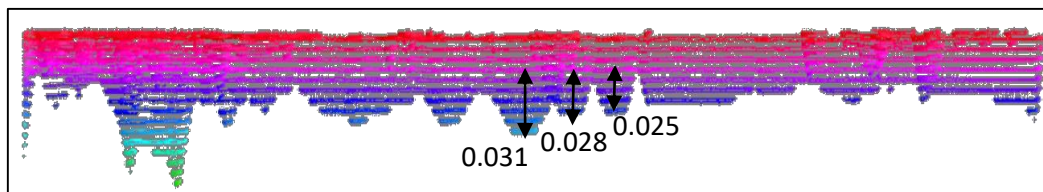
| Element Name | Observation | Location of Distress | Photo No. | Units | Distress Details | | | Area of Repair (Sq./RM Tm3) |
|---|---|---|---|---|---|---|---|---|
| Abutment 1 | Hollow Pocket | | 9 | M | 0.34 | 0.23 | 0.028 | 0.0021 |

**9. Hollow pocket observed on the Right Hand Side (RHS) of A1 at HP 5, measuring 0.34 m in length and 0.23 m in width. Depth ranges from 0.025 m (min) to 0.031 m (max), with an average depth of 0.028 m. The calculated volume of the distress is 0.0021 m<sup>3</sup>.**

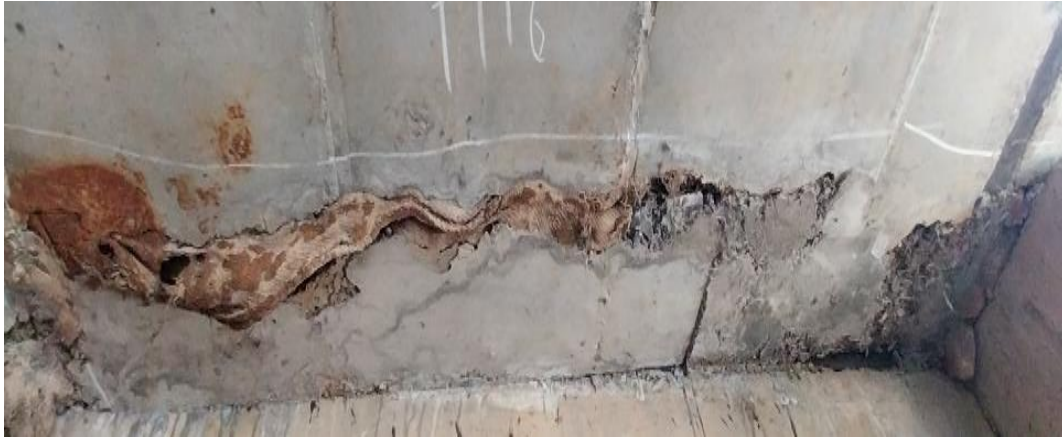
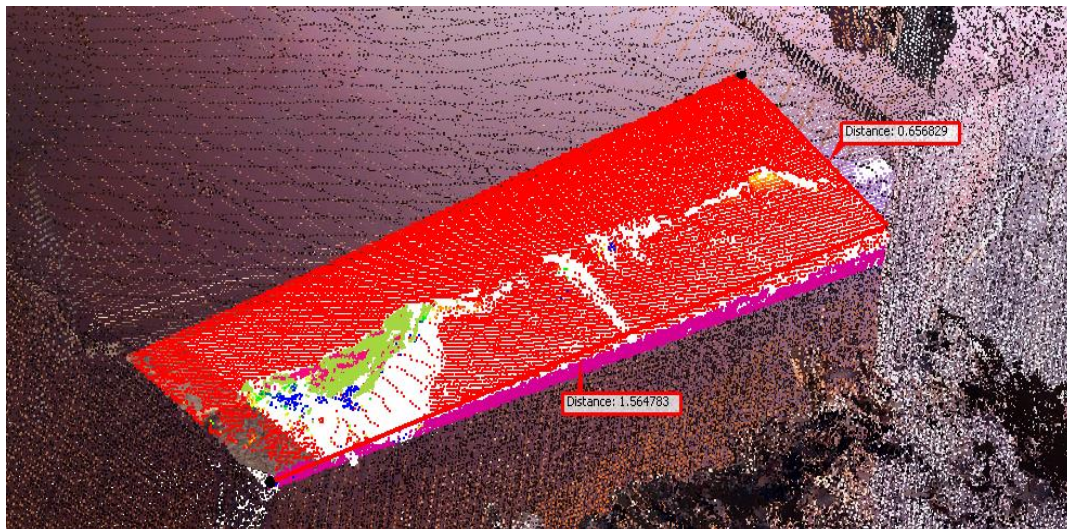
| Element Name | Observation | Location of Distress | Photo No. | Units | Distress Details | | | Area of Repair (Sq./RM Tm3) |
|---|---|---|---|---|---|---|---|---|
| Abutment 1 | Hollow Pocket | | 10 | M | 1.56 | 0.65 | 0.040 | 0.0405 |

**10. Hollow pocket observed on the Right Hand Side (RHS) of A1 at HP 6, measuring 1.56 m in length and 0.65 m in width. Depth ranges from 0.031 m (min) to 0.049 m (max), with an average depth of 0.040 m. The calculated volume of the distress is 0.0405 m<sup>3</sup>.**

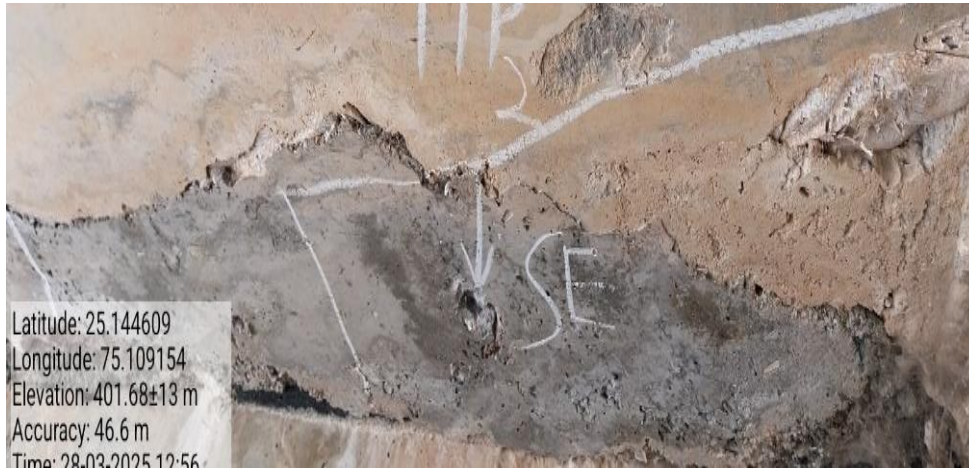
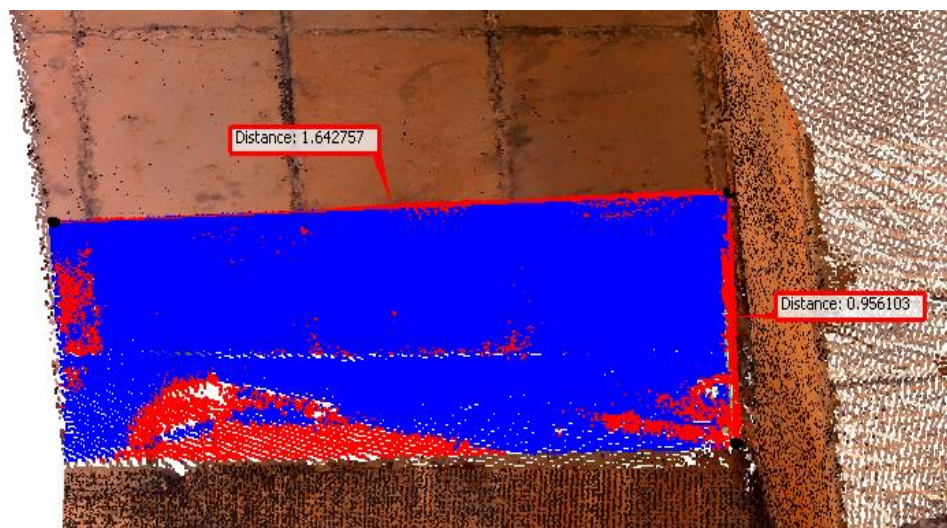
| Element Name | Observation | Location of Distress | Photo No. | Units | Distress Details | | | Area of Repair (Sq./RM Tm3) |
|---|---|---|---|---|---|---|---|---|
| Abutment 1 | Hollow Pocket | | 11 | M | 1.64 | 0.95 | 0.045 | 0.0701 |

**11. Hollow pocket observed on RHS A1 HP 2, measuring 1.64 m in length and 0.95 m in width. Depth ranges from 0.025 m (min) to 0.057 m (max), with an average depth of 0.045 m. The calculated volume of the distress is 0.0701 m<sup>3</sup>.**

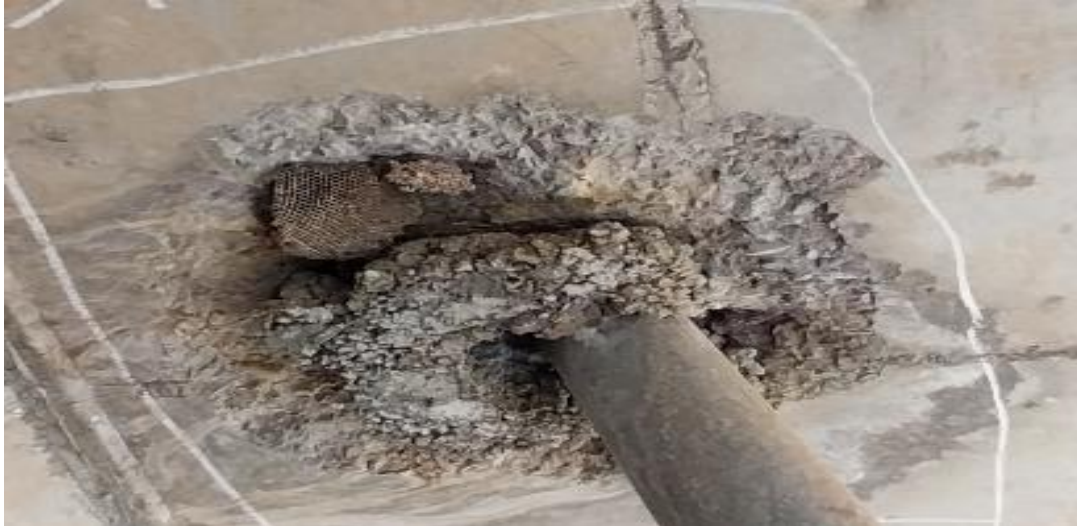
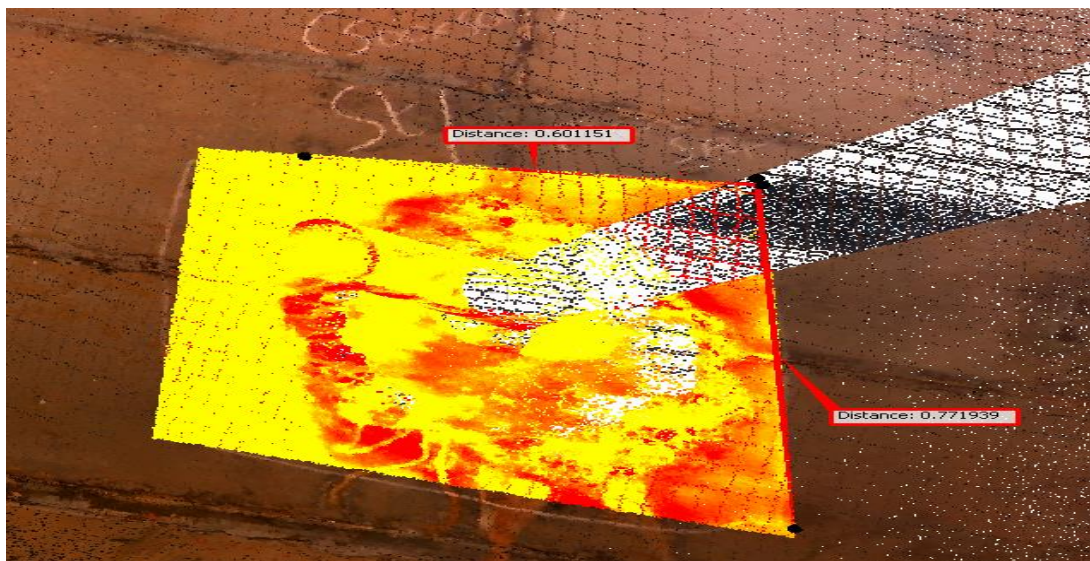
| Element Name | Observation | Location of Distress | Photo No. | Units | Distress Details | | | Area of Repair (Sq./RM Tm3) |
|---|---|---|---|---|---|---|---|---|
| Abutment 2 | Steel Exposed | | 12 | M | 0.60 | 0.77 | | 0.462 |

**12. Steel exposure observed on RHS span between A1 and A2 (cantilever side), measuring 0.60 m in length and 0.77 m in width, covering an area of 0.462 m<sup>2</sup>.**

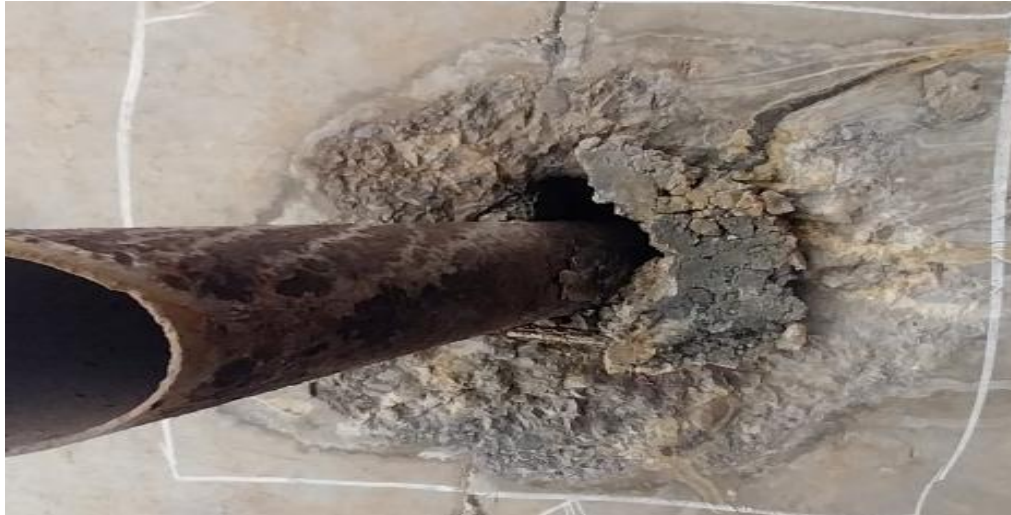
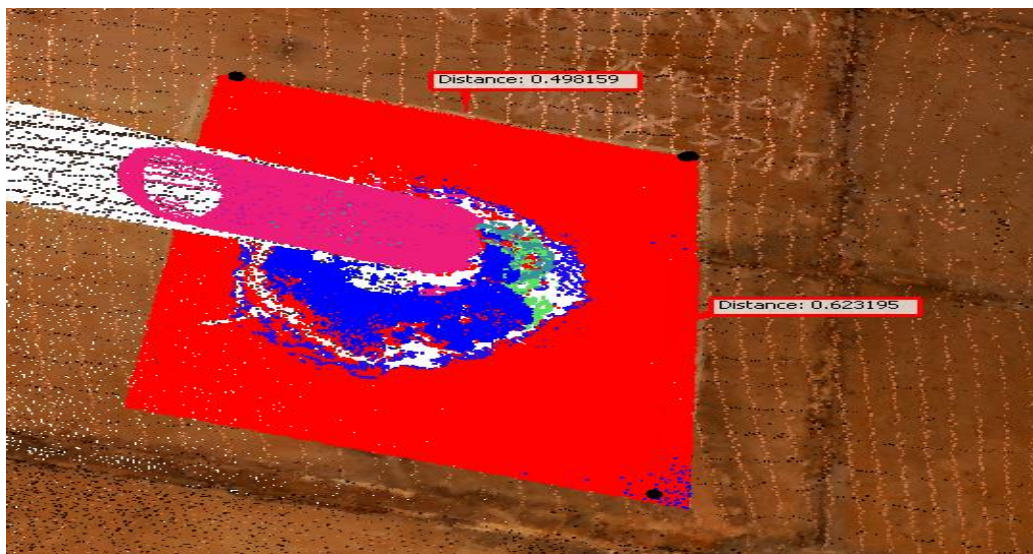
| Element Name | Observation | Location of Distress | Photo No. | Units | Distress Details | | | Area of Repair (Sq./RM Tm3) |
|---|---|---|---|---|---|---|---|---|
| Abutment 2 | Steel Exposed | | 13 | M | 0.62 | 0.49 | | 0.303 |

**13. Steel exposure observed on RHS span between A1 and A2 (cantilever side), measuring 0.62 m in length and 0.49 m in width, covering an area of 0.3038 m<sup>2</sup>.**

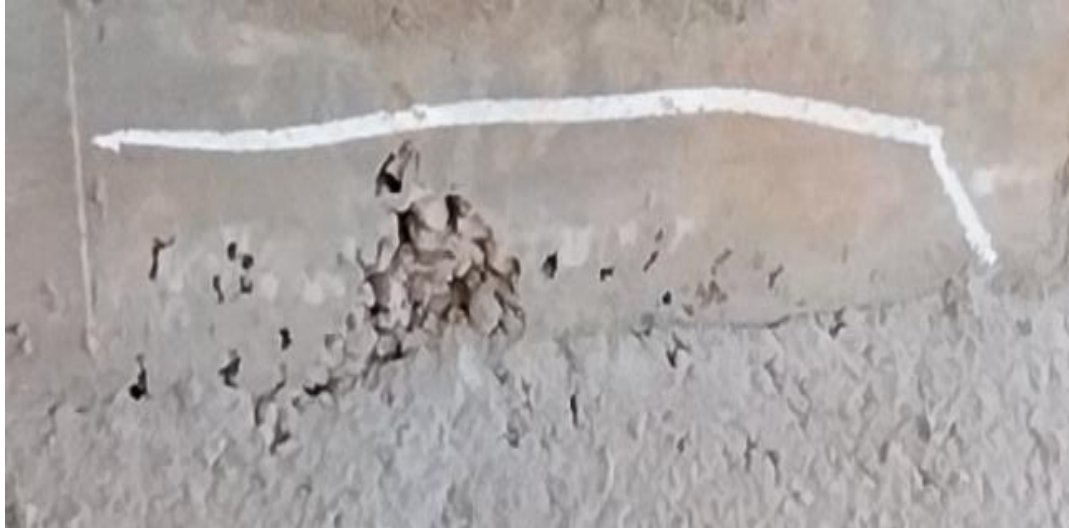
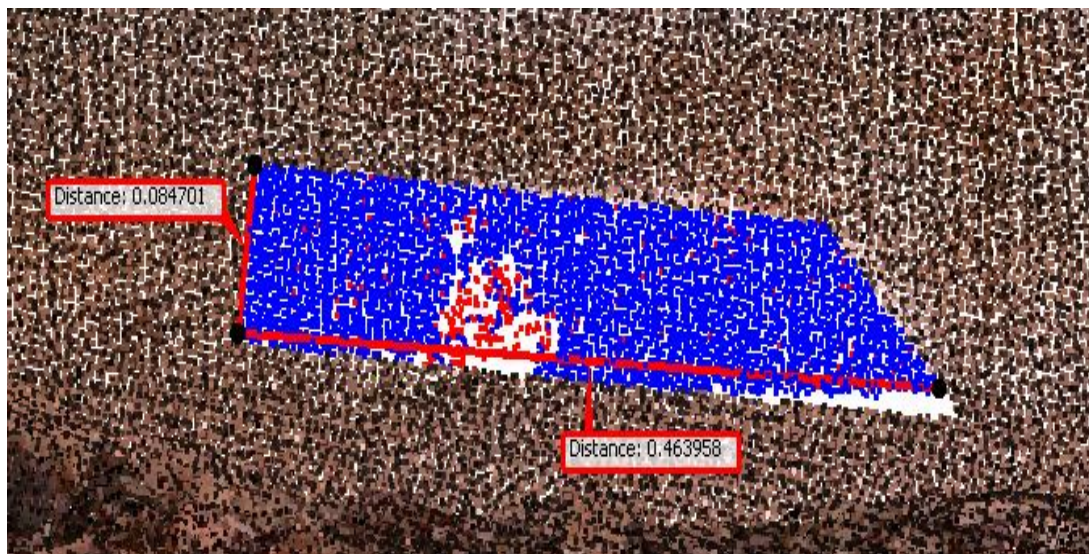
| Element Name | Observation | Location of Distress | Photo No. | Units | Distress Details | | | Area of Repair (Sq./RM Tm3) |
|---|---|---|---|---|---|---|---|---|
| Abutment 2 | Scaling | | 14 | M | 0.46 | 0.08 | | 0.368 |

**14. Scaling observed on RHS A2, measuring 0.46 m in length and 0.08 m in width, covering an area of 0.0368 m<sup>2</sup>.**

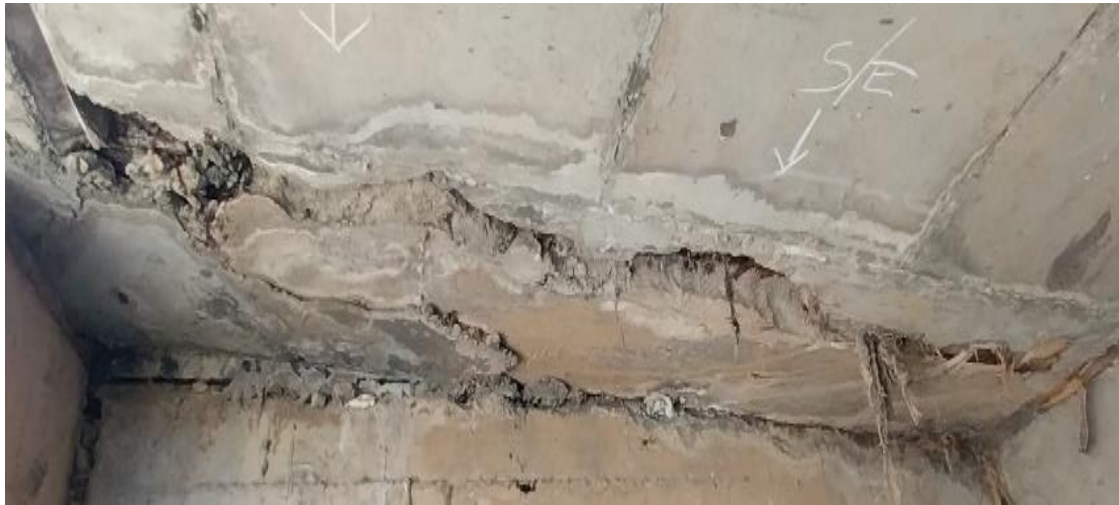
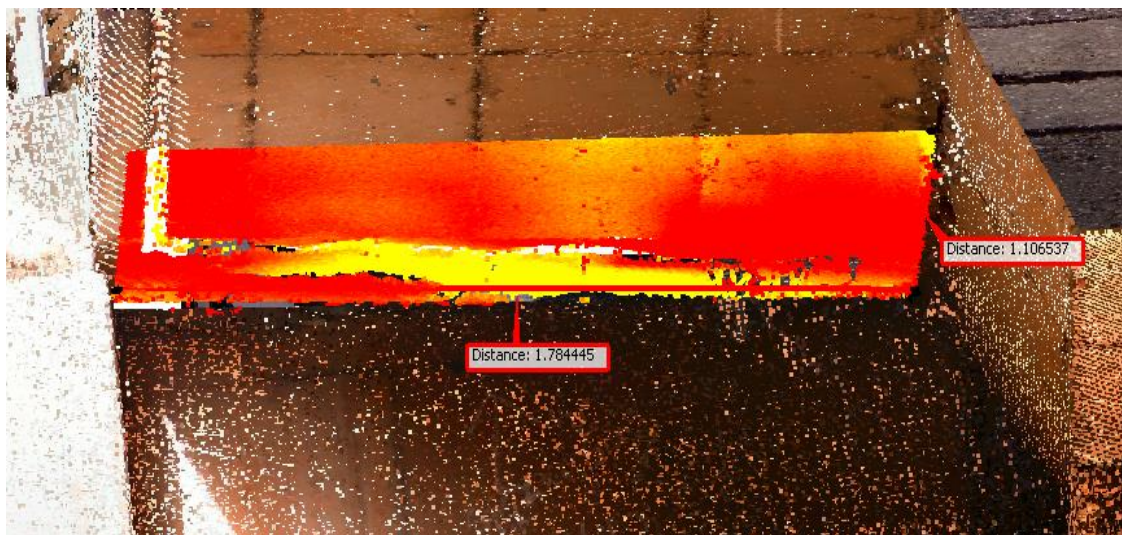
| Element Name | Observation | Location of Distress | Photo No. | Units | Distress Details | | | Area of Repair (Sq./RM Tm3) |
|---|---|---|---|---|---|---|---|---|
| Abutment 2 | Spalling | | 15 | M | 1.78 | 1.10 | 0.041 | 0.0802 |

**15. Spalling observed on RHS A2 SPL 1, measuring 1.78 m in length and 1.10 m in width. Depth ranges from 0.034 m (min) to 0.062 m (max), with an average depth of 0.041 m. The calculated volume of the distress is 0.0802 m<sup>3</sup>.**
