# **LIDAR Inspection Report of Slab Culvert ch. 978+620**

**Bridge Chainage:** 978+620 (CKRP)

- CKRP: Chittorgarh to kota
- State: Rajasthan NH 27
- Zone: RJ-06

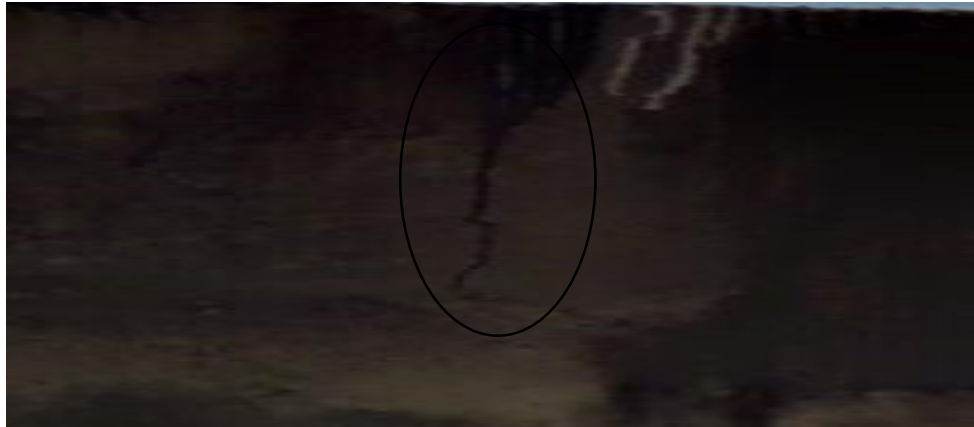
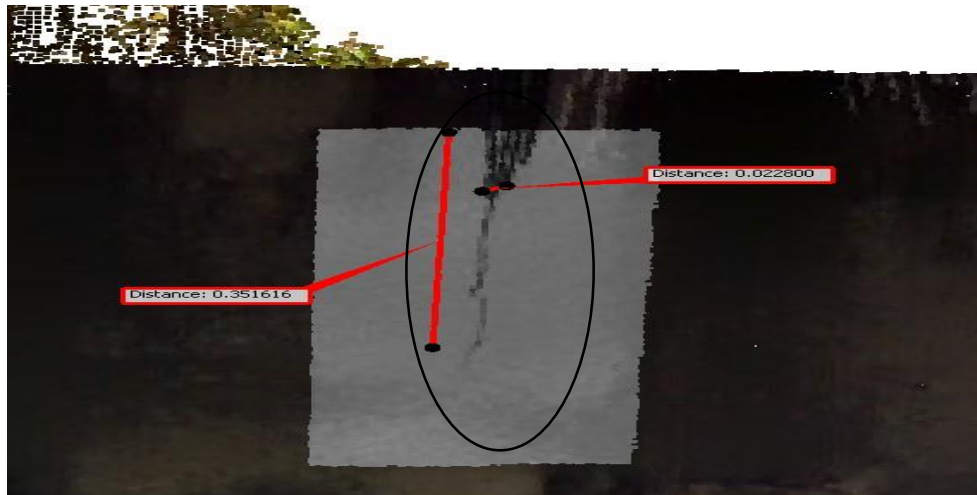
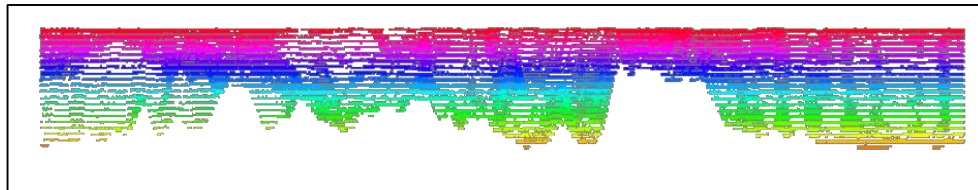
| Element Name | Observation | Location of Distress | Photo No. | Units | Distress Details | | | Area of Repair (Sq.m/R MT) |
|---|---|---|---|---|---|---|---|---|
| A2 LHS dirt wall | Crack | - | 1 | M | 0.35 | 0.02 | 0.12 | 0.026 |

**1. Crack observed on LHS Abutment 2 dirt wall, measuring 0.35 m in length and 0.02 m in width covering an area of 0.07 m<sup>2</sup>.**
