# **LIDAR Inspection Report of Slab Culvert ch.979+360**

**Bridge Chainage:** 979 + 360 (CKRP)

- **CKRP:** Chittorgarh to kota
- **State:** Rajasthan NH 27
- **Zone:** RJ-06

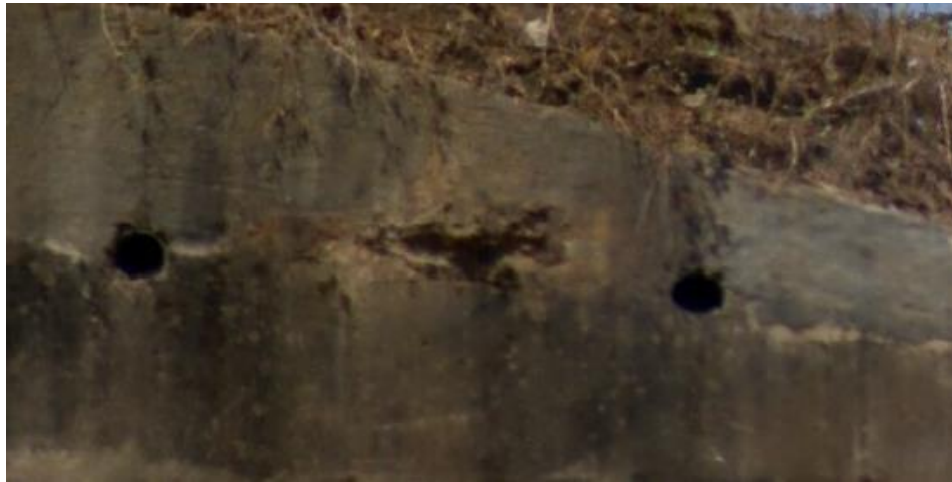
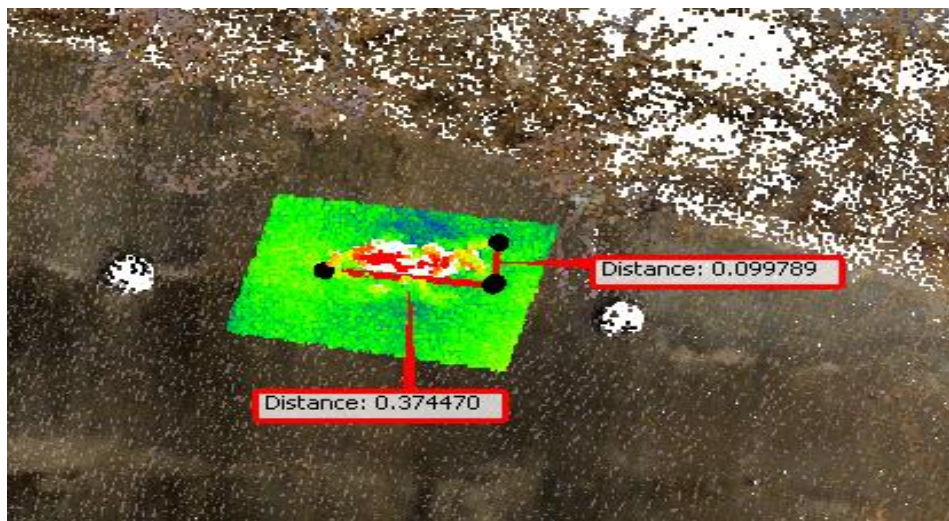
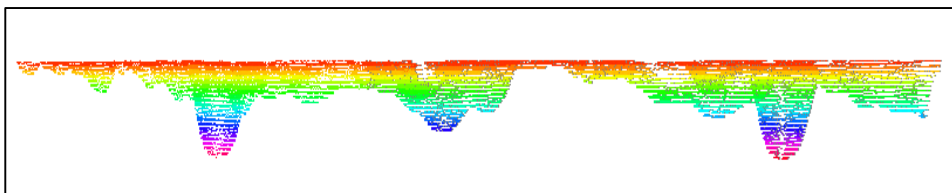
| Element Name | Observation | Location of Distress | Photo No. | Units | Distress Details | | | Area of Repair<br>(Sq.m/R<br>MT/m3) |
|---|---|---|---|---|---|---|---|---|
| Wing Wall | Spalling | | 1 | M | 0.37 | 0.09 | | 0.033 |

1. Spalling observed on Wing Wall, measuring 0.37 m in length and 0.09 m in width, covering an area of 0.033 m<sup>2</sup>.

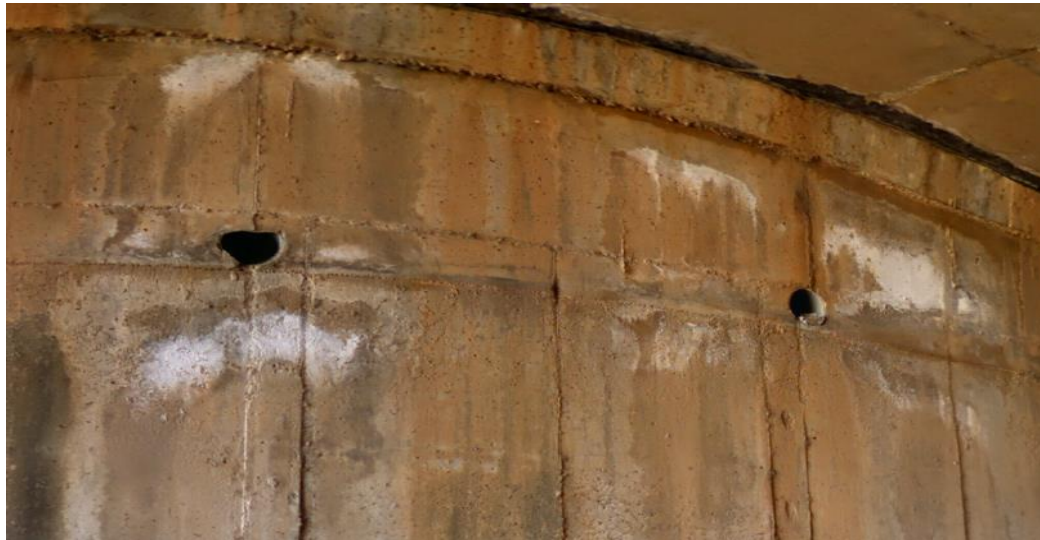
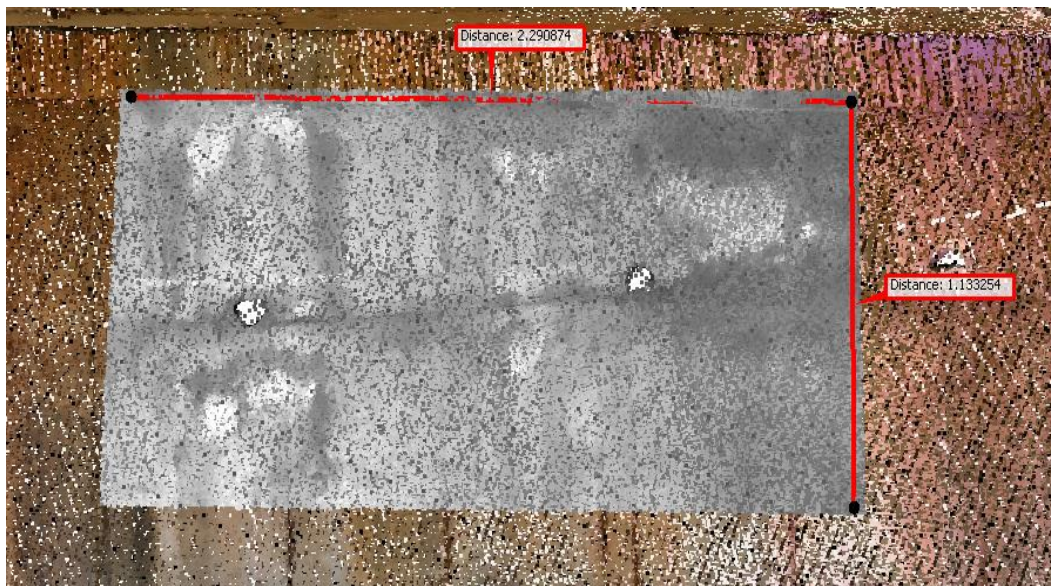
| Element Name | Observation | Location of Distress | Photo No. | Units | Distress Details | | | Area of Repair<br>(Sq.m/R<br>MT/m3) |
|---|---|---|---|---|---|---|---|---|
| Abutment 1 | Efflorescence | | 2 | M | 2.29 | 1.13 | | 2.58 |

- 2. Efflorescence observed on A1, measuring 2.29 m in length and 1.13 m in width, covering an area of 2.58 m<sup>2</sup>.**
