# **LIDAR Inspection Report of Slab Culvert ch.980+285**

**Bridge Chainage:** 980+285 (CKRP)

- **Bridge No:** -
- **Chainage:** 980+285
- **Structure type:** Slab Culvert

- **CKRP:** Chittorgarh to kota
- **State:** Rajasthan NH 27
- **Zone:** RJ-06

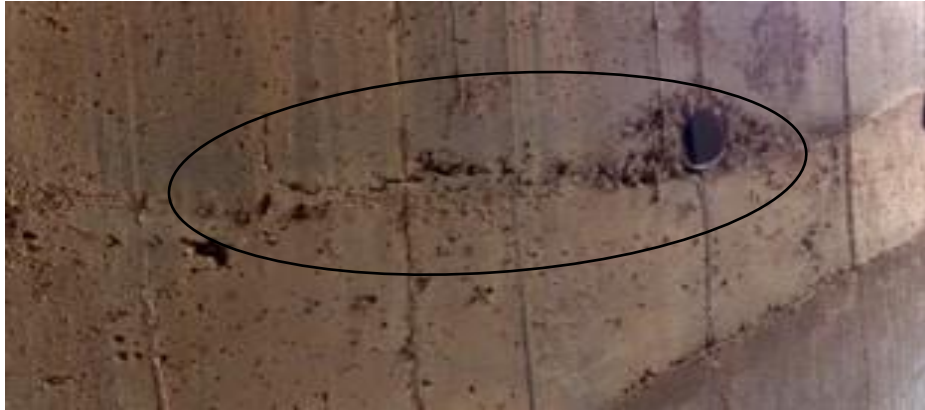
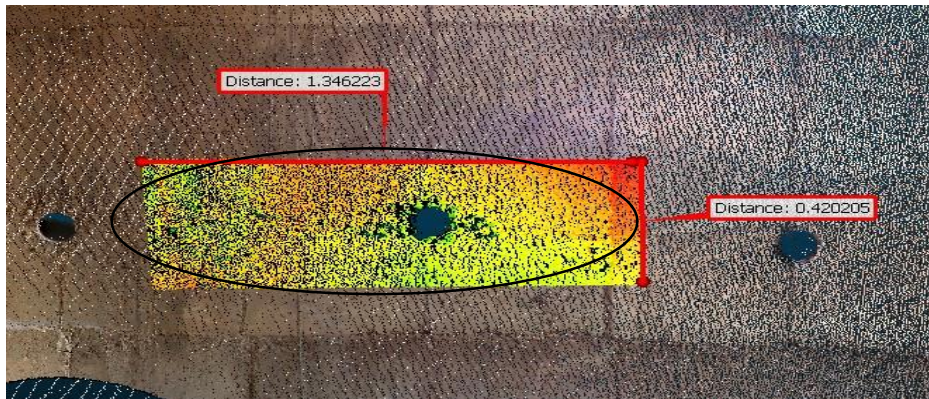
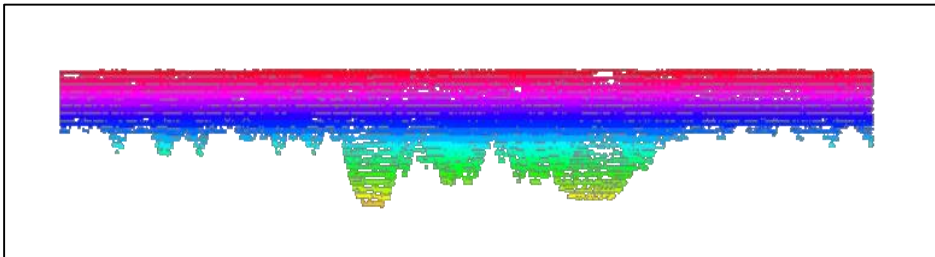
| Element Name | Observation | Location of Distress | Photo No. | Units | Distress Details | | | Area of Repair (Sq.m/R MT/m3) |
|---|---|---|---|---|---|---|---|---|
| Abutment 1 | Scaling | - | 1 | M | 1.34 | 0.42 | | 0.5638 |

**1. Scaling observed on LHS Abutment 1 Wall, measuring 1.34 m in length and 0.42 m in width, covering an area of 0.5628 m<sup>2</sup>.**

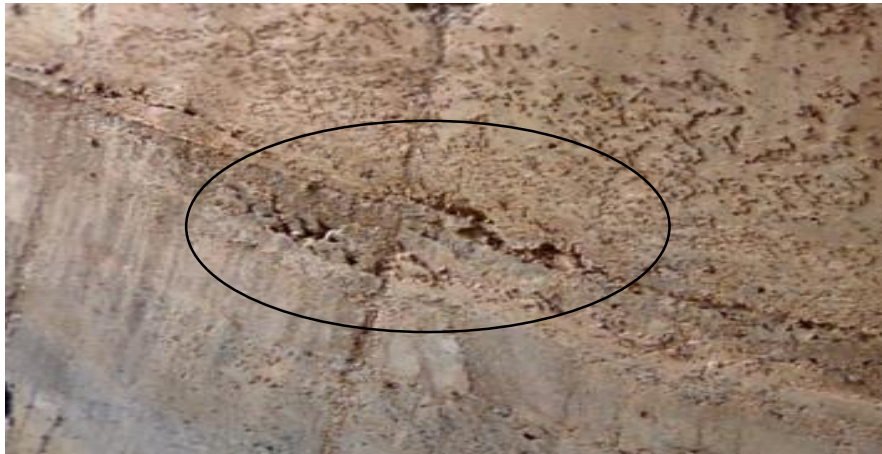
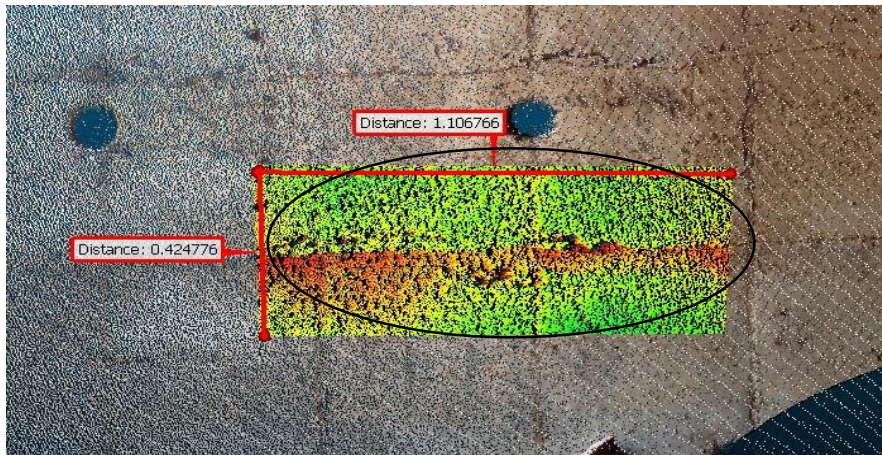
| Element Name | Observation | Location of Distress | Photo No. | Units | Distress Details | | | Area of Repair (Sq.m/R MT/m3) |
|---|---|---|---|---|---|---|---|---|
| Abutment 2 | Scaling | - | 2 | M | 1.10 | 0.42 | | 0.462 |

**2. Scaling observed on LHS Abutment 2 Wall, measuring 1.10 m in length and 0.42 m in width, covering an area of 0.462 m<sup>2</sup>.**

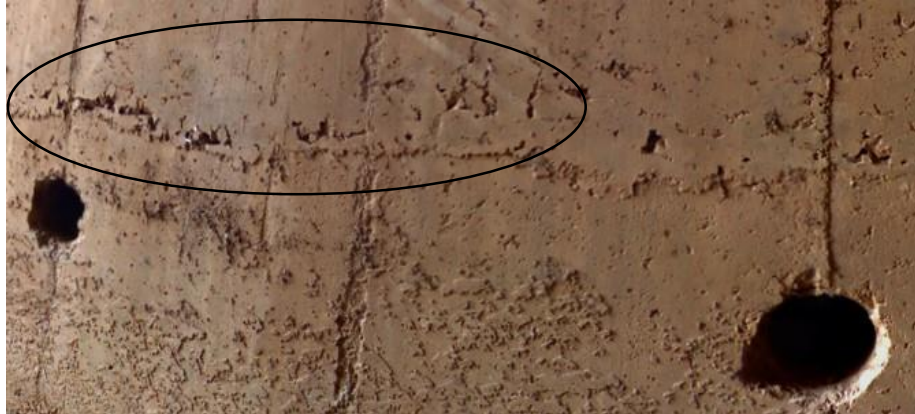
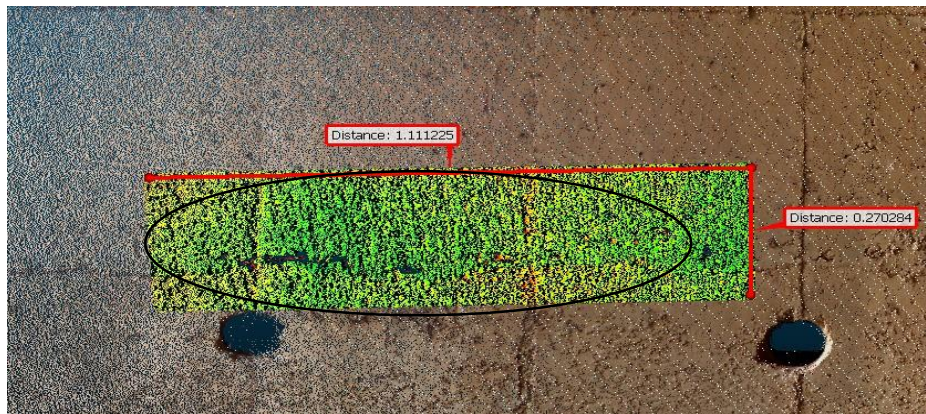
| Element Name | Observation | Location of Distress | Photo No. | Units | Distress Details | | | Area of Repair (Sq.m/R MT/m3) |
|---|---|---|---|---|---|---|---|---|
| Abutment 2 | Scaling | - | 3 | M | 1.11 | 0.27 | | 0.2997 |

**3. Scaling observed on LHS Abutment 2 Wall, measuring 1.11 m in length and 0.27 m in width, covering an area of 0.2997 m<sup>2</sup>.**

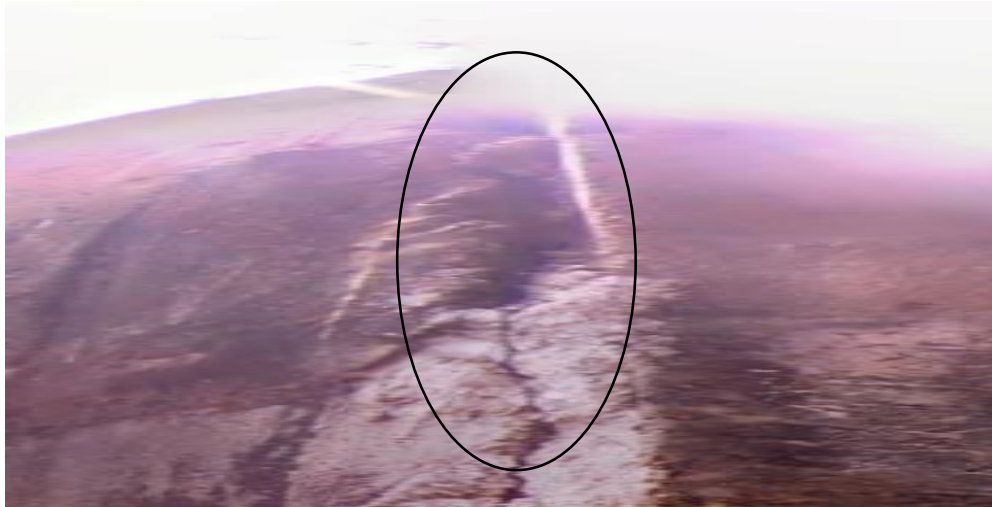
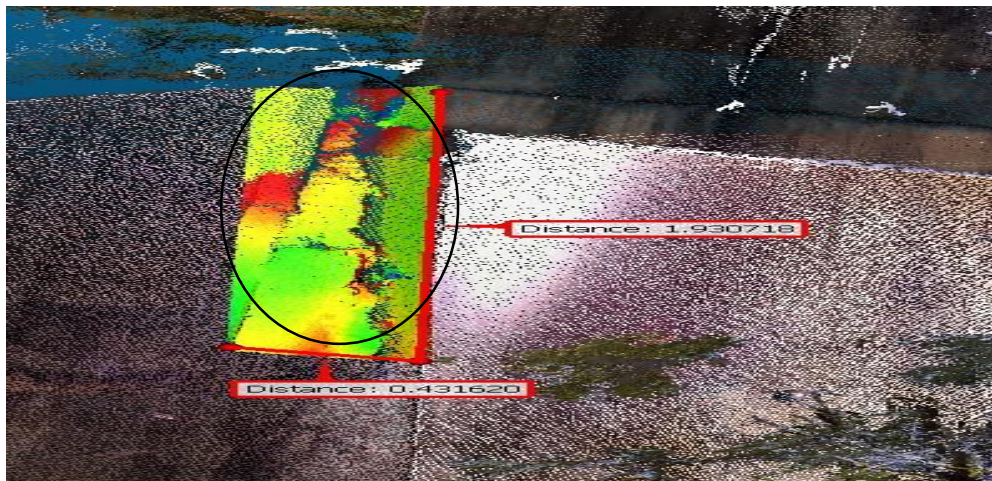
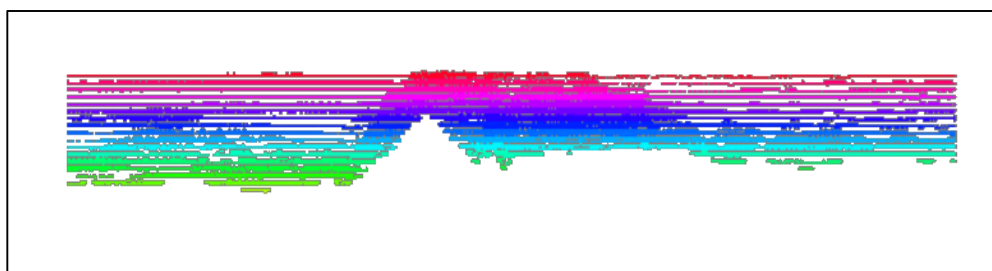
| Element Name | Observation | Location of Distress | Photo No. | Units | Distress Details | | | Area of Repair (Sq.m/R MT/m3) |
|---|---|---|---|---|---|---|---|---|
| Abutment 2 | Crack | - | 4 | M | 0.43 | 1.93 | | 0.8299 |

**4. Crack observed on LHS Abutment 2 Wall, measuring 0.43 m in length and 1.93 m in width, covering an area of 0.8299 m<sup>2</sup>.**

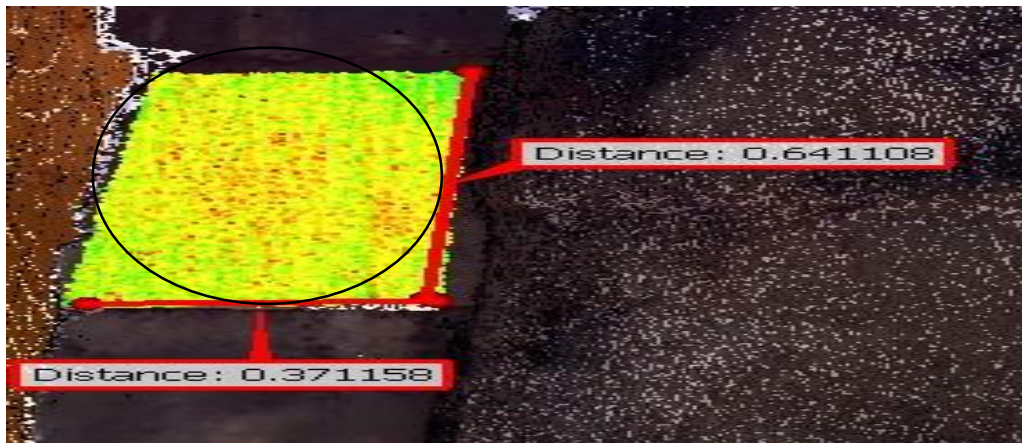
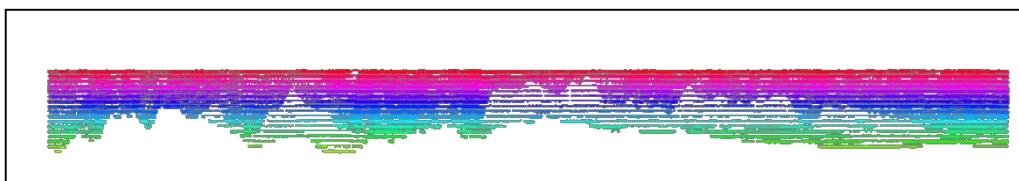
| Element Name | Observation | Location of Distress | Photo No. | Units | Distress Details | | | Area of Repair (Sq.m/R MT/m3) |
|---|---|---|---|---|---|---|---|---|
| Abutment 1 | Scaling | - | 5 | M | 0.37 | 0.64 | | 0.2368 |

**5. Scaling observed on RHS Abutment 1 Wall , measuring 0.37 m in length and 0.64 m in width, covering an area of 0.2368 m<sup>2</sup>.**

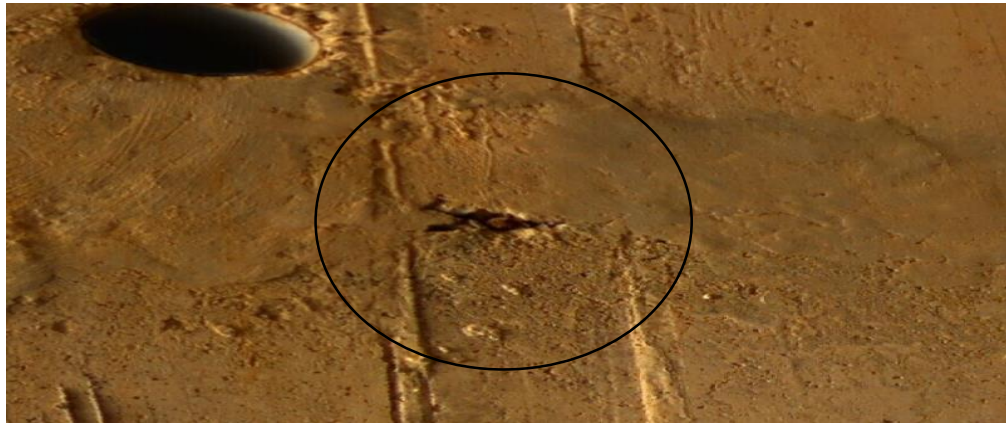
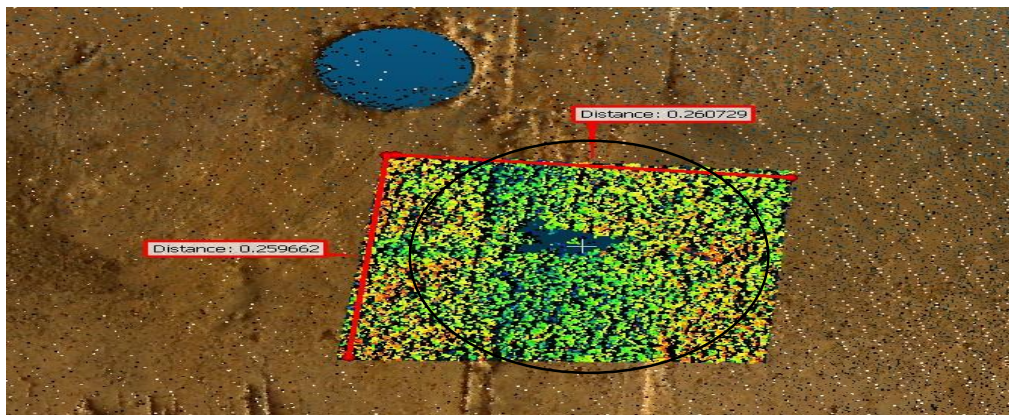
| Element Name | Observation | Location of Distress | Photo No. | Units | Distress Details | | | Area of Repair (Sq.m/R MT/m3) |
|---|---|---|---|---|---|---|---|---|
| Abutment 1 | Steel Expose | - | 6 | M | 0.25 | 0.26 | | 0.065 |

**6. Steel Expose observed on RHS Abutment 1 Wall , measuring 0.25 m in length and 0.26 m in width, covering an area of 0.065 m<sup>2</sup>.**

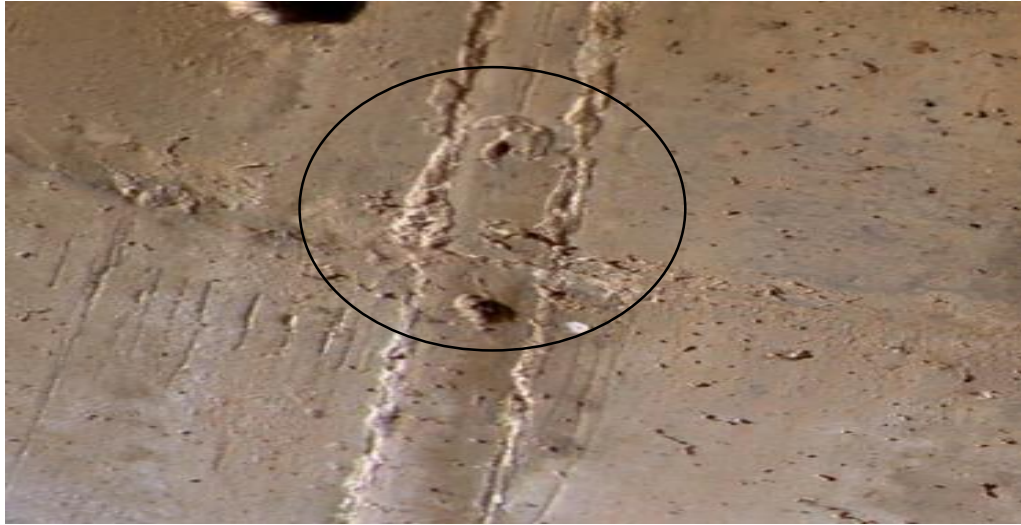
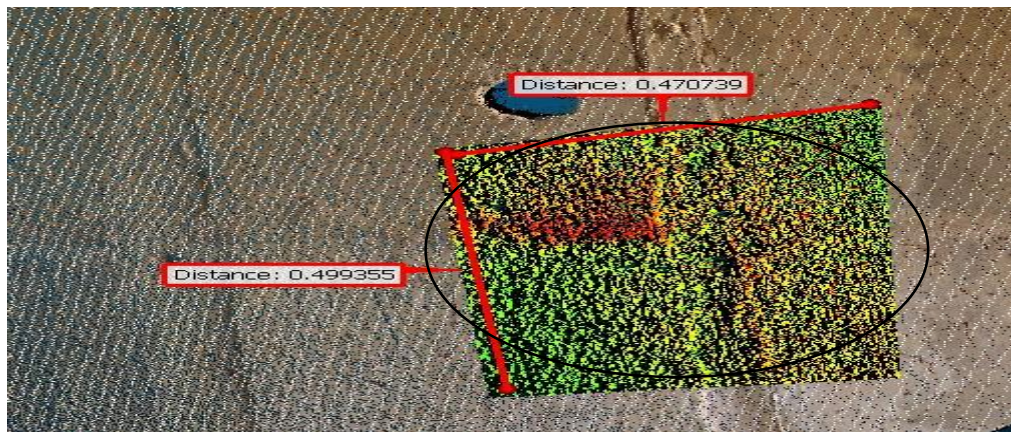
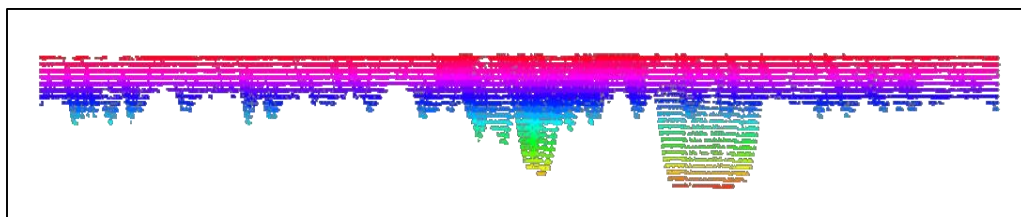
| Element Name | Observation | Location of Distress | Photo No. | Units | Distress Details | | | Area of Repair (Sq.m/R MT/m3) |
|---|---|---|---|---|---|---|---|---|
| Abutment 1 | Scaling | - | 7 | M | 0.49 | 0.47 | | 0.2303 |

**7. Scaling observed on RHS Abutment 1 Wall , measuring 0.49 m in length and 0.47 m in width, covering an area of 0.2303 m<sup>2</sup>.**

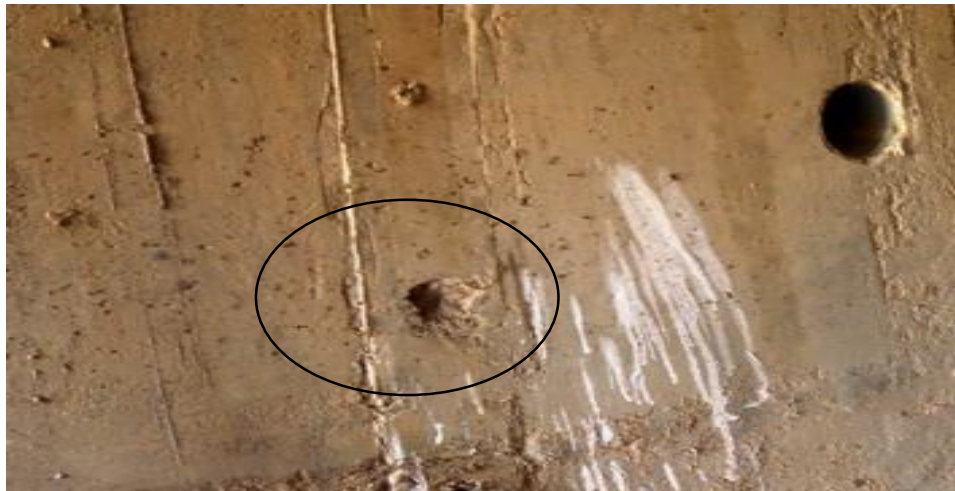
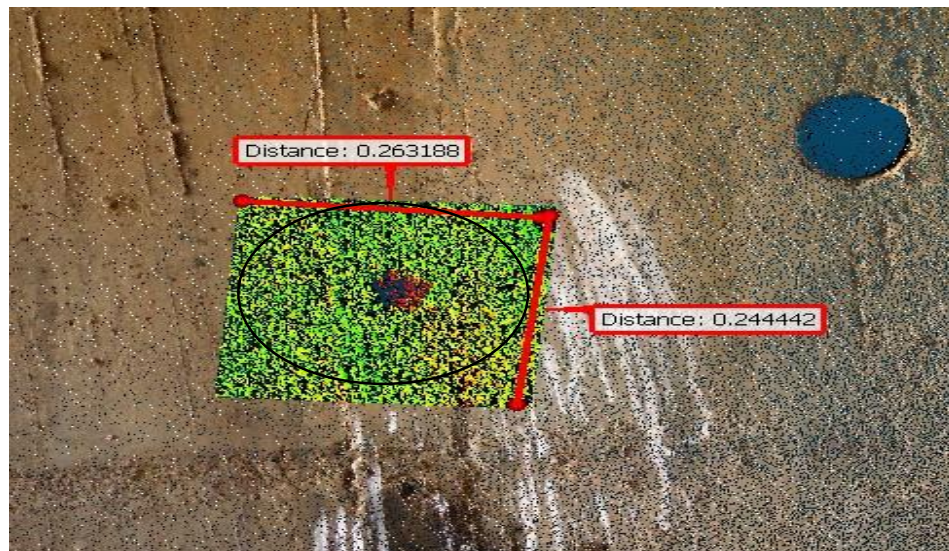
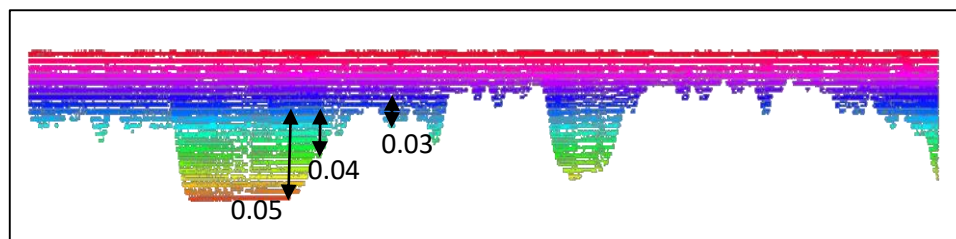
| Element Name | Observation | Location of Distress | Photo No. | Units | Distress Details | | | Area of Repair (Sq.m/R MT/m3) |
|---|---|---|---|---|---|---|---|---|
| Abutment 1 | Damage | - | 8 | M | 0.26 | 0.24 | 0.060 | 0.0037 |

**8. Concrete damage observed on RHS Abutment 1 Wall, measuring 0.26 m in length and 0.24 m in width, Depth ranges from 0.03 (min) to 0.05 m (max), with an average depth of 0.04 m. The calculated volume of the distress is 0.0037 m<sup>3</sup>.**
