# LIDAR Inspection Report of **Box Culvert** ch.980+810

**Bridge No:** Box Culvert

**Bridge Chainage:** 980+810 (CKRP)

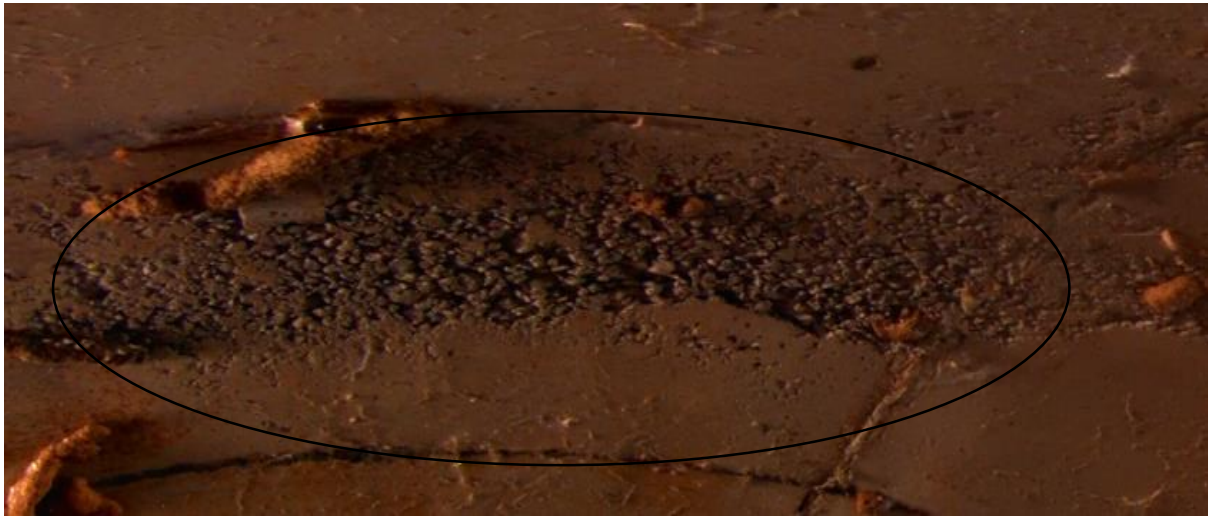
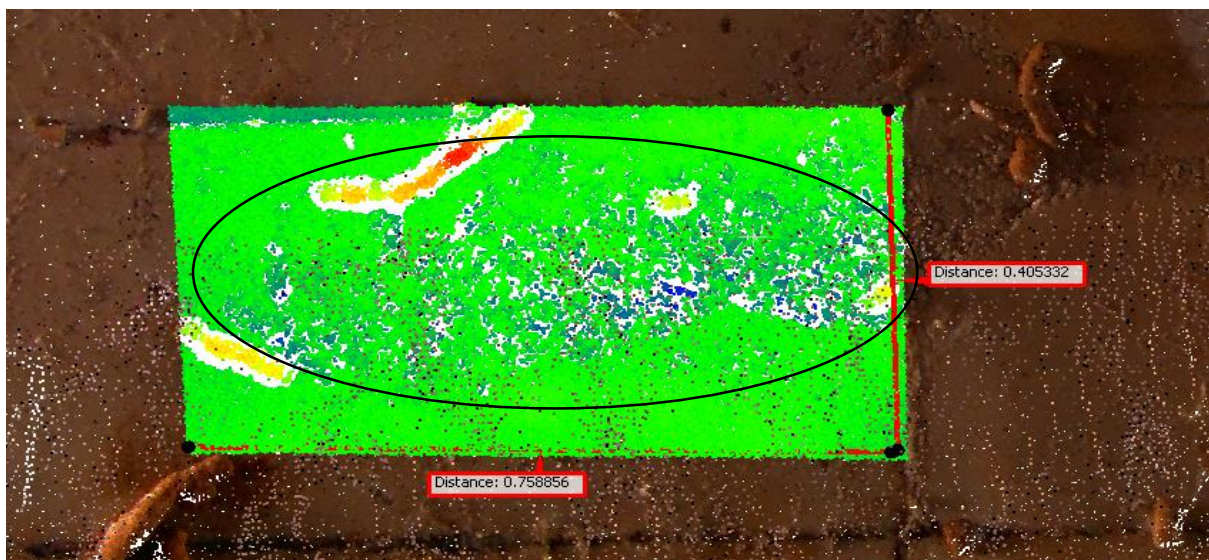
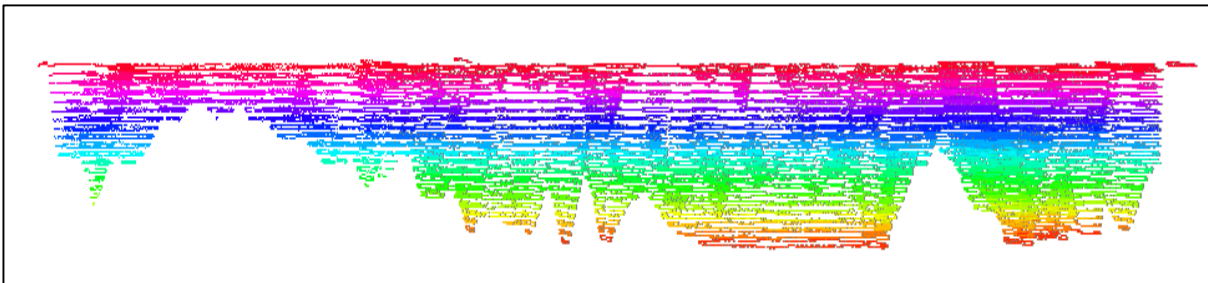
| Element Name | Observation | Location of Distress | Photo No. | Units | Distress Details | | | Area of Repair (Sq.m/R MT/m3) |
|---|---|---|---|---|---|---|---|---|
| Slab bottom | Scaling | - | 1 | M | 0.75 | 0.40 | - | 0.3 |

**1. Scaling observed on slab bottom, measuring 0.75 m in length and 0.40 m in width, covering an area of 0.3 m<sup>2</sup>.**
