# LIDAR Inspection Report of **Box Culvert** ch.981+940

**Bridge Chainage:** 981+940 (CKRP)

- **CKRP:** Chittorgarh to kota
- **State:** Rajasthan NH 27
- **Zone:** RJ-06

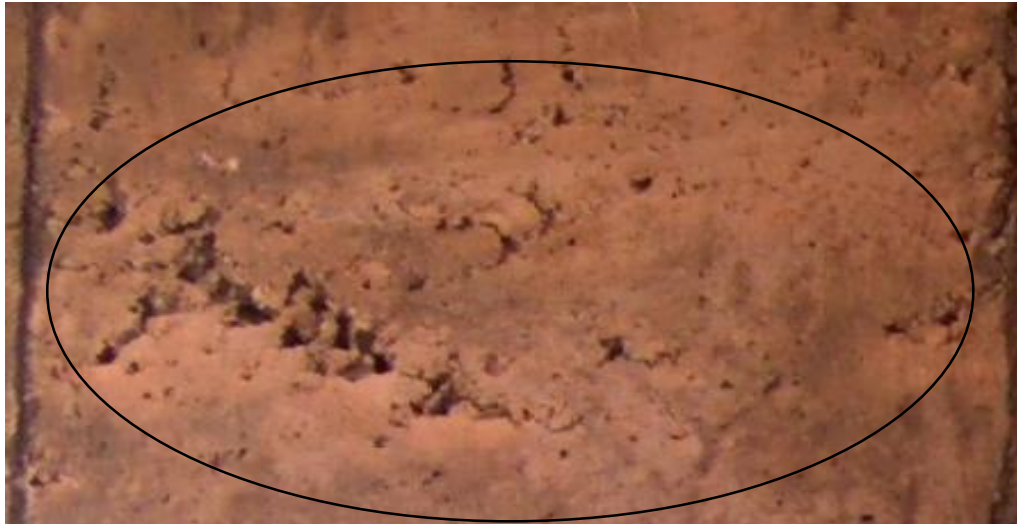
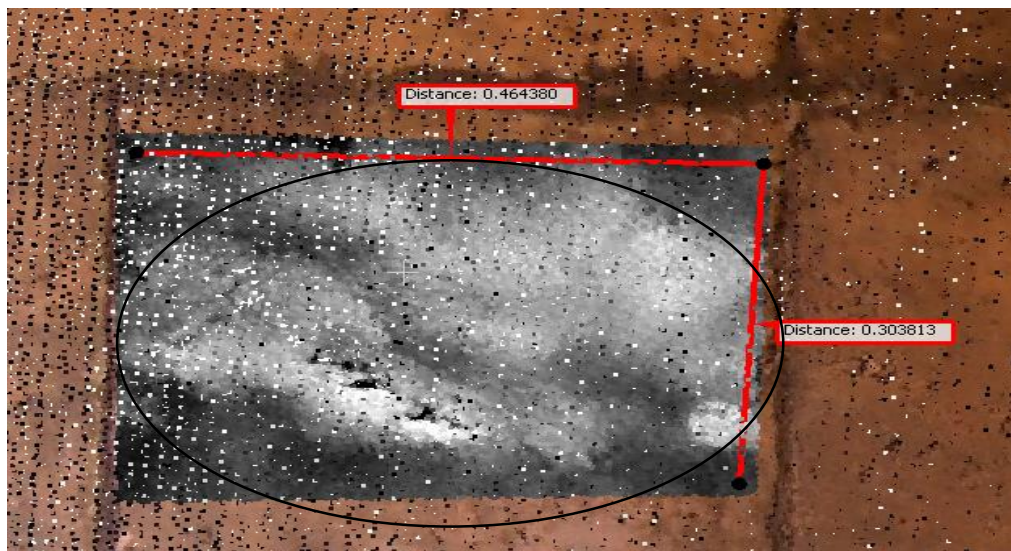
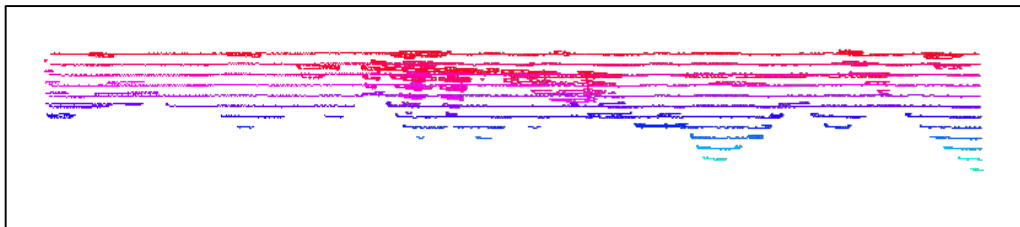
| Element Name | Observation | Location of Distress | Photo No. | Units | Distress Details | | | Area of Repair (Sq.m/R MT/m3) |
|---|---|---|---|---|---|---|---|---|
| Abutment | Scaling 1 | - | 1 | M | 0.46 | 0.30 | - | 0.138 |

**1. Scaling observed on Abutment (Scaling 1), measuring 0.46 m in length and 0.30 m in width, covering an area of 0.138 m<sup>2</sup>.**

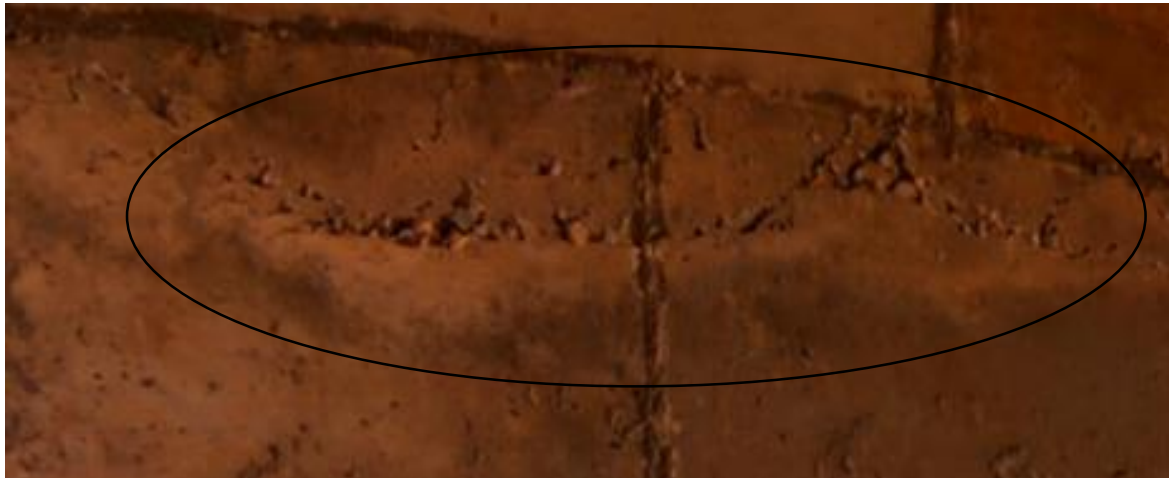
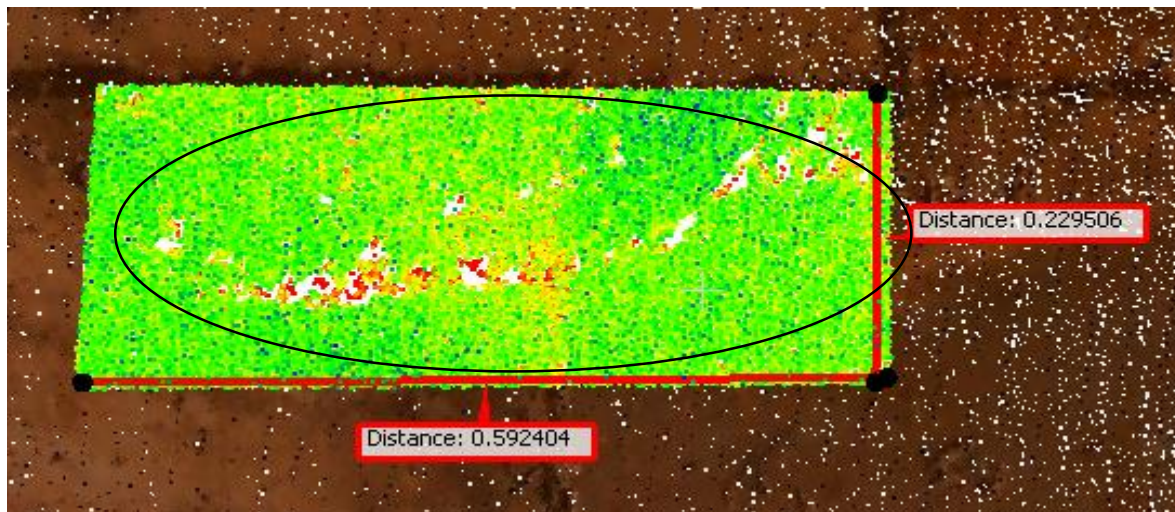
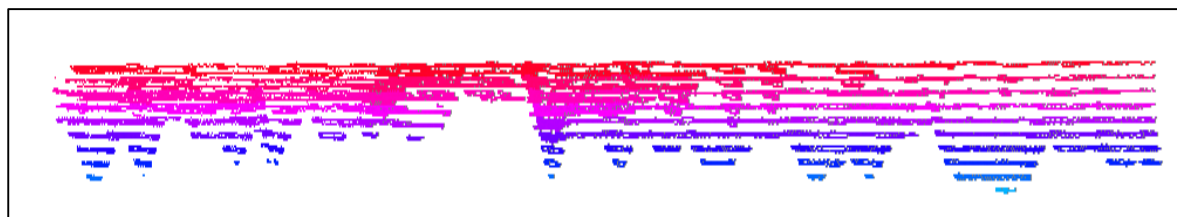
| Element Name | Observation | Location of Distress | Photo No. | Units | Distress Details | | | Area of Repair (Sq.m/R MT/m3) |
|---|---|---|---|---|---|---|---|---|
| Abutment | Scaling 2 | - | 2 | M | 0.59 | 0.22 | - | 0.1298 |

**2. Scaling observed on Abutment (Scaling 2), measuring 0.59 m in length and 0.22 m in width, covering an area of 0.1298 m<sup>2</sup>.**

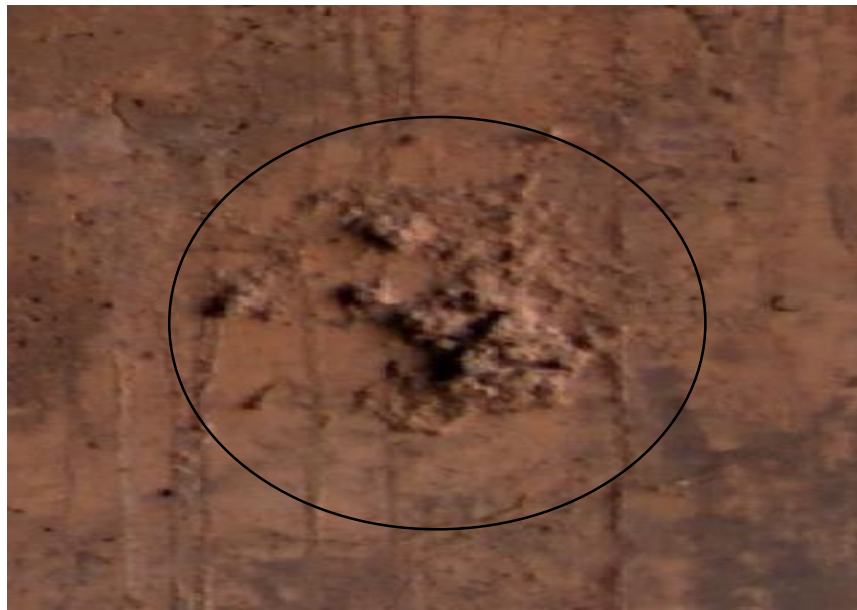
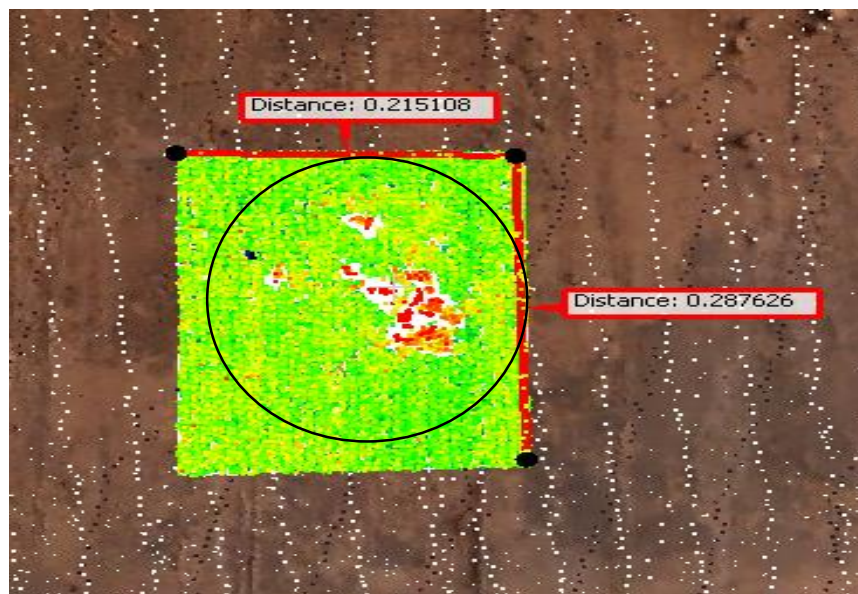
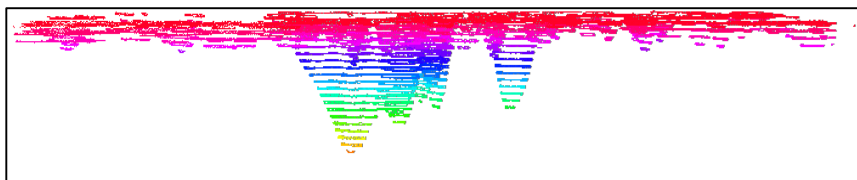
| Element Name | Observation | Location of Distress | Photo No. | Units | Distress Details | | | Area of Repair (Sq.m/R MT/m3) |
|---|---|---|---|---|---|---|---|---|
| Abutment | Scaling 3 | - | 3 | M | 0.28 | 0.21 | - | 0.0588 |

**3. Scaling observed on Abutment (Scaling 3), measuring 0.28 m in length and 0.21 m in width, covering an area of 0.0588 m<sup>2</sup>.**
