# **LIDAR Inspection Report of Slab Culvert ch.982+845**

**Bridge Chainage:** 982+845 (CKRP)

- **Bridge No:** -
- **Chainage:** 982+845
- **Structure type:** Slab Culvert

- **CKRP:** Chittorgarh to kota
- **State:** Rajasthan NH 27
- **Zone:** RJ-06

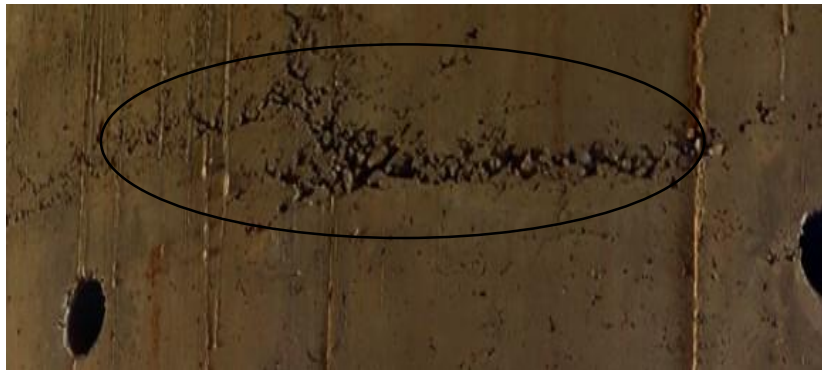
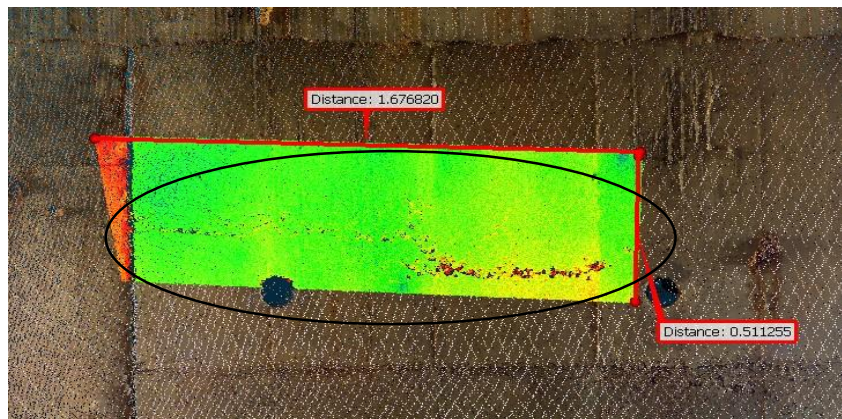
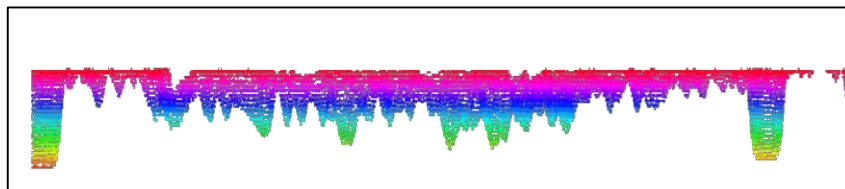
| Element Name | Observation | Location of Distress | Photo No. | Units | Distress Details | | | Area of Repair (Sq.m/R MT/m3) |
|---|---|---|---|---|---|---|---|---|
| Abutment 1 | Honeycombing | - | 1 | M | 1.67 | 0.51 | | 0.8517 |

**1. Honeycombing observed on LHS Abutment 1 , measuring 1.67 m in length and 0.51 m in width, covering an area of 0.8517 m<sup>2</sup>.**

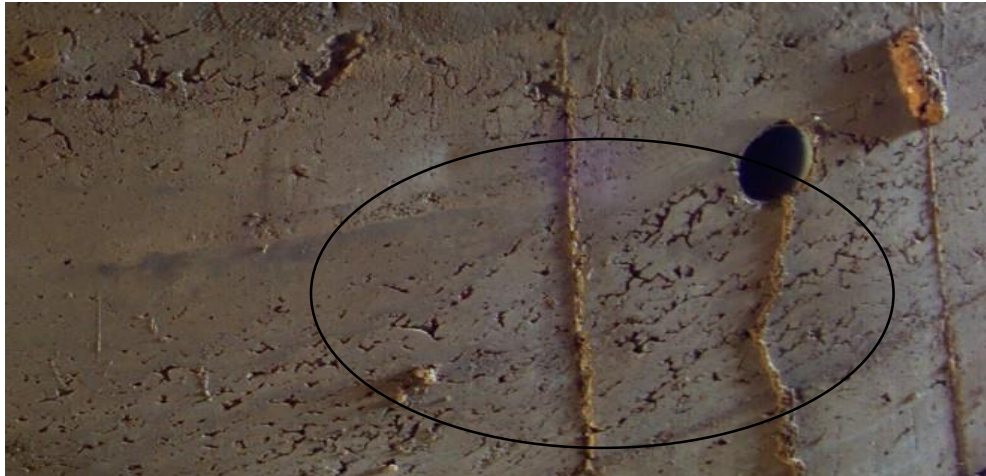
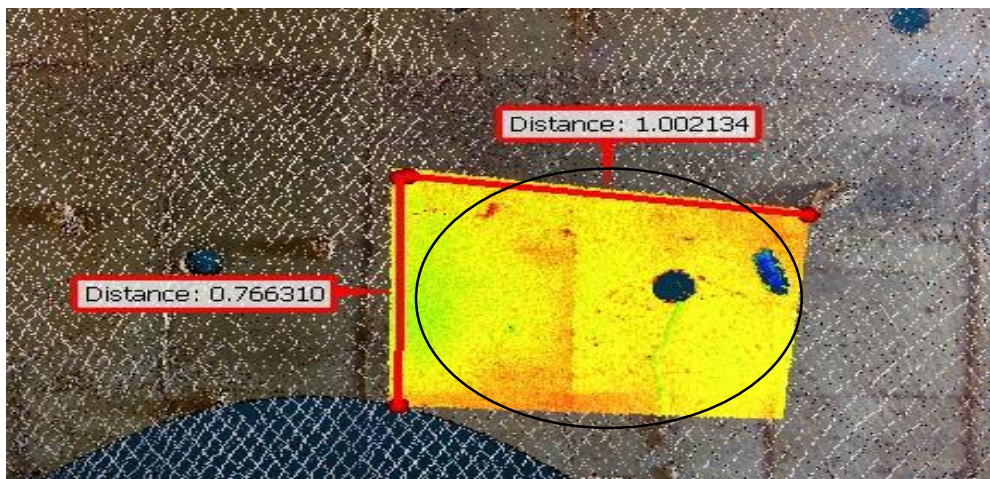
| Element Name | Observation | Location of Distress | Photo No. | Units | Distress Details | | | Area of Repair (Sq.m/R MT/m3) |
|---|---|---|---|---|---|---|---|---|
| Abutment 1 | Scaling | - | 2 | M | 1.00 | 0.76 | | 0.76 |

**2. Scaling observed on LHS Abutment 1, measuring 1.00 m in length and 0.76 m in width, covering an area of 0.76 m<sup>2</sup>.**

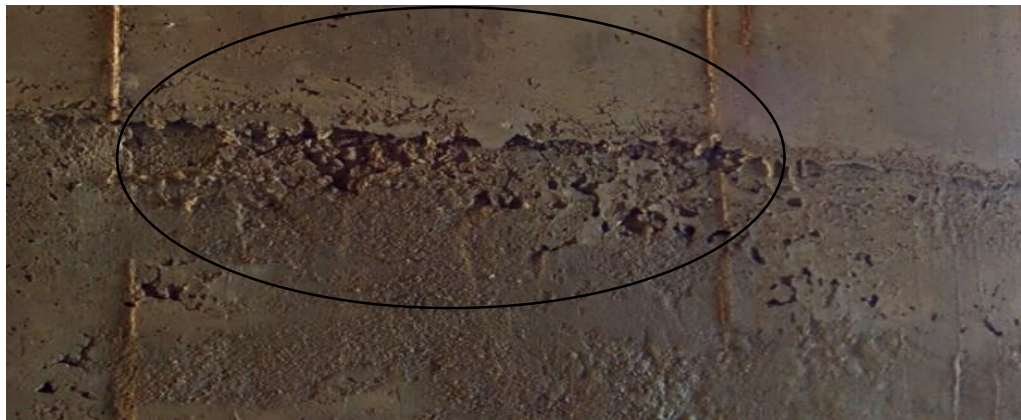
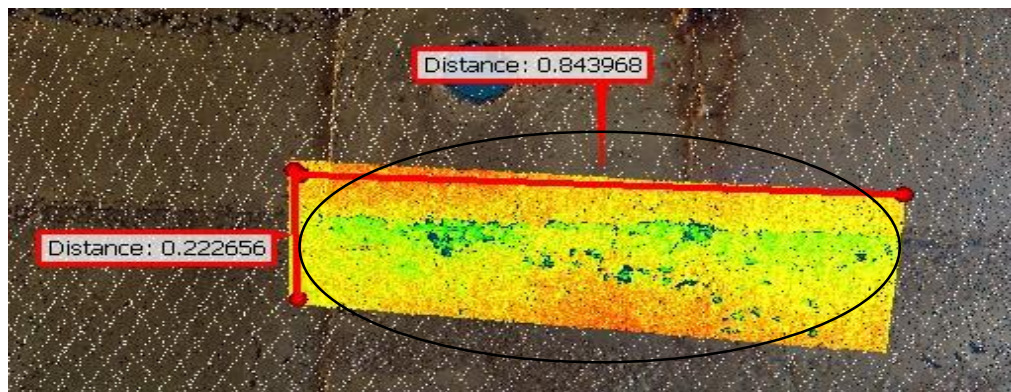
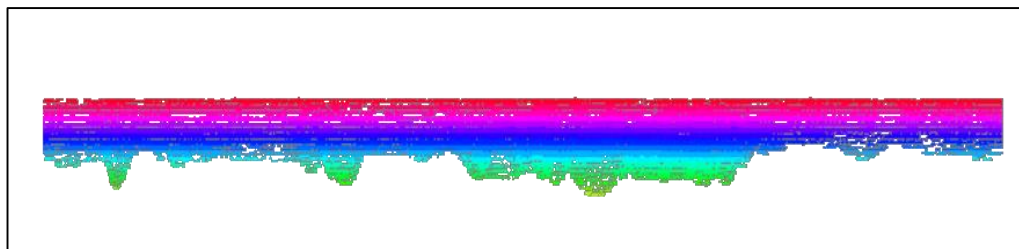
| Element Name | Observation | Location of Distress | Photo No. | Units | Distress Details | | | Area of Repair (Sq.m/R MT/m3) |
|---|---|---|---|---|---|---|---|---|
| Abutment 1 | Honeycombing | - | 3 | M | 0.84 | 0.22 | | 0.1848 |

**3. Honeycombing observed on LHS Abutment 1, measuring 0.84 m in length and 0.22 m in width, covering an area of 0.1848 m<sup>2</sup>.**

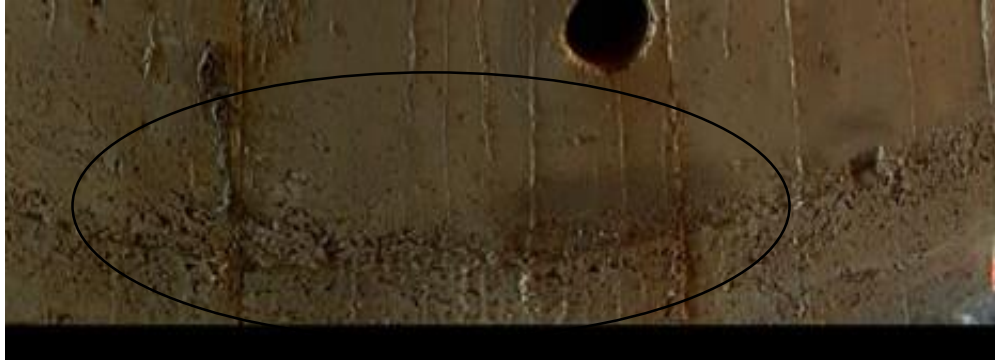
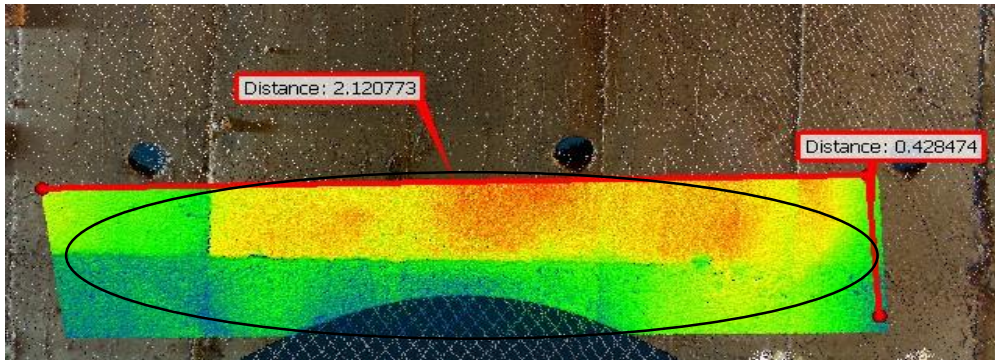
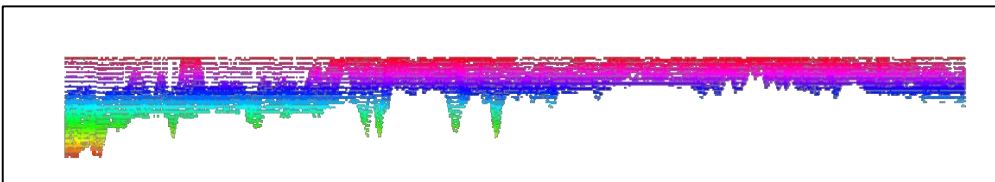
| Element Name | Observation | Location of Distress | Photo No. | Units | Distress Details | | | Area of Repair (Sq.m/R MT/m3) |
|---|---|---|---|---|---|---|---|---|
| Abutment 2 | Scaling | - | 4 | M | 2.12 | 0.42 | | 0.8904 |

**4. Scaling observed on LHS Abutment 2, measuring 2.12 m in length and 0.42 m in width, covering an area of 0.8904 m<sup>2</sup>.**

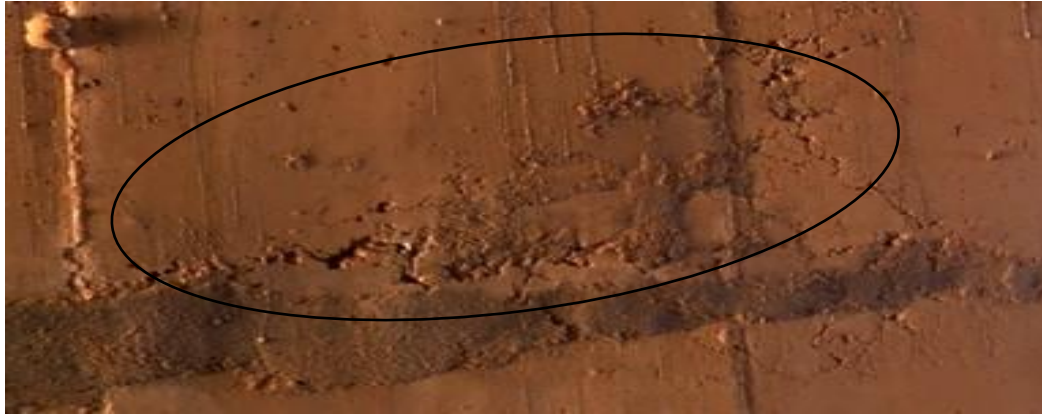
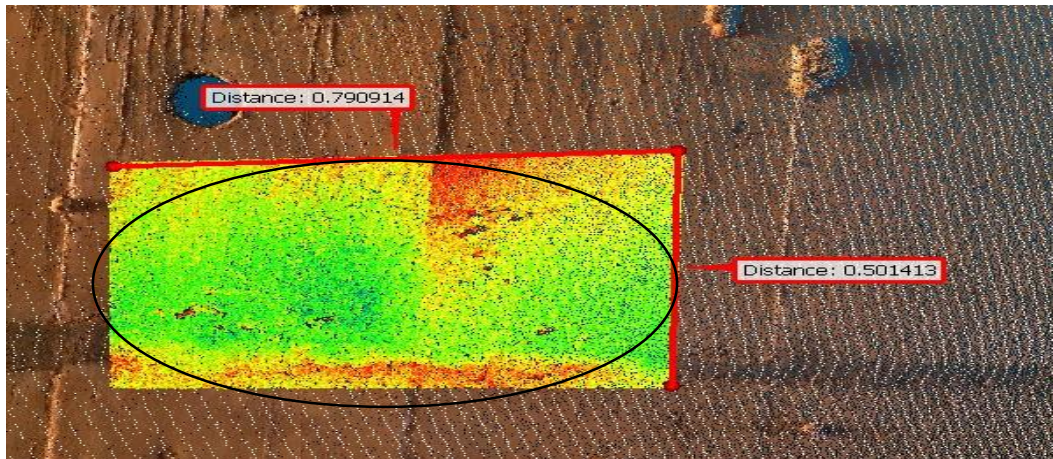
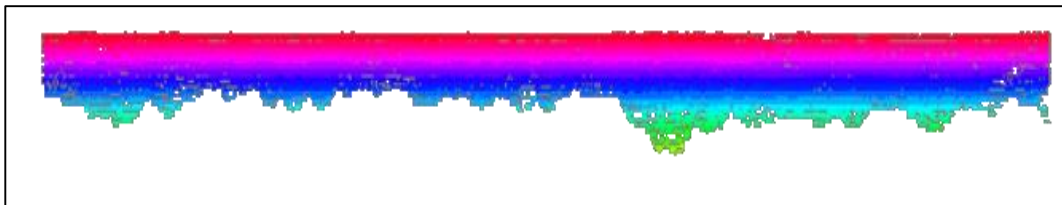
| Element Name | Observation | Location of Distress | Photo No. | Units | Distress Details | | | Area of Repair (Sq.m/R MT/m3) |
|---|---|---|---|---|---|---|---|---|
| Abutment 1 | Scaling | - | 5 | M | 0.79 | 0.50 | | 0.395 |

**5. Scaling observed on RHS Abutment 1, measuring 0.79 m in length and 0.50 m in width, covering an area of 0.395 m<sup>2</sup>.**

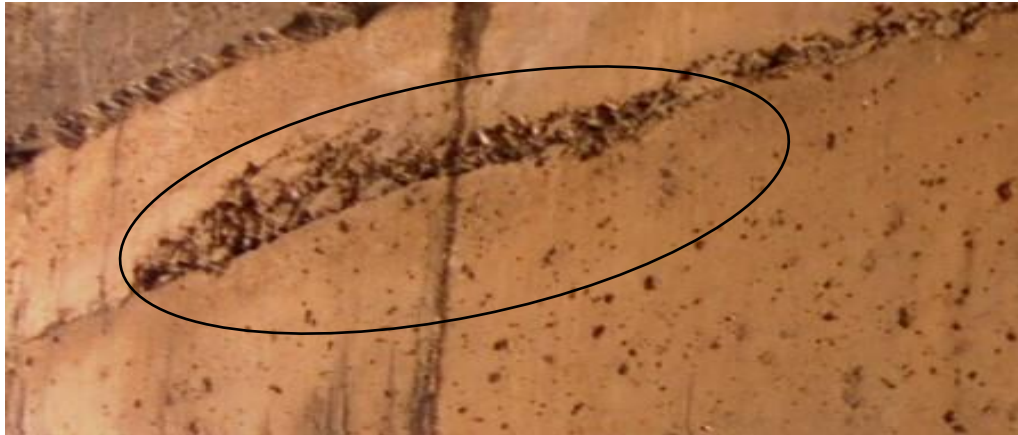
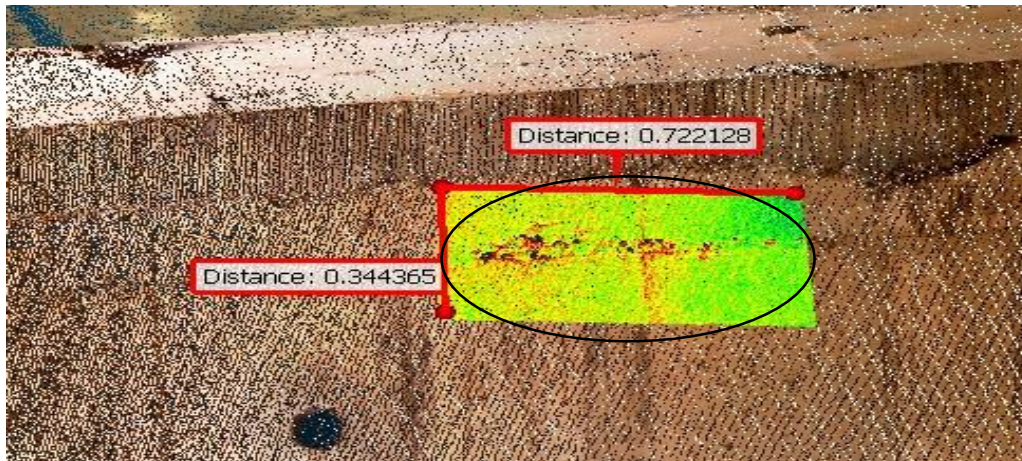
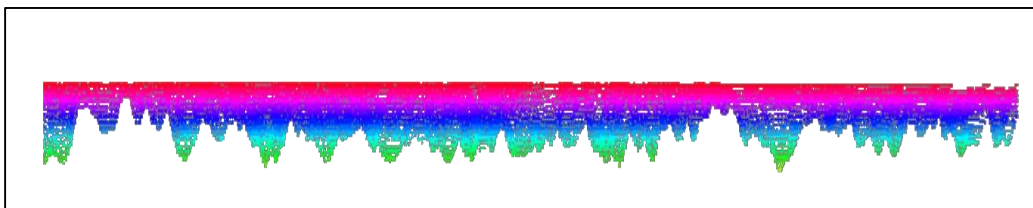
| Element Name | Observation | Location of Distress | Photo No. | Units | Distress Details | | | Area of Repair (Sq.m/R MT/m3) |
|---|---|---|---|---|---|---|---|---|
| Abutment 1 | Honeycombing | - | 6 | M | 0.72 | 0.34 | | 0.2448 |

**6. Honeycombing observed on RHS Abutment 1 , measuring 0.72 m in length and 0.34 m in width, covering an area of 0.2448 m<sup>2</sup>.**

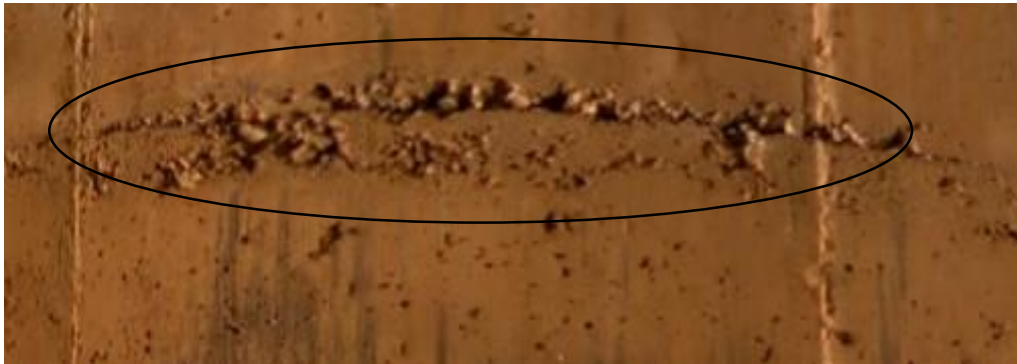
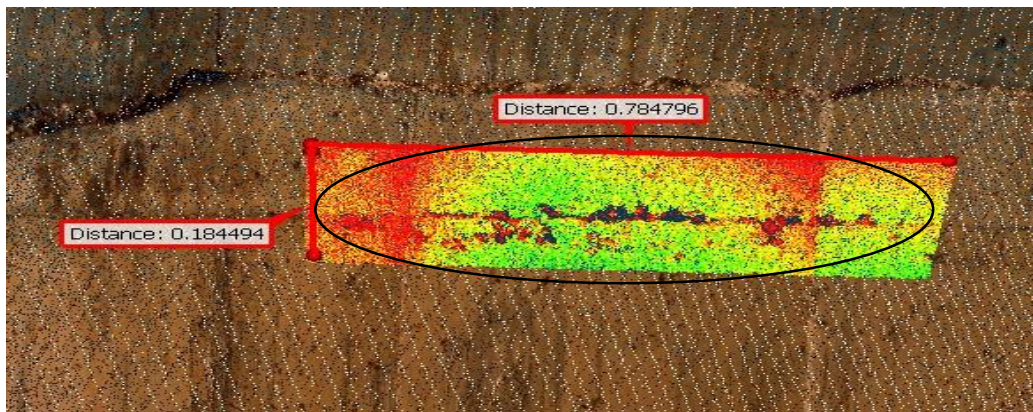
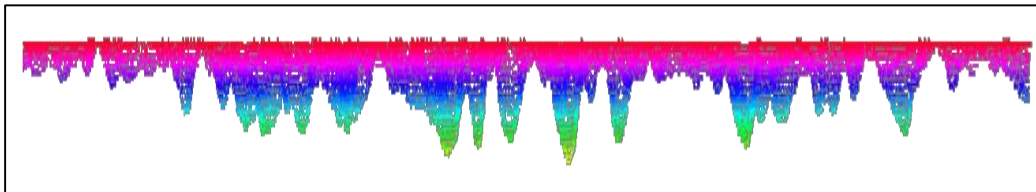
| Element Name | Observation | Location of Distress | Photo No. | Units | Distress Details | | | Area of Repair (Sq.m/R MT/m3) |
|---|---|---|---|---|---|---|---|---|
| Abutment 1 | Honeycombing | - | 7 | M | 0.78 | 0.18 | | 0.1404 |

**7. Honeycombing observed on RHS Abutment 1, measuring 0.78 m in length and 0.18 m in width, covering an area of 0.1404 m<sup>2</sup>.**

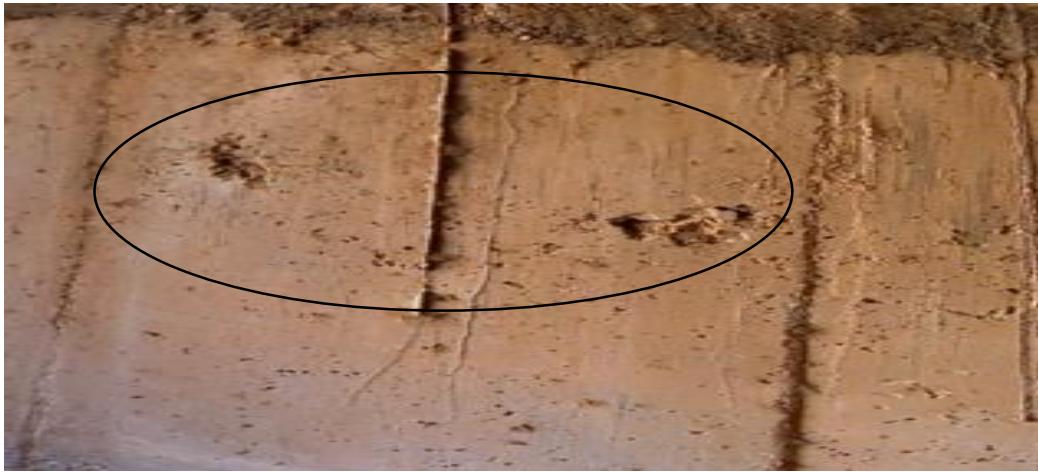
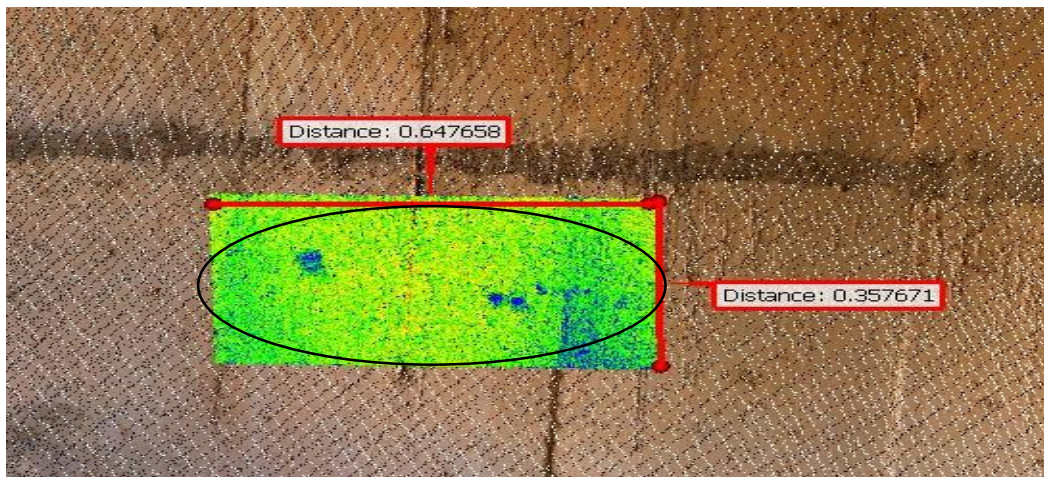
| Element Name | Observation | Location of Distress | Photo No. | Units | Distress Details | | | Area of Repair (Sq.m/R MT/m3) |
|---|---|---|---|---|---|---|---|---|
| Abutment 1 | Damage | - | 8 | M | 0.64 | 0.35 | | 0.224 |

**8. Damage observed on RHS Abutment , measuring 0.64 m in length and 0.35 m in width, covering an area of 0.224 m<sup>2</sup>.**

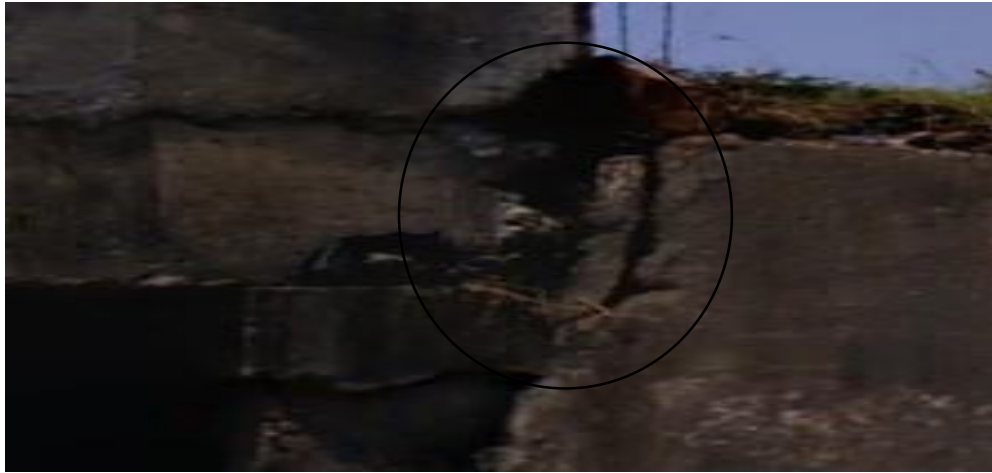
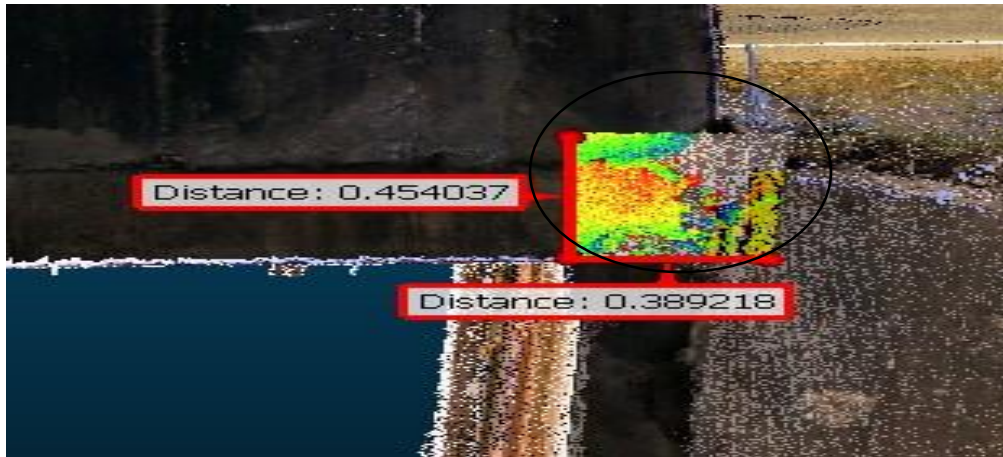
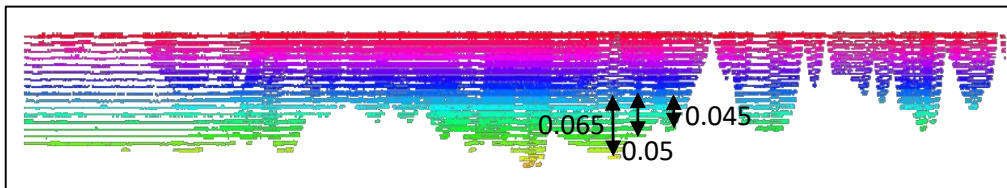
| Element Name | Observation | Location of Distress | Photo No. | Units | Distress Details | | | Area of Repair (Sq.m/R MT/m3) |
|---|---|---|---|---|---|---|---|---|
| Abutment 2 | Damage | | 9 | M | 0.38 | 0.45 | 0.05 | 0.008 |

**9. Damage observed on RHS Abutment 2, measuring 0.38 m in length and 0.45 m in width, Depth ranges from 0.045 (min) to 0.065 m (max), with an average depth of 0.05 m. The calculated volume of the distress is 0.008 m<sup>3</sup>.**
