# **LIDAR Inspection Report of Box Culvert ch.983+140**

**Bridge Chainage:** 983+140

- **Bridge No:** -
- **Chainage:** 983+140
- **Structure type:** Box Culvert

# **CH: 983+140 BOX CULVERT**

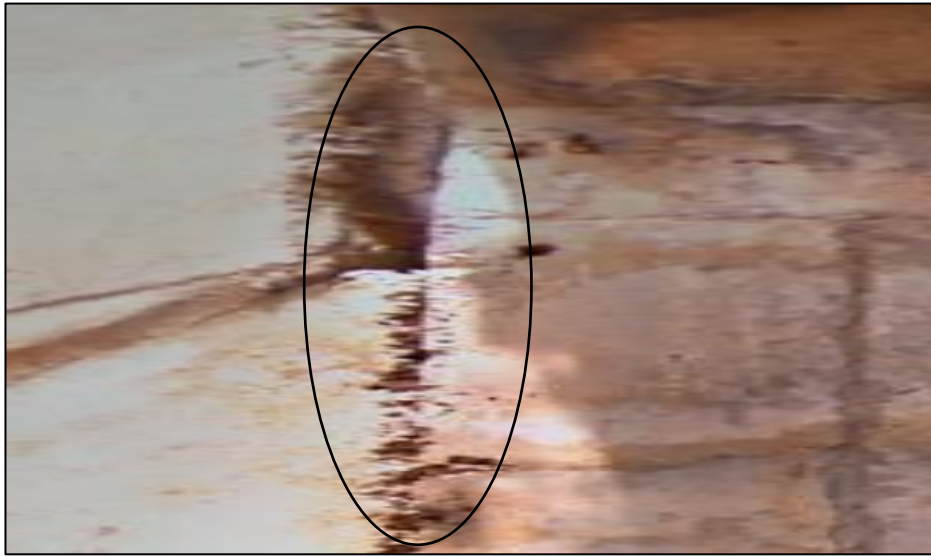
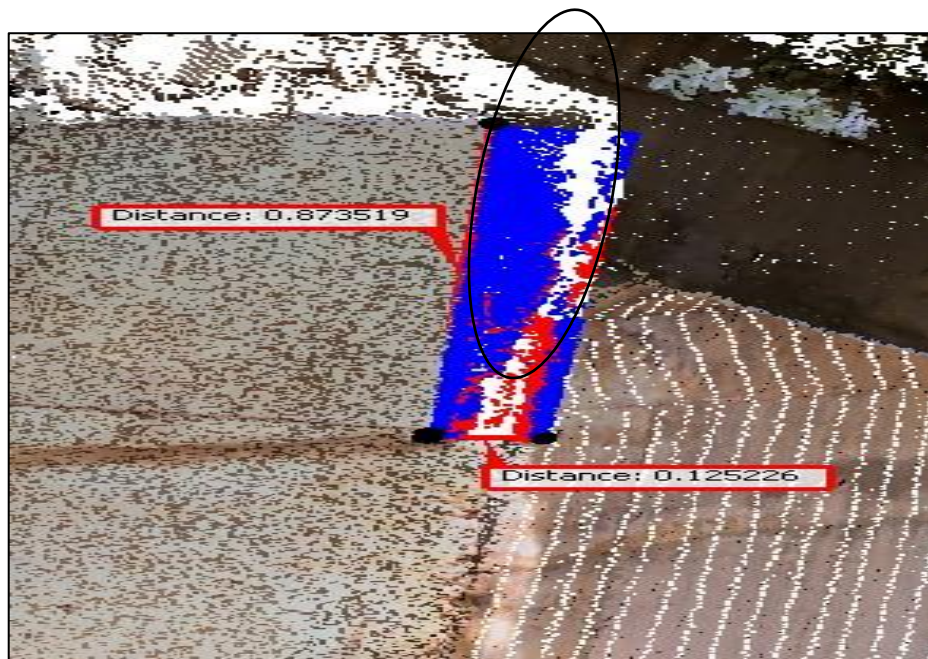
| Element Name | Observation | Location of Distress | Photo No. | Units | Distress Details | | | Area of Repair (Sq.m/ RMT/ m3) |
|---|---|---|---|---|---|---|---|---|
| Wing Wall | Damage | | 1 | | 0.8735 | 0.1252 | 0.013 | 0.0014<br>2 |

1. Wing Wall Damage observed on A1 (RHS), measuring 0.8735 m in length and 0.1252 m in width, covering an area of 0.00142 m<sup>2</sup>, with an average depth of 0.013 m.
