# **LIDAR Inspection Report of VUP ch.983+400**

**Bridge Chainage:** 983+400 (CKRP)

- **Bridge No:** -
- **Chainage:** 983+400
- **Structure type:** VUP

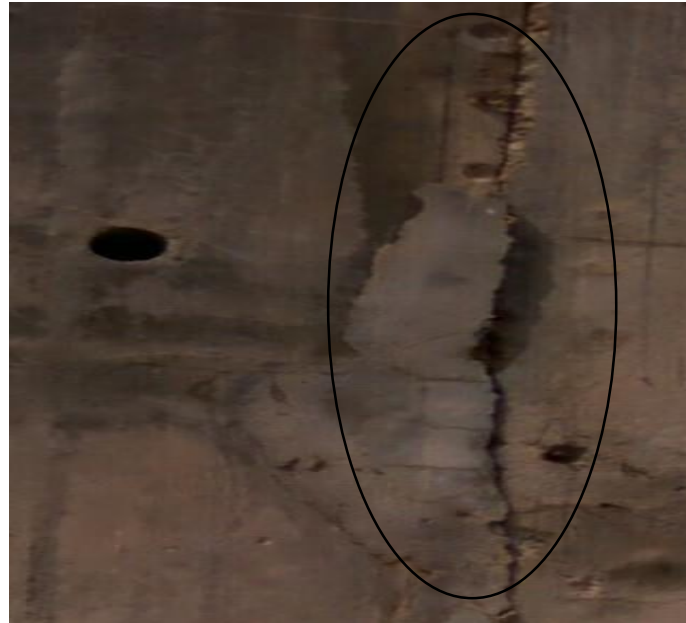
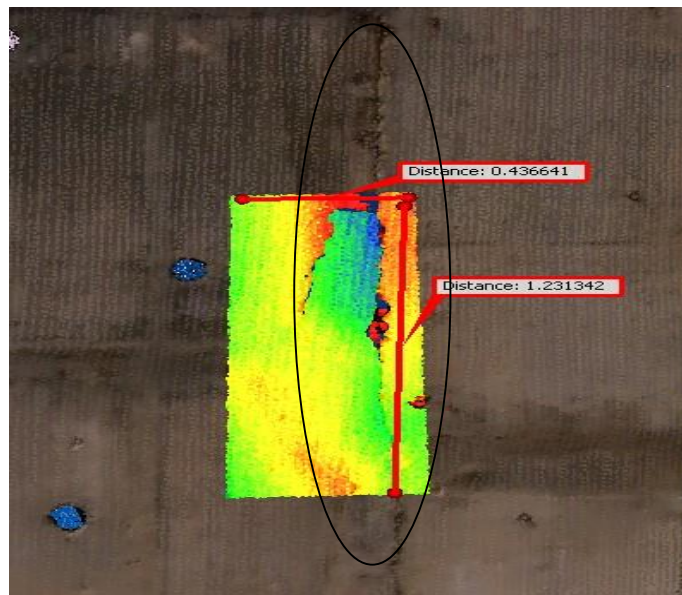
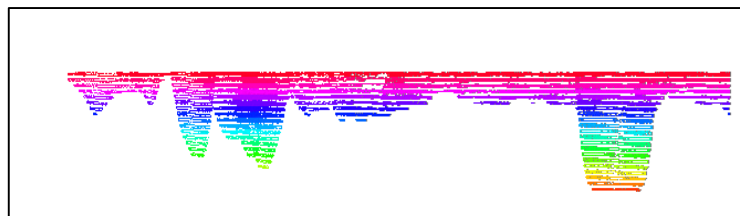
| Element Name | Observation | Location of Distress | Photo No. | Units | Distress Details | | | Area of Repair<br>(Sq.m/R<br>MT/m3) |
|---|---|---|---|---|---|---|---|---|
| Abutment 2<br>Wall | Damage | - | 1 | M | 0.43 | 1.23 | - | 0.528 |

**1. Abutment Wall damage observed on LHS, measuring 0.43 m in length and 1.23 m in width, covering an area of 0.528 m<sup>2</sup>."**
