# **LIDAR Inspection Report of Slab Culvert ch.983+835**

**Bridge Chainage:** 983+835(CKRP)

- **Bridge No:** -
- **Chainage:** 983+835
- **Structure type:** Slab Culvert

- **CKRP:** Chittorgarh to kota
- **State:** Rajasthan NH 27
- **Zone:** RJ-06

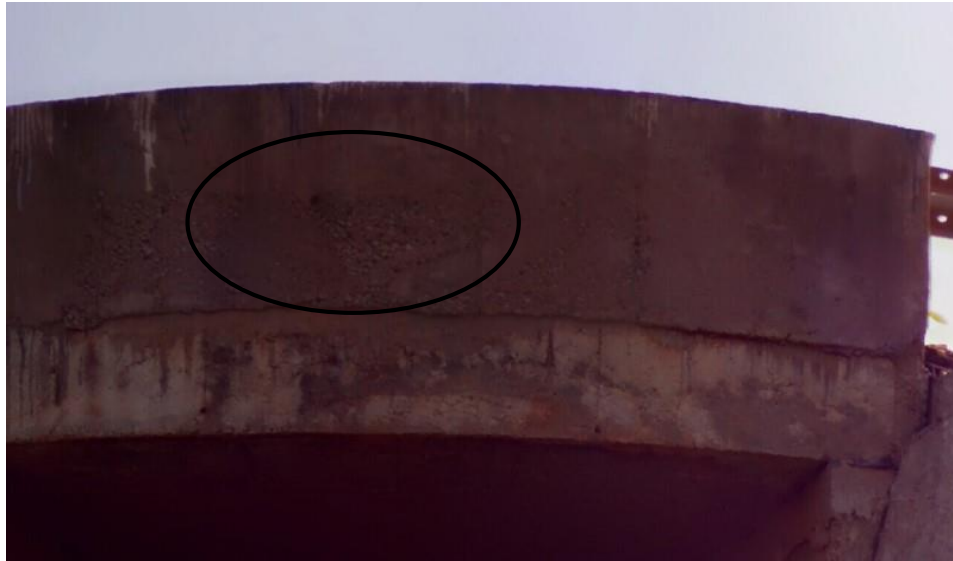
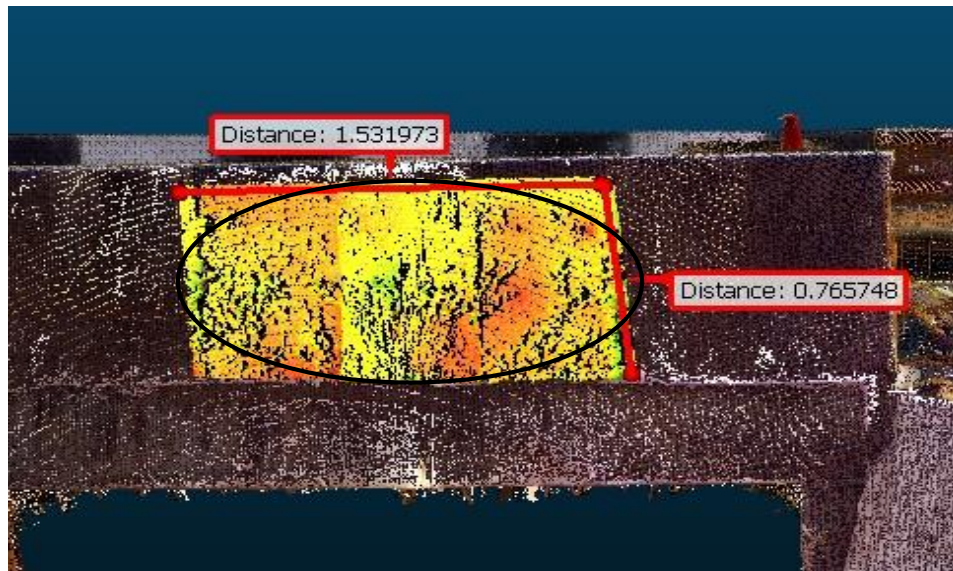
| Element Name | Observation | Location of Distress | Photo No. | Units | Distress Details | | | Area of Repair (Sq.m/R MT/m3) |
|---|---|---|---|---|---|---|---|---|
| Parapet Wall | Honeycombing | - | 1 | M | 1.53 | 0.76 | | 1.16 |

**1. Honeycombing observed on parapet wall, measuring 1.53 m in length and 0.76 m in width, covering an area of 1.16 m<sup>2</sup>.**

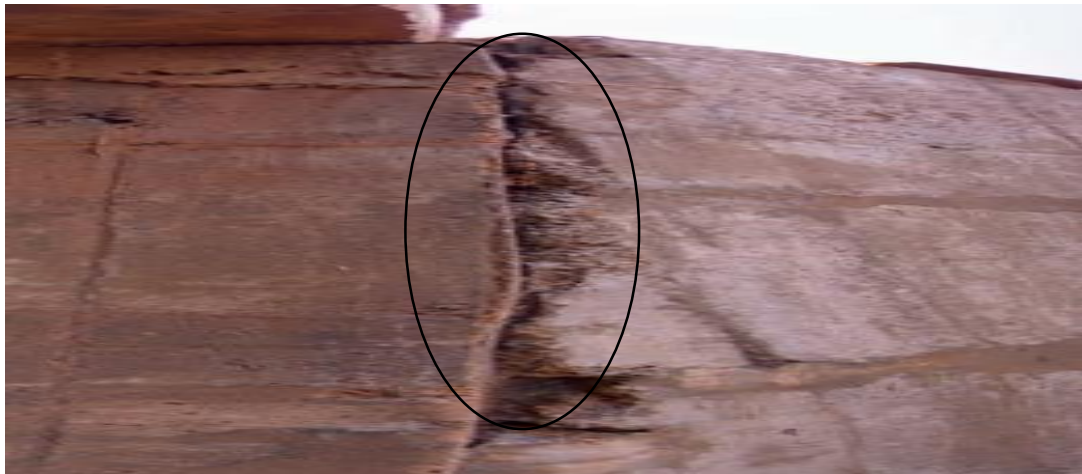
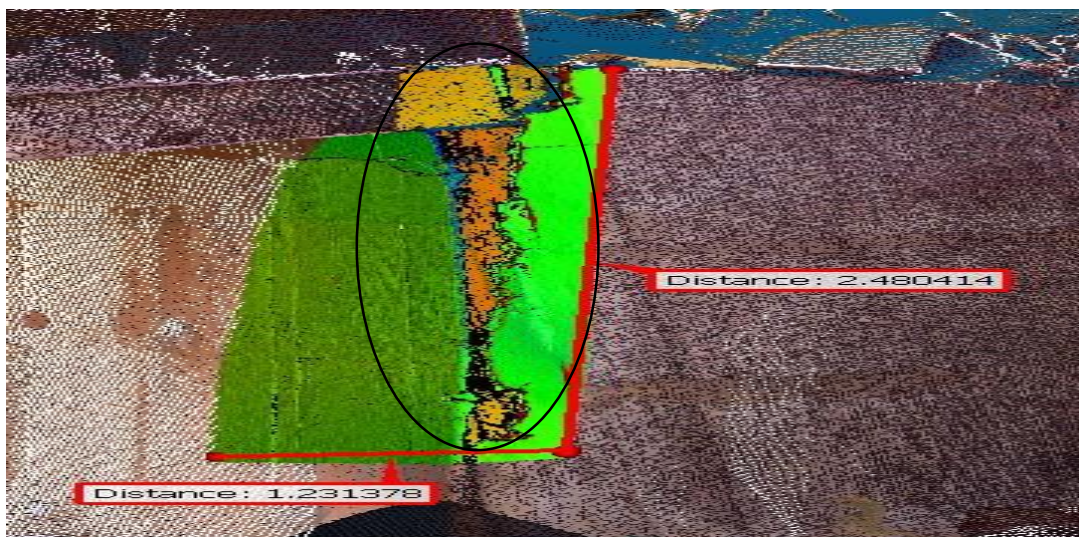
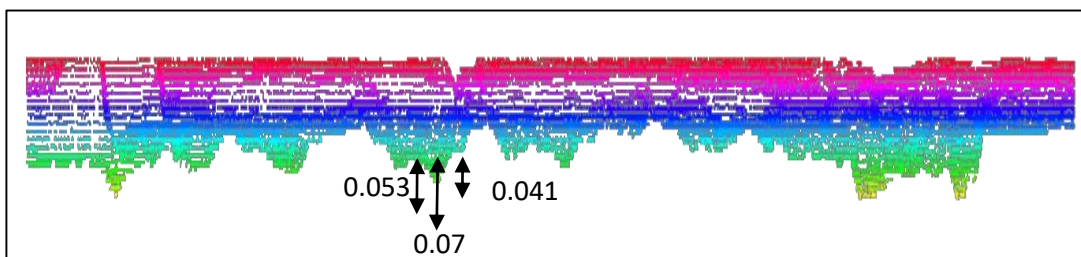
| Element Name | Observation | Location of Distress | Photo No. | Units | Distress Details | | | Area of Repair (Sq.m/R MT/m3) |
|---|---|---|---|---|---|---|---|---|
| Abutment | Damage | - | 2 | M | 1.23 | 2.48 | 0.053 | 0.1616 |

2. Damage observed on Abutment wall, measuring 1.23 m in length and 2.48 m in width, Depth ranges from 0.041 (min) to 0.07 m (max), with an average depth of 0.053 m. The calculated volume of the distress is 0.1616 m<sup>3</sup>.

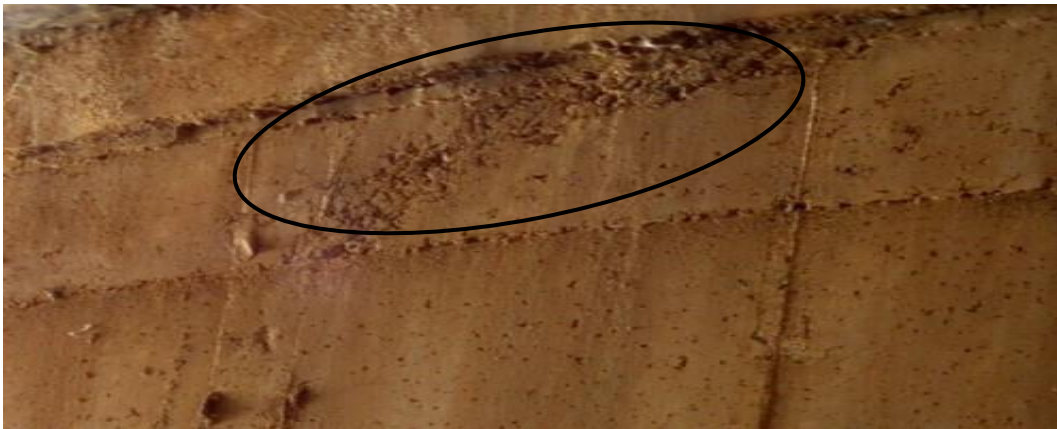
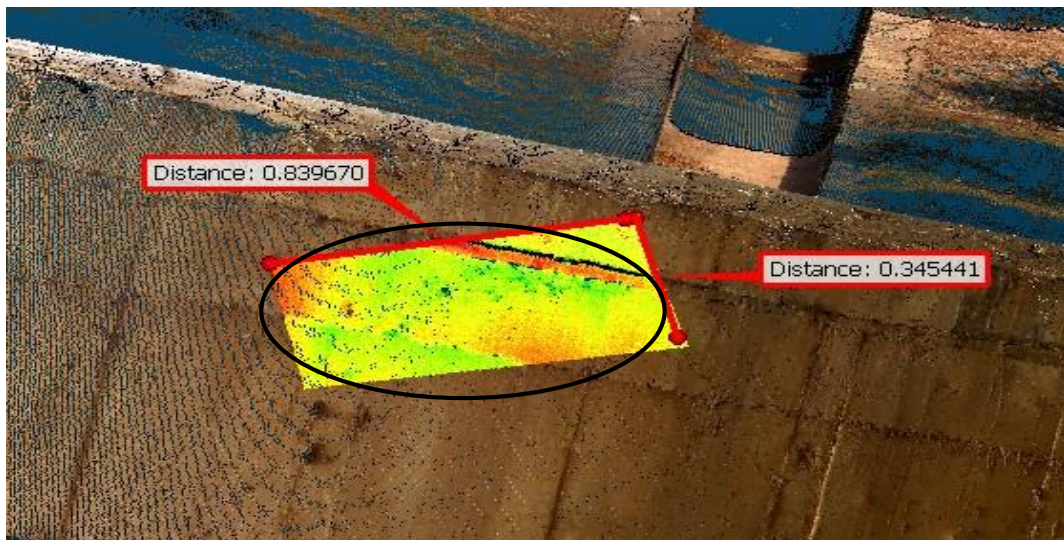
| Element Name | Observation | Location of Distress | Photo No. | Units | Distress Details | | | Area of Repair (Sq.m/R MT/m3) |
|---|---|---|---|---|---|---|---|---|
| Abutment | Honeycombing | - | 3 | M | 0.83 | 0.34 | | 0.2822 |

**3. Honeycombing observed on Abutment wall, measuring 0.83 m in length and 0.34 m in width, covering an area of 0.2822 m<sup>2</sup>.**

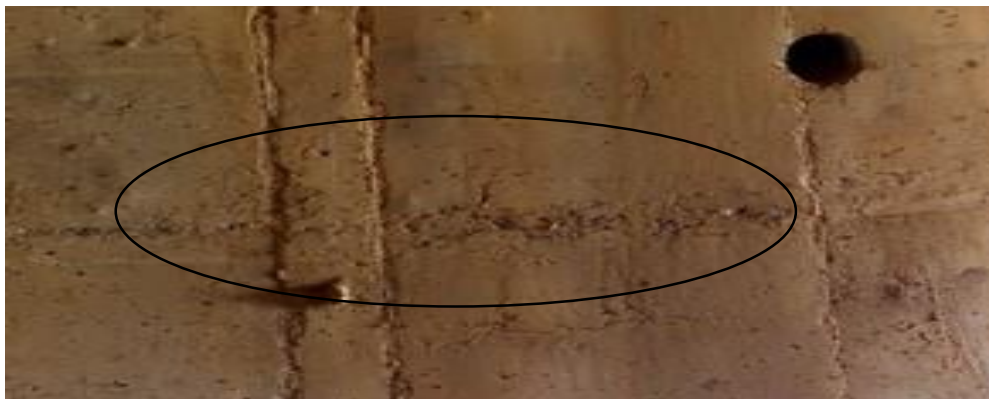
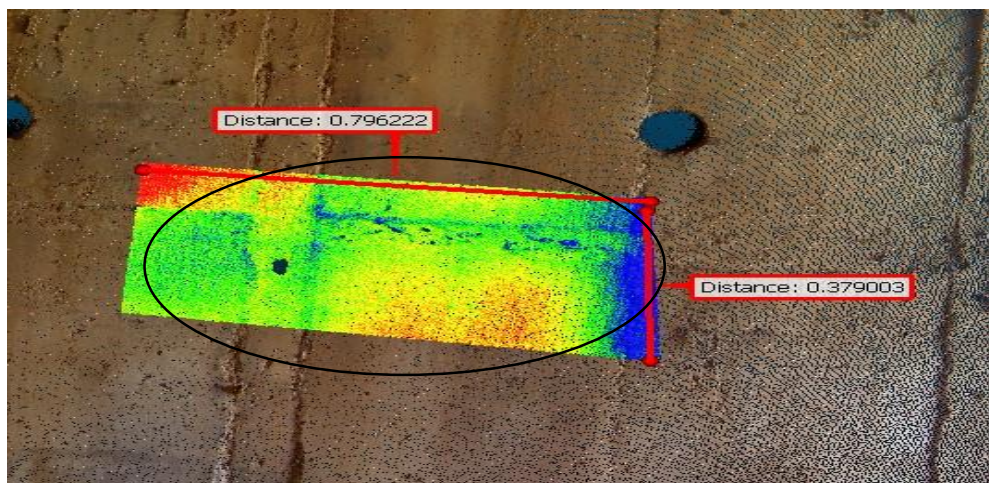
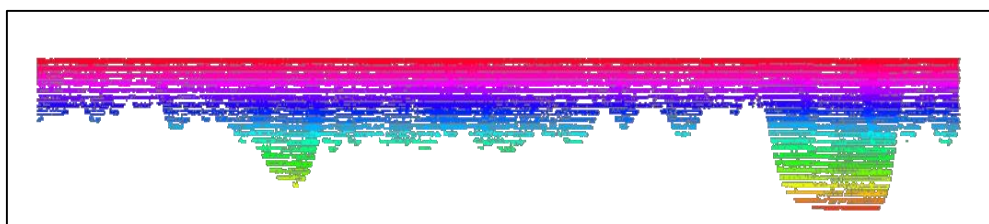
| Element Name | Observation | Location of Distress | Photo No. | Units | Distress Details | | | Area of Repair (Sq.m/R MT/m3) |
|---|---|---|---|---|---|---|---|---|
| Abutment | Scaling | - | 4 | M | 0.79 | 0.37 | | 0.2923 |

**4. Scaling observed on Abutment wall, measuring 0.79 m in length and 0.37 m in width, covering an area of 0.2923 m<sup>2</sup>.**

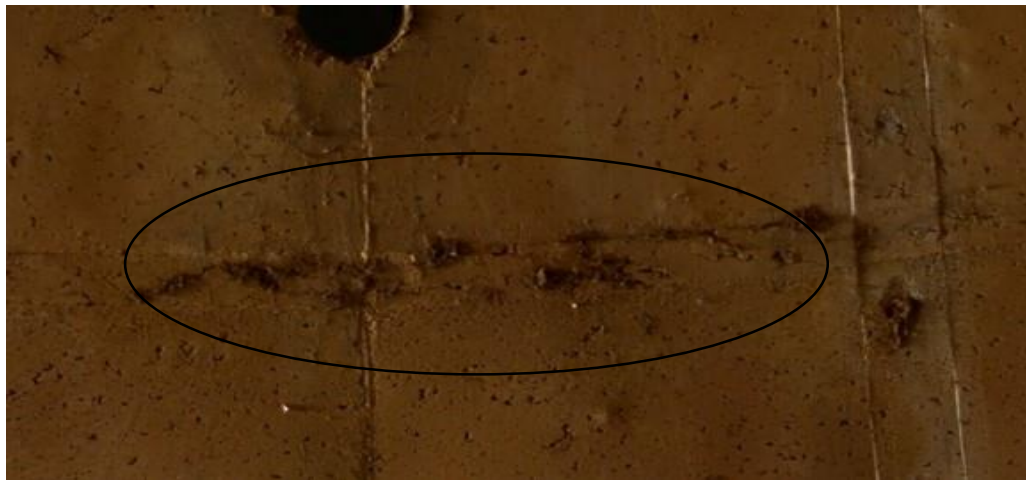
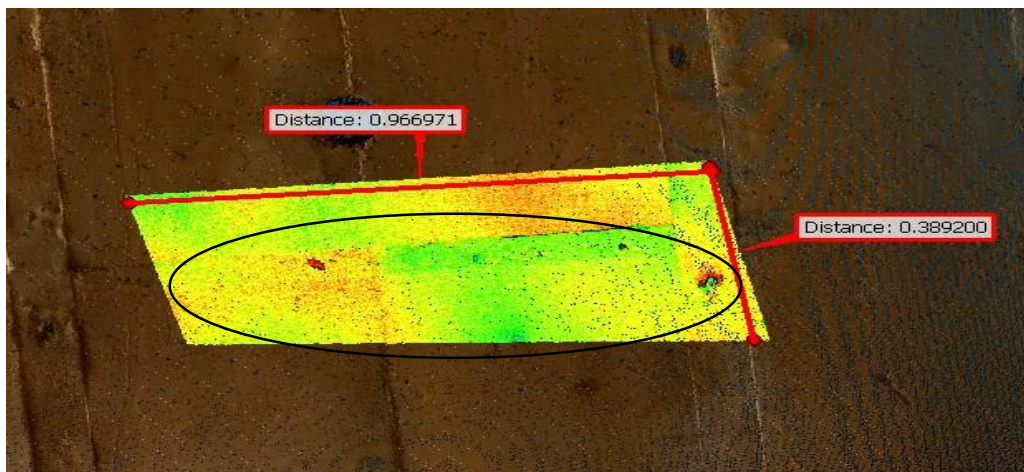
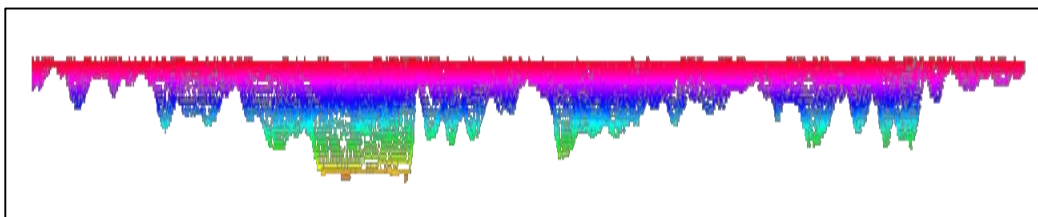
| Element Name | Observation | Location of Distress | Photo No. | Units | Distress Details | | | Area of Repair (Sq.m/R MT/m3) |
|---|---|---|---|---|---|---|---|---|
| Abutment | Scaling | - | 5 | M | 0.96 | 0.38 | | 0.3648 |

5. Scaling observed on Abutment wall, measuring 0.96 m in length and 0.38 m in width, covering an area of 0.3648 m<sup>2</sup>.

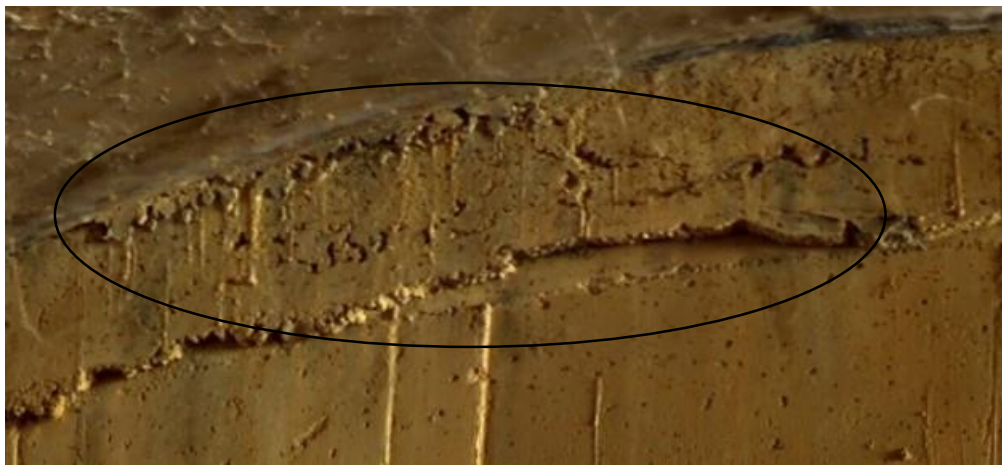
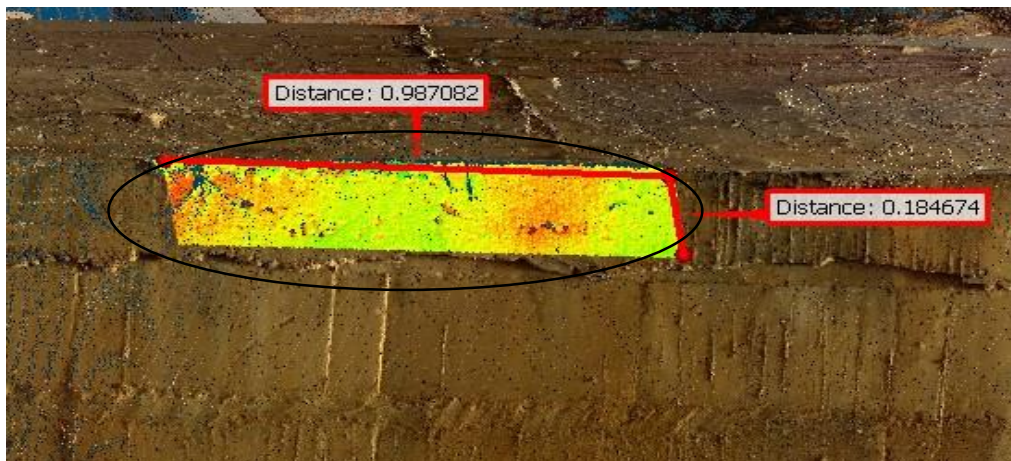
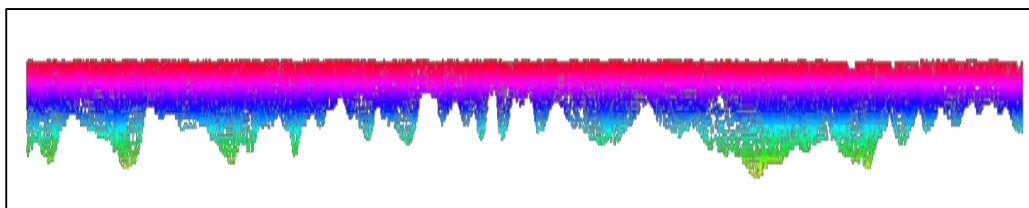
| Element Name | Observation | Location of Distress | Photo No. | Units | Distress Details | | | Area of Repair (Sq.m/R MT/m3) |
|---|---|---|---|---|---|---|---|---|
| Abutment | Honeycombing | - | 6 | M | 0.98 | 0.18 | | 0.1764 |

**6. Honeycombing observed on Abutment wall, measuring 0.98 m in length and 0.18 m in width, covering an area of 0.1764 m<sup>2</sup>.**

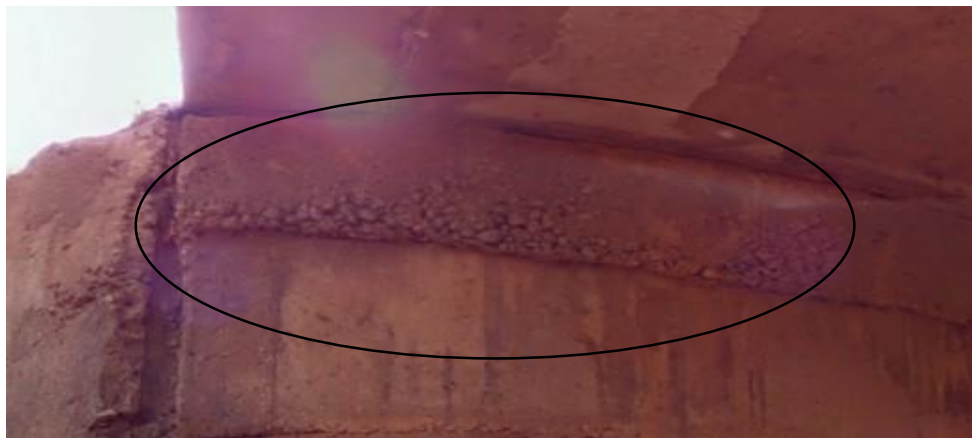
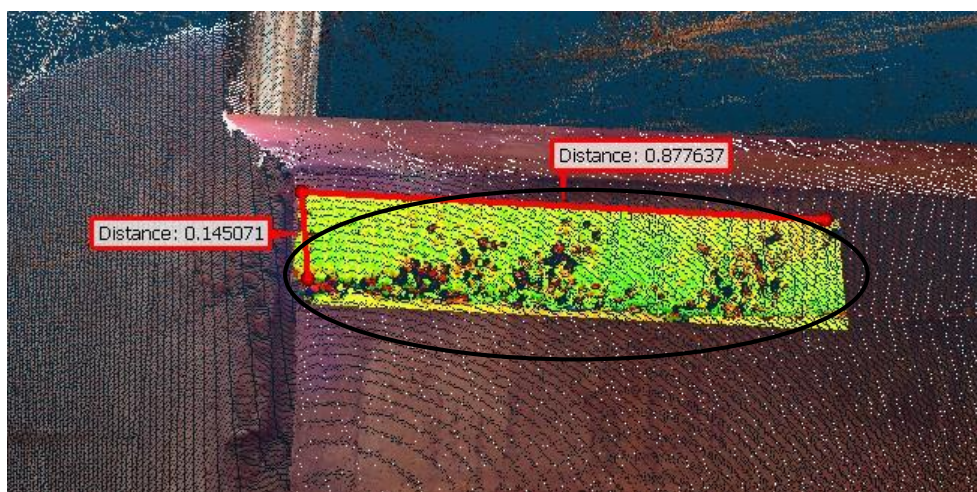
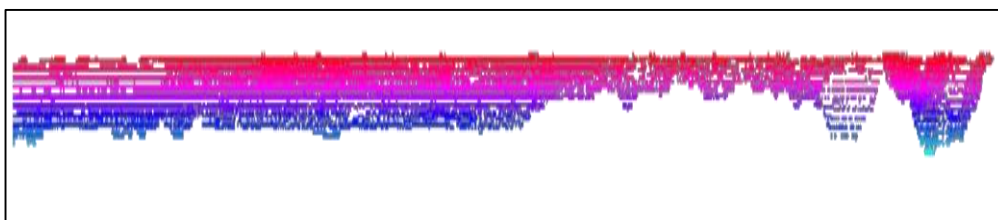
| Element Name | Observation | Location of Distress | Photo No. | Units | Distress Details | | | Area of Repair (Sq.m/R MT/m3) |
|---|---|---|---|---|---|---|---|---|
| Abutment | Honeycombing | - | 7 | M | 0.87 | 0.14 | | 0.1218 |

**7. Honeycombing observed on Abutment wall, measuring 0.87 m in length and 0.14 m in width, covering an area of 0.1218 m<sup>2</sup>.**
